**RE:** Update on curling centre

# Comox Valley Curling Rink Renovation Study Report **DRAFT**

Comox Valley Curling Rink, 4835 Headquarters Road, Courtenay, BC

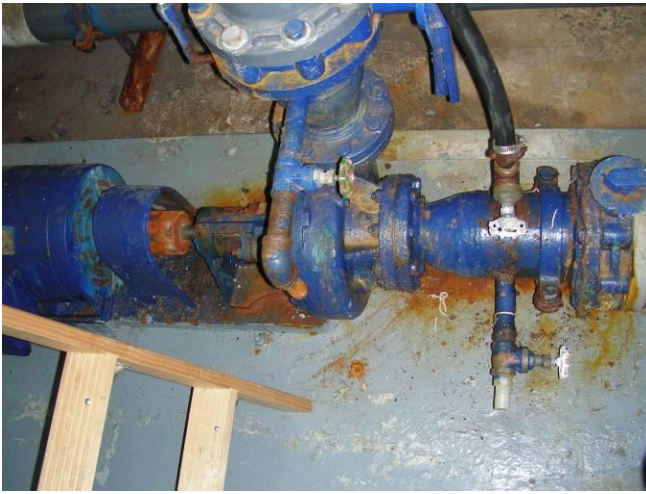
Fig. 2.3.1 Curling rink brine pump

The first four items in the following list are located in the room known as the ice plant in the north-east corner of the Rink Component. Most of them are older than their expected service lives.

- Most of the mechanical equipment in the ice plant is at the end of its service life and is recommended to be replaced. If not, failure of the equipment will likely lead to the loss of the sheet ice. Reinstatement of the sheet ice, even on an accelerated schedule will take approximately 8 days after receipt and installation of replacement equipment. The replacement process for failed equipment could take approximately 5 months.

- Replace curling rink brine pump
- Replace curling rink brine chiller
- Replace curling rink condenser
- Replace curling rink compressor
- Replace curling rink de-humidifier 1
- Replace curling rink de-humidifier 2

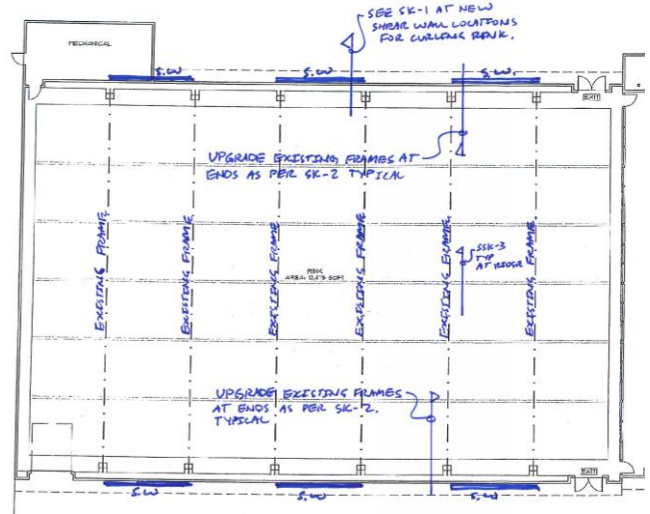
Fig. 2.4.1 Excerpt from RJC Structural Assessment Report Plan view showing areas to be modified.

- Upgrading to current building code requires a sprinkler system to be installed.
- To upgrade for seismic and snow loading, modifications to the perimeter walls and glulam frames are required. New concrete grade beam ties are needed replace the original sub-slab glulam frame tie rods.

Add new metal plate connections and tie rods to existing glulam frames.

Install new concrete grade beam ties to replace the original sub-slab glulam frame tie rods.

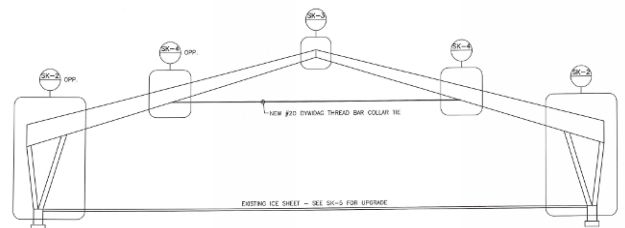
Fig. 2.4.2 Excerpt from RJC Structural Assessment Report Cross-section showing areas to be modified.

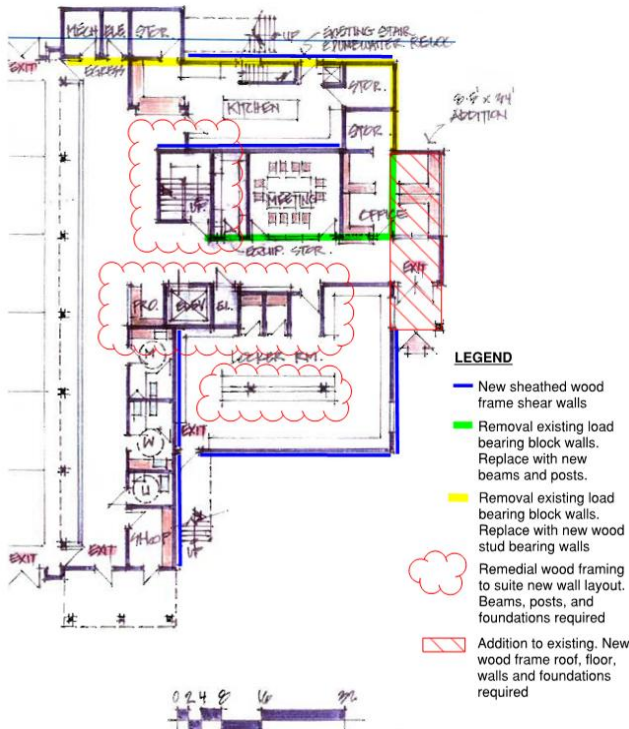
Fig. 2.4.3 Excerpt from RJC Structural Assessment Report Structural modifications of main floor marked up on Vic Davies drawing.

Add new wood frame shear walls and new concrete pad and strip foundations.

Upgrade or replace existing unreinforced concrete block.

Add new beams, posts, and foundations.

Install foundation and framing for new elevator.

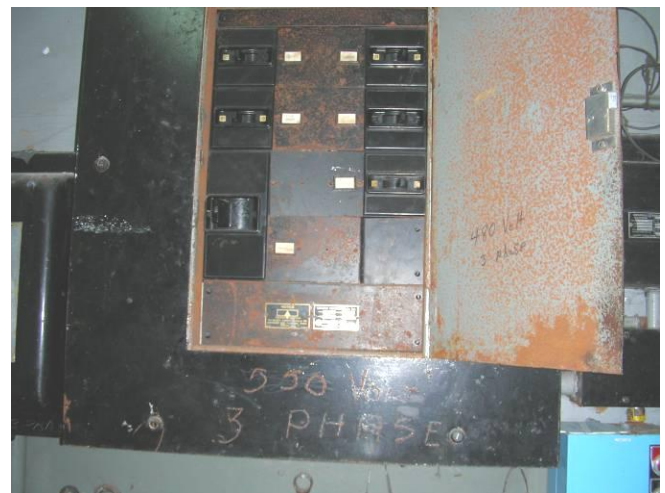
Fig. 2.5.1 Corroded 480 volt electrical panel.

- Although most of the electrical equipment is of advanced age, imminent failure cannot be predicted. As such, a maintenance approach has been presented. Nevertheless, it should be recognized that there are risks associated with this approach, namely, electrical equipment failure could result in loss of sheet ice and associated down time.

Completely replace electrical distribution equipment for the 480V service.

Completely replace electrical distribution equipment for the 240V service.

Replace or verify the main grounding system.

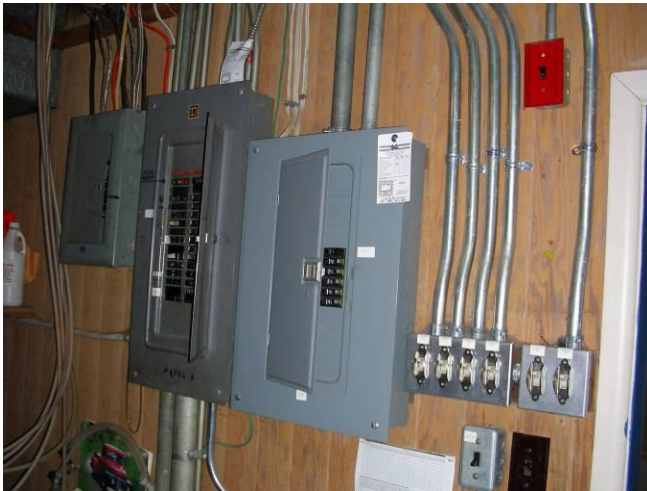
Fig. 2.5.2 Panels to be combined and rotated to face, and be accessed, from corridor.

Replace several subpanels on the 120/240V system. In one case, a set of three panels should be combined into one larger panel, rotated 180 degrees to face the corridor.

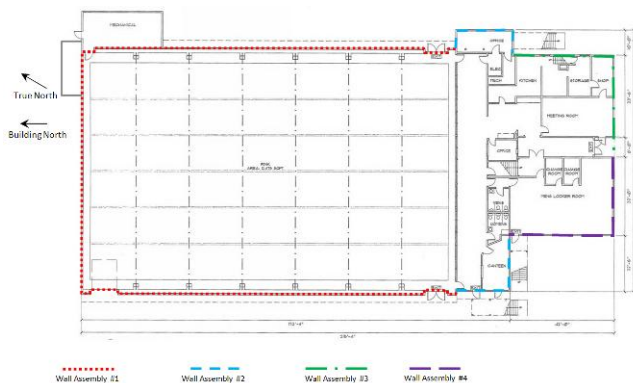
Fig. 2.6.1 Small scale excerpt from Building Enclosure Assessment Report.

The figure below is a small scale version of the figure identifying the location of various exterior wall assemblies. Wall Assembly #1, shown in red, is the typical wall assembly of the Curling Component. The other wall assemblies are associated with the Social Component.

Wall Assembly #1: Perform spot repairs to vinyl cladding.

Wall Assembly #1: Remove the vinyl cladding, strapping, building paper, and expanded polystyrene. Install a continuous air / vapour / moisture barrier over outboard sheathing, then an optimized level of insulation, spacers, and durable cladding.
