**RISK ANALYSIS OF
CVRD FORCEMAIN
ON BALMORAL BEACH**

DRAFT REPORT

Comox Valley Regional District

19 September 2016

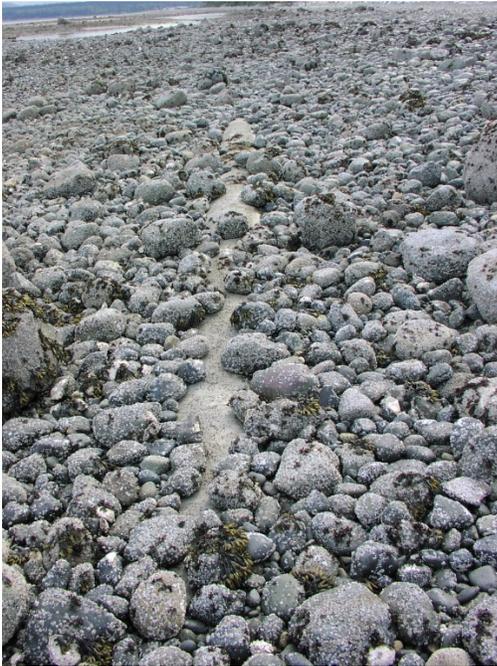
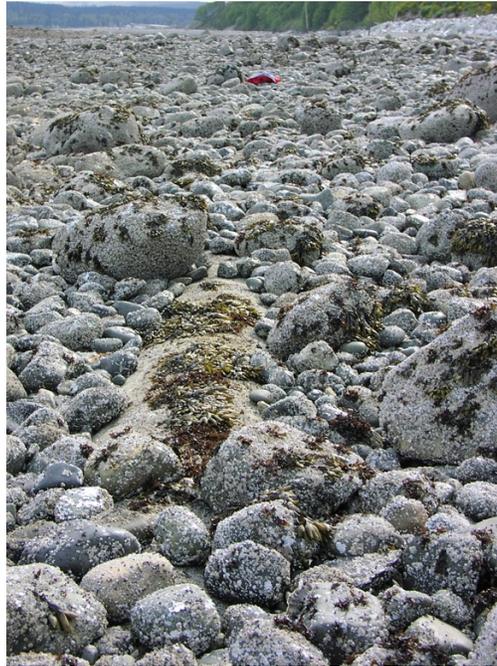
Monitoring by the CVRD in 2003 indicated that the depth of cover over the forcemain was less than 0.5 m in some locations (Figure 8). In May 2003, inspections showed that portions of the line were exposed (Photo 5). The study concluded that the forcemain was vulnerable to scour and undermining due to long-term lowering of the beach profile and identified four alternatives to prevent a failure of the forcemain:

Photo 5: Exposed sections of forcemain near Sta. 11+00 in May 2003

1. Re-locate the sewer line away from the foreshore.
2. Install a parallel section of line at a lower elevation to prevent undermining.
3. Install protection over the portion of the line that is threatened by scour.
4. Place a gravel and cobble berm over the line and install a series of groynes to retain the beach material.

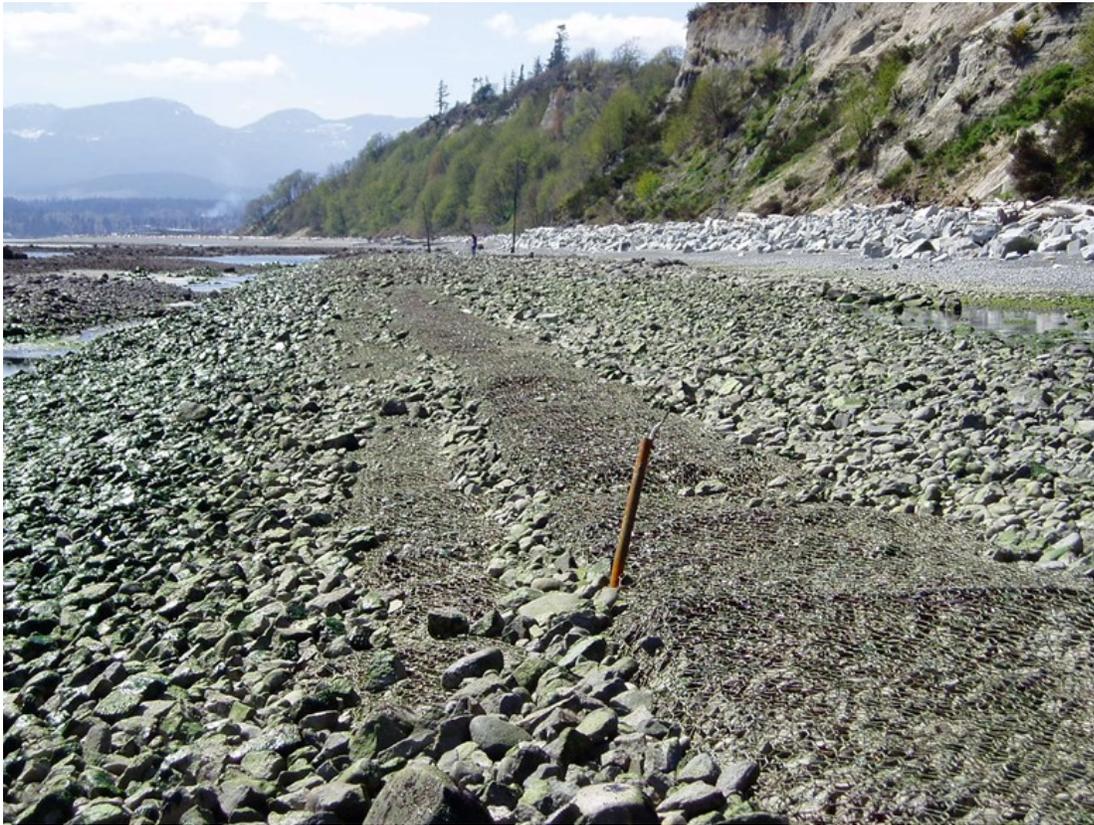
Photo 6: Waves have removed cobble-boulder cover and deposited material landward (April 2004)

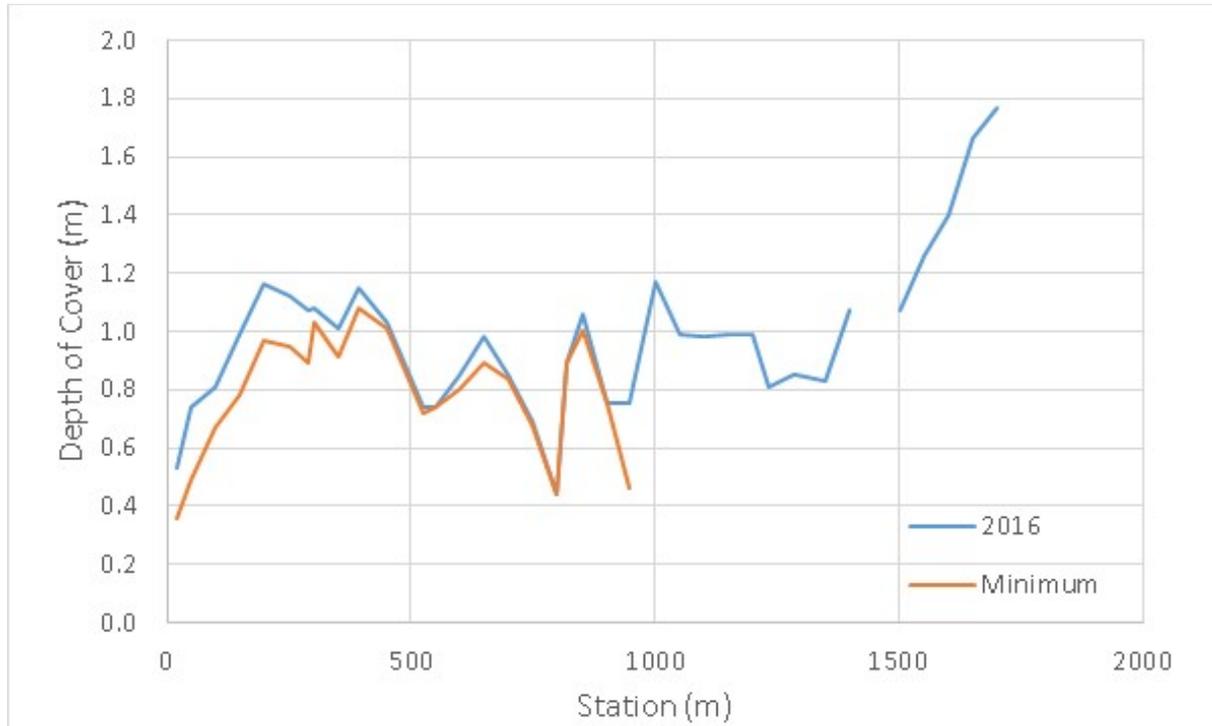
Figure 13: Depth of cover over forcemain in 2016

Trends over time are plotted in Figure 10 through Figure 12. Figure 13 shows the depth of cover along the forcemain in 2016 as well as the minimum depth of cover observed between 2003 and 2016.

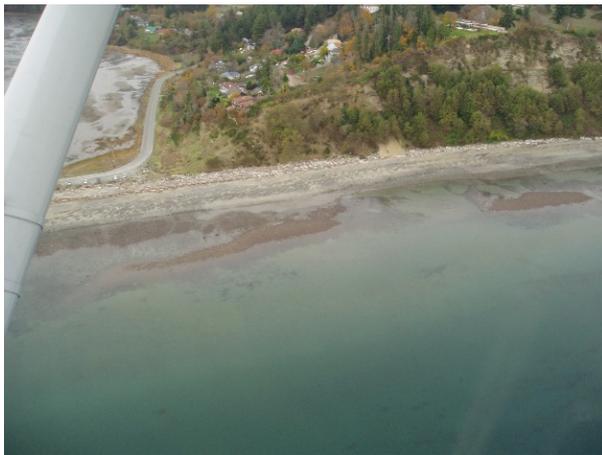
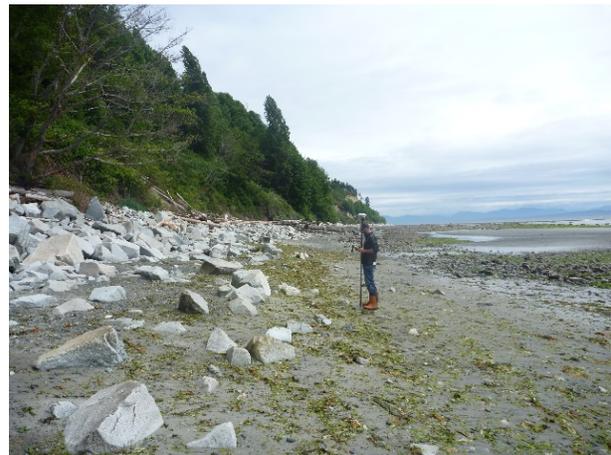
Photo 7: Near Station 2+00 viewing north. Shoreline has been ripped since 2003. Riprap appears to have been displaced by waves onto beach

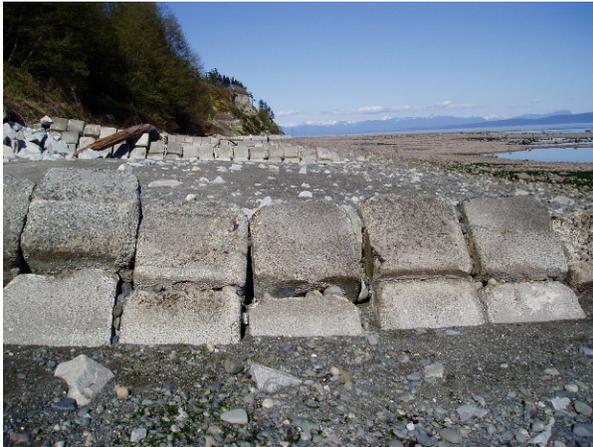
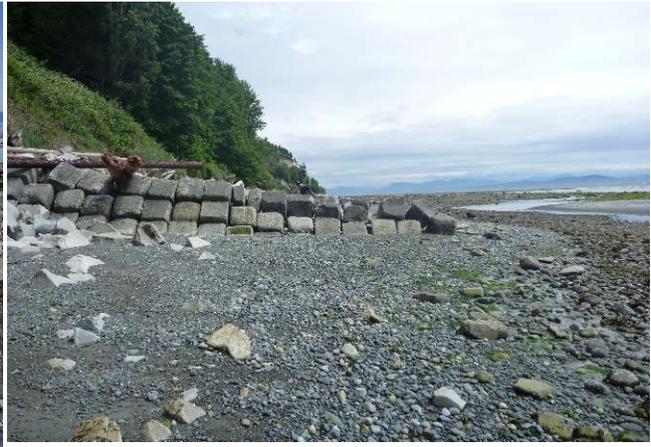
Photo 8: Near Station 4+50, viewing north. Displaced riprap and concrete blocks on groynes

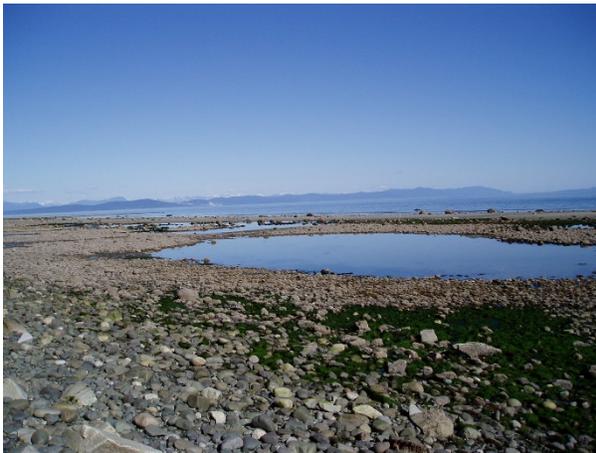
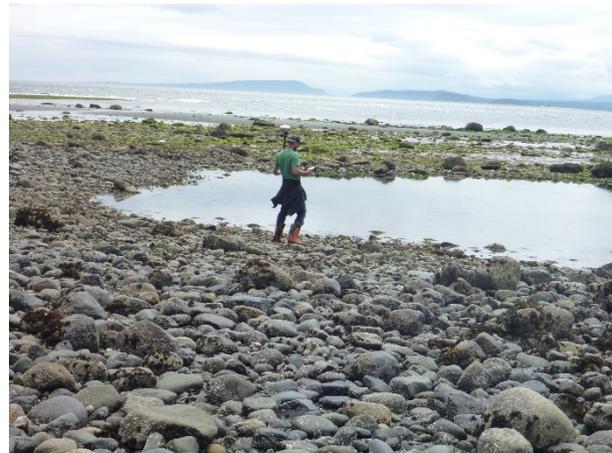
Photo 9: Near Station 8+00 showing coarse-grained lower beach

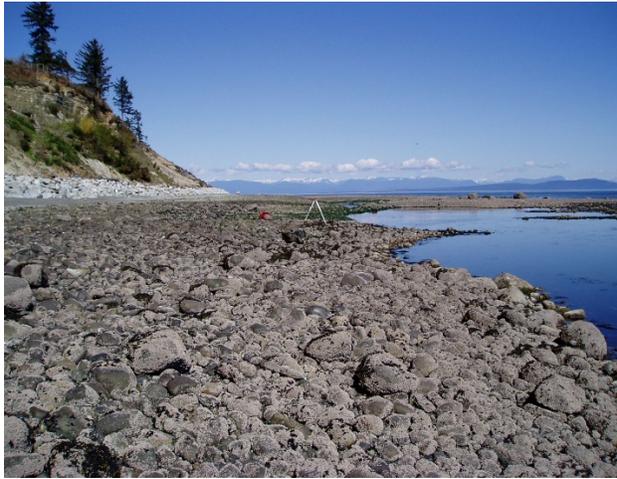
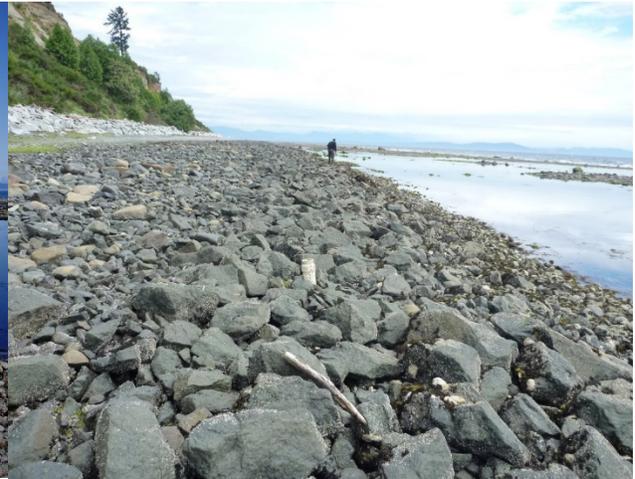
Photo 10: Near Station 9+40, viewing north showing start of cobble/boulder protection over forcemain

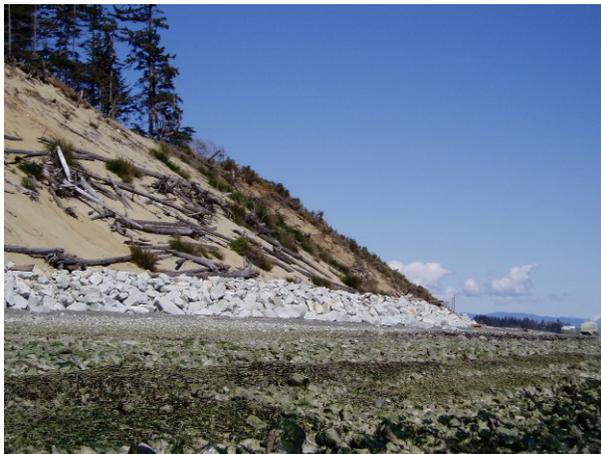
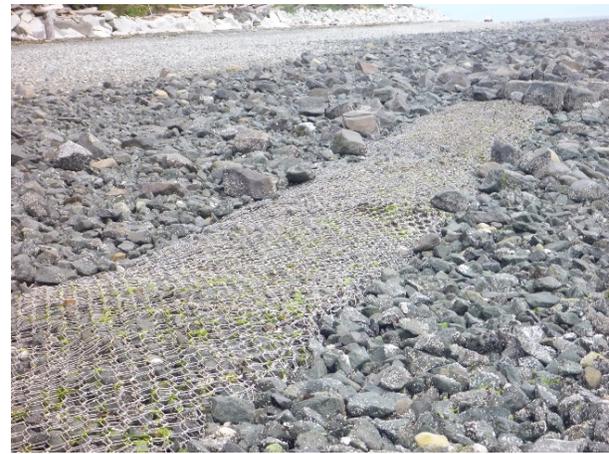
Photo 11: Near Station 10+80 viewing north, showing exposed top of mattress

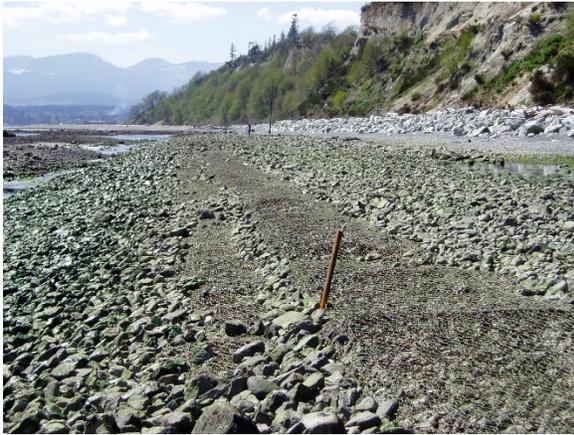
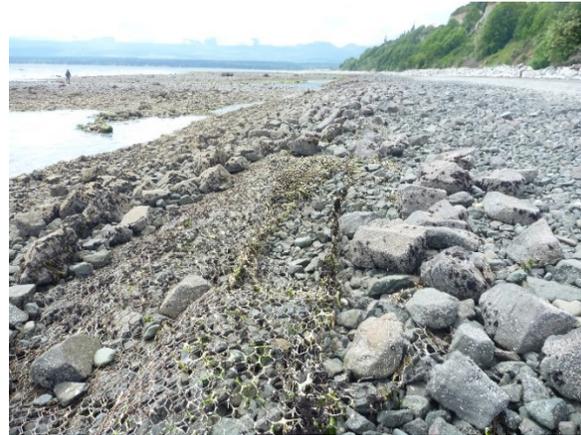
Photo 12: Near Station 12+20 viewing southwest, showing exposed mattress and shoreward displacement of boulder/cobble cover

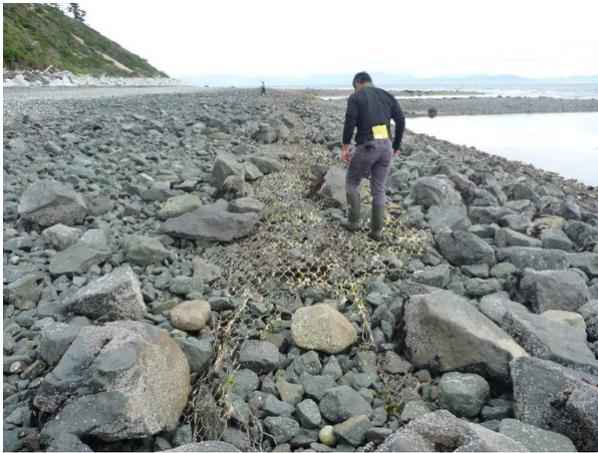
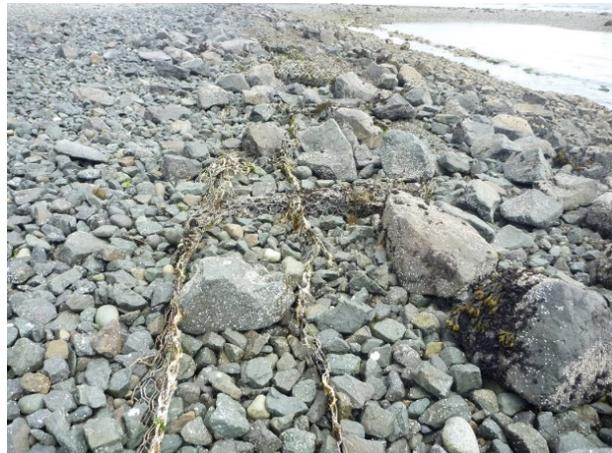
Photo 13: Damaged top cover of mattress between Station 11+50 and Station 12+50, June 2016

- Monitoring and inspection of the beach should be carried out annually over the entire length of the forcemain on the beach (at present only the southern section is surveyed). A brief condition report should be prepared interpreting the survey data and the condition of the existing protection and indicating whether repairs or other work is required.
- Emergency response plans should be reviewed to deal with a potential breakage of the forcemain. This should include identifying and obtaining critical equipment that would be needed to repair a break.
- The top layer of the existing mattress that has experienced damage should be repaired.

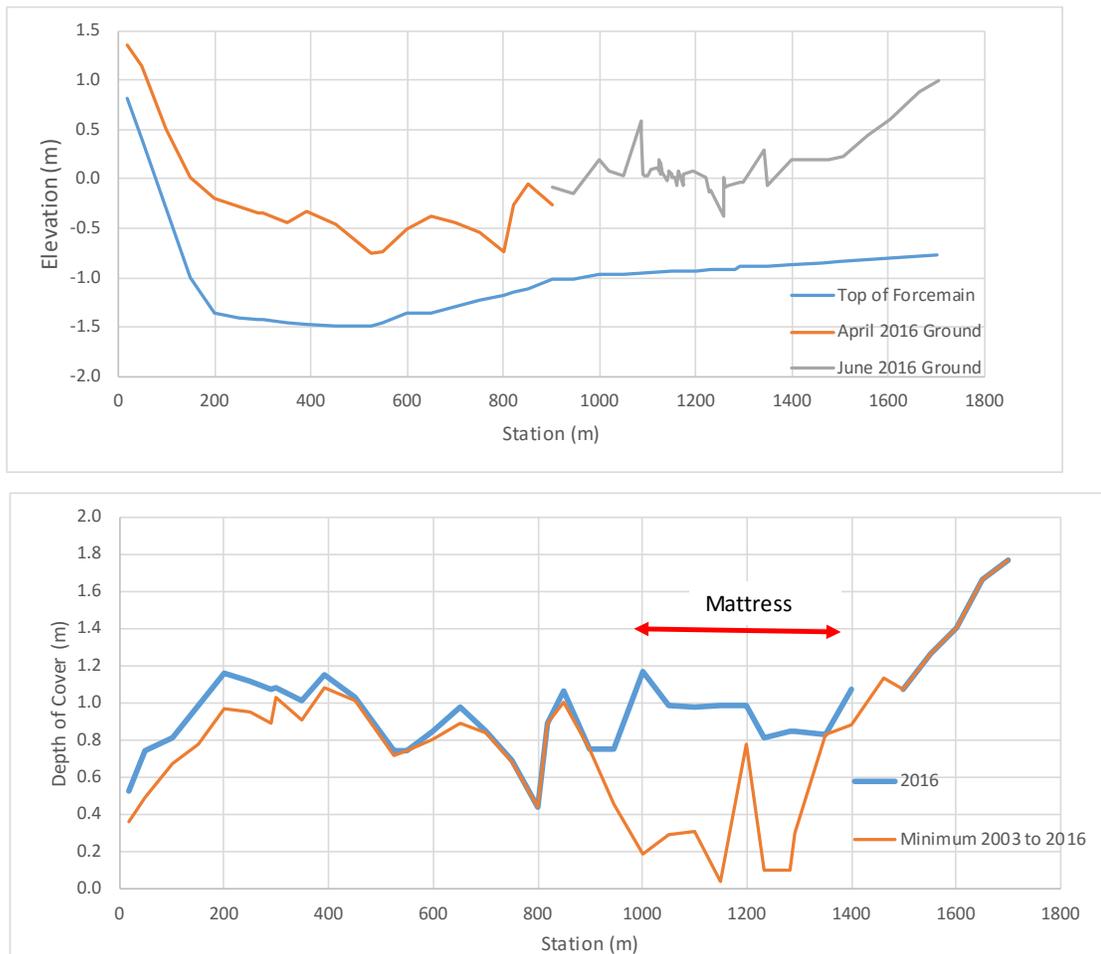
Figure 14: Beach topography along forcemain (top) and present depth of cover (bottom)

The low depth of cover near the south end reflects the rise in the level of the pipe as it approaches the manhole in Goose Spit Park. The depth of cover has remained near 1 m between Station 2+00 and 4+50 where the pipe is at its lowest level (El. -1.5 m CGVD). The depth of cover decreases north of Station 4+50 where the pipe starts to rise and the level of the beach drops off. The minimum cover in 2016 was 0.4 m near Station 8+00. The mattress protection between Station 10+00 and 13+50 has maintained the depth of cover at approximately 0.8 to 1.0 m since 2003.
