RE: Comox Valley Aquatic Centre Facility Condition Assessment

Comox Valley Aquatic Centre Facility Condition Assessment
377 Lerwick Road, Courtenay, BC V9N 9G4
Weather: 8 °C, Mostly Cloudy

Structural Condition Assessment

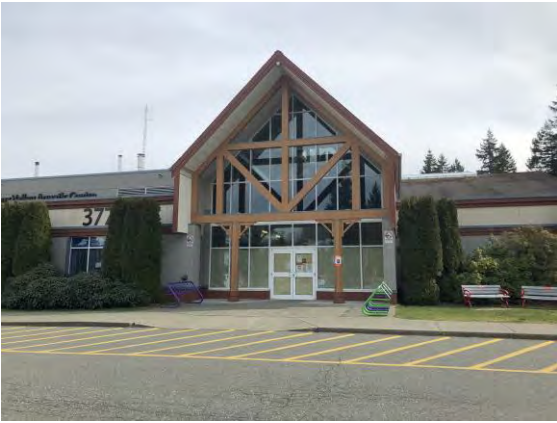
<p>Photo 1 Exposed structure at entrance</p>
<p>Location: Natatorium</p> <p>Observation: The structure of the natatorium consists of two cast-in-place concrete pools, concrete block walls supporting the adjacent roofs, and a steel structure over the pools.</p> <p>Recommendation: No action.</p> <p>Time Frame: N/A</p>

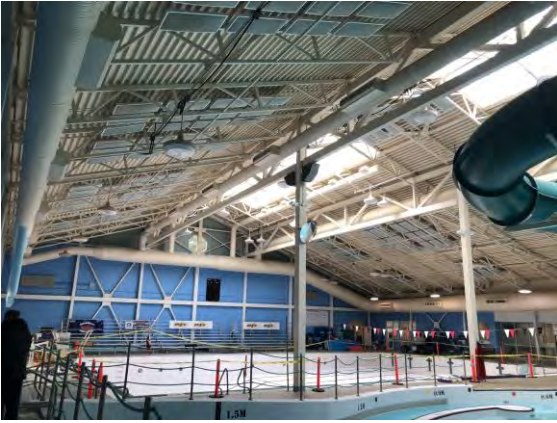
<p>Photo 2 General photo of pool area</p>
<p>Location: Natatorium – West Pool</p> <p>Observation: The west pool had been drained to allow for visual review of the basin.</p> <p>Recommendation: No action.</p> <p>Time Frame: N/A</p>

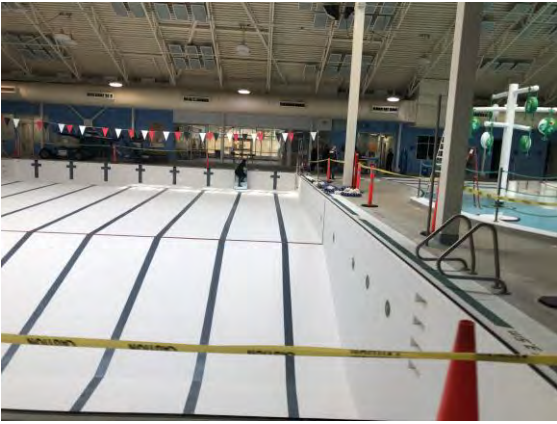
<p>Photo 3 West pool</p>

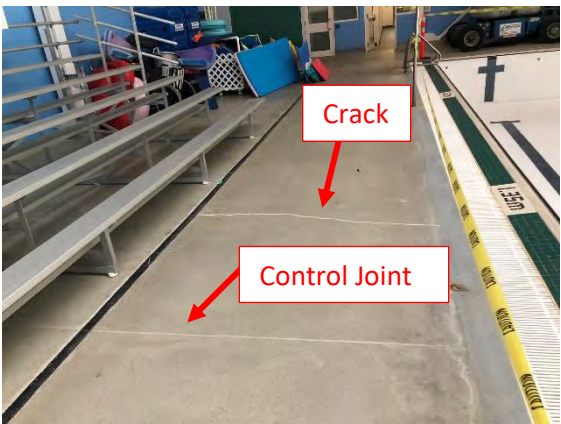
Photo 4 Control joint and crack in pool deck

Location: Natatorium – central pool deck

Time Frame: 1-5 years

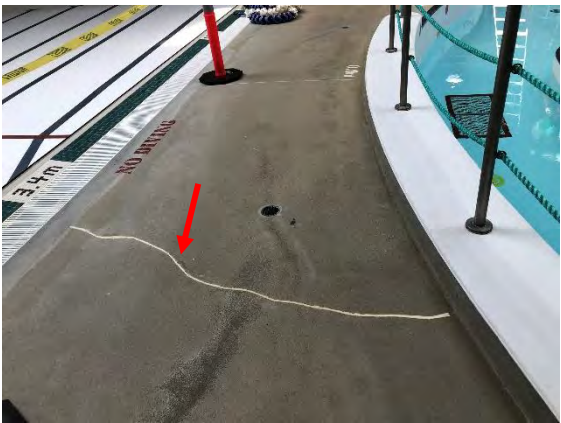
Photo 5 Repaired crack in pool deck

Location: Natatorium – south wall

Time Frame: 1-5 years

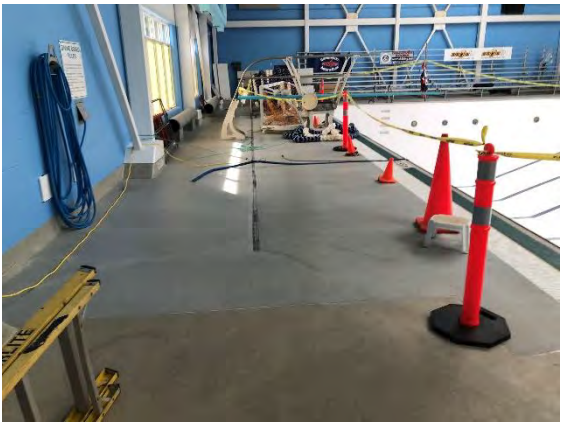
Photo 6 Area of renewed coating at pool deck

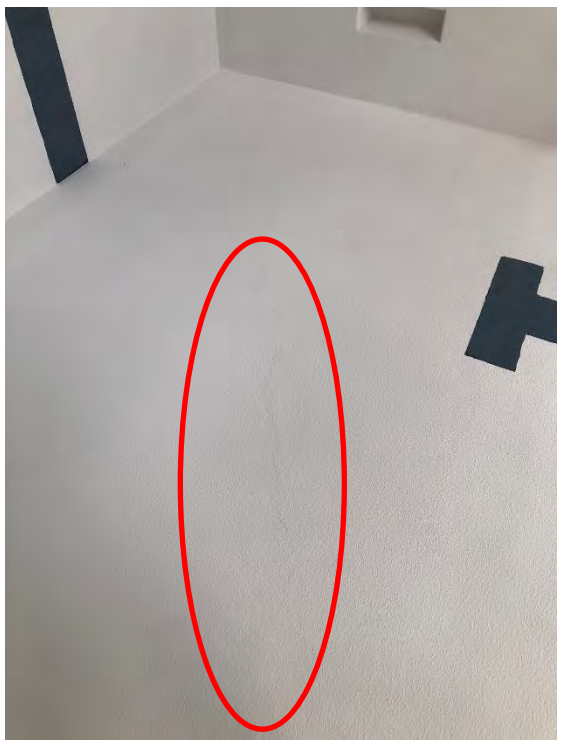
Photo 8 Crack in floor at south end of pool

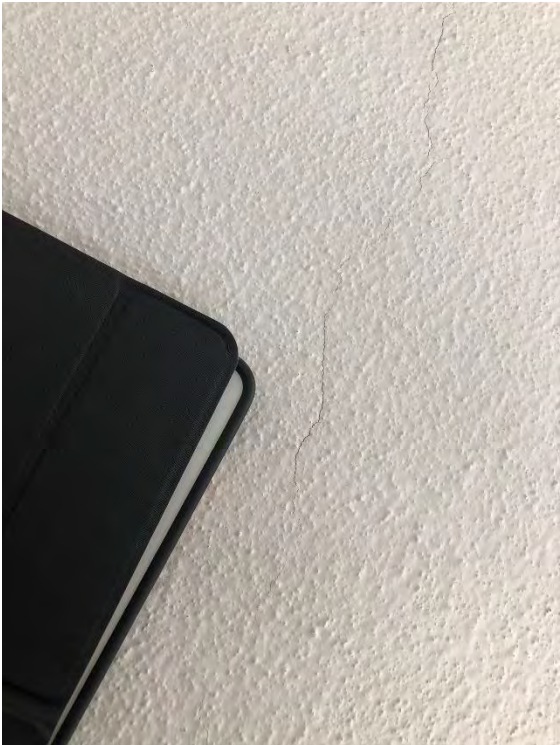
Photo 9 Close-up of crack in Photo 8

Location: Natatorium – west pool

Time Frame: N/A

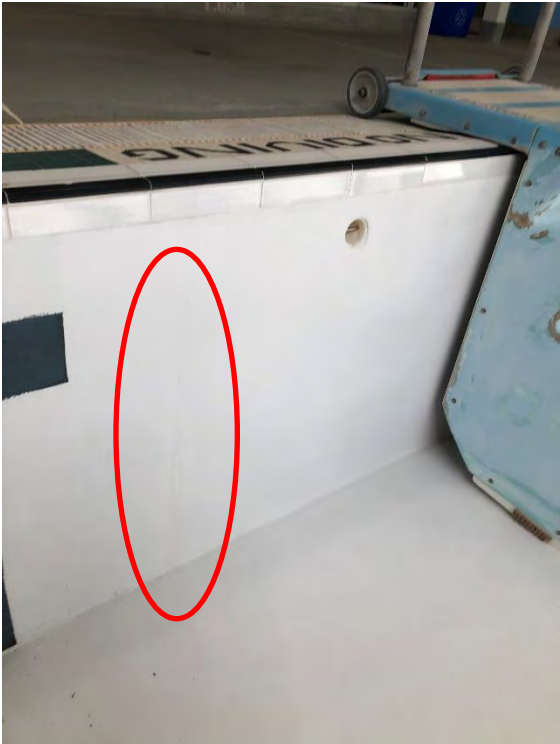
Photo 10 Crack in wall of pool at south end

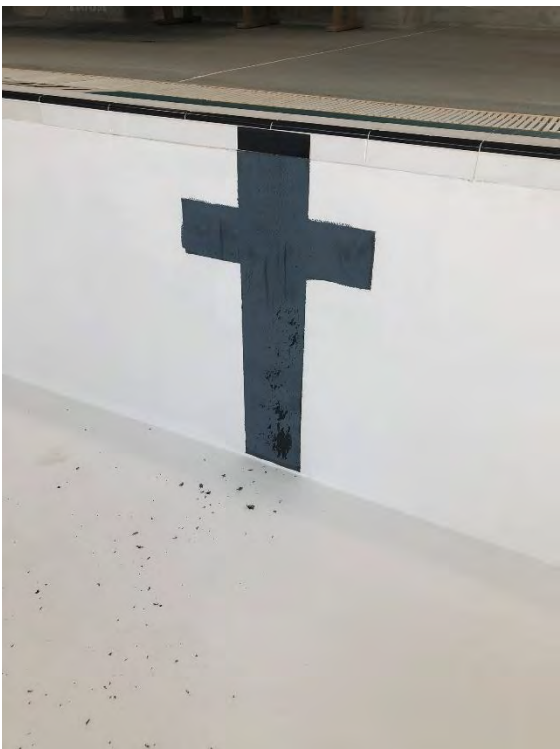
Photo 11 Flaking paint markings

Location: Natatorium – west pool

Time Frame: 1-2 Years

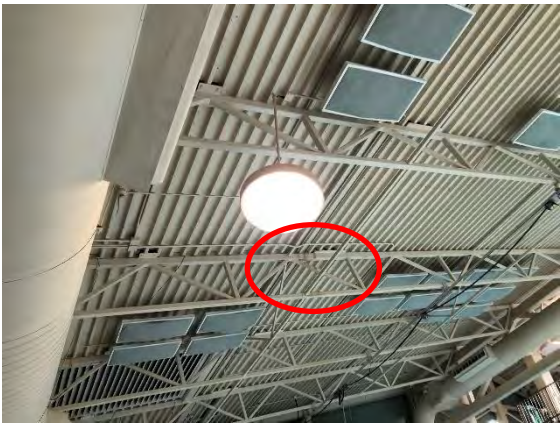
Photo 12 Staining on roof truss

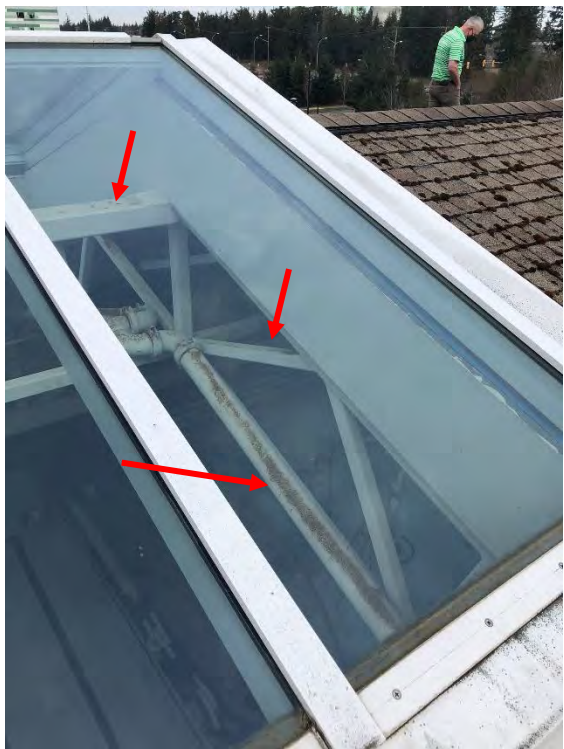
Photo 13 Roof truss and roof drain lines

Location: Natatorium – east wall

Time Frame: 1-2 years

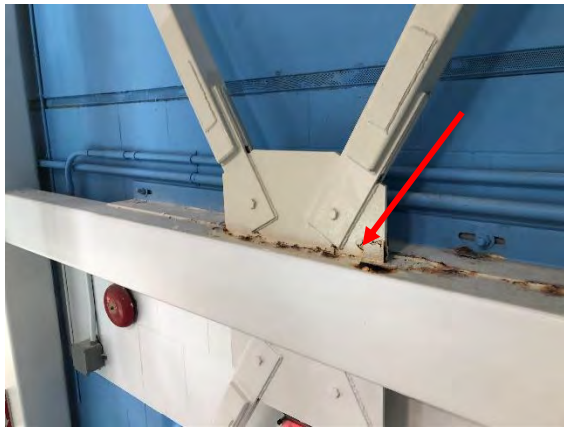
Photo 14 Corrosion at steel bracing

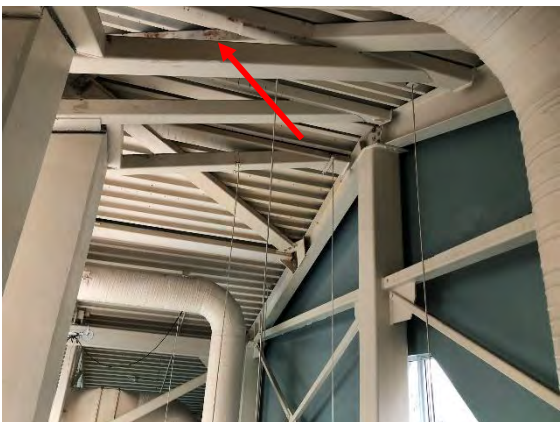
Photo 15 Corrosion on roof framing

Location: Natatorium – slide tower

Time Frame: 1-2 years

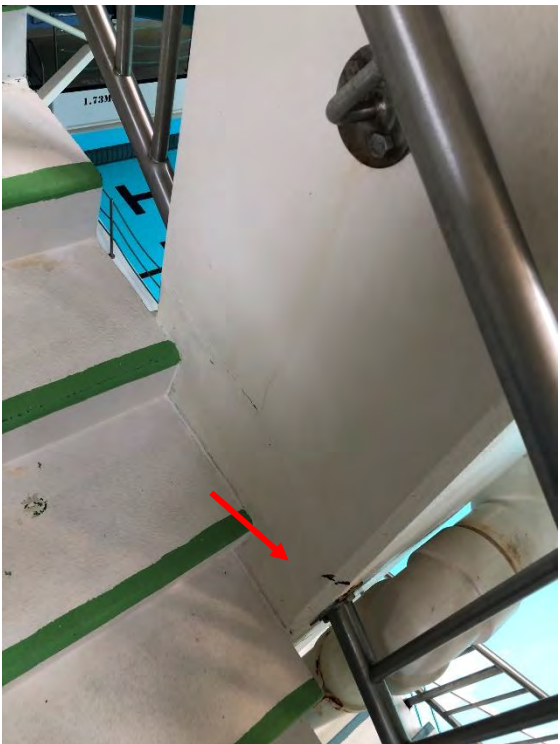
Photo 16 Damage/deterioration of column

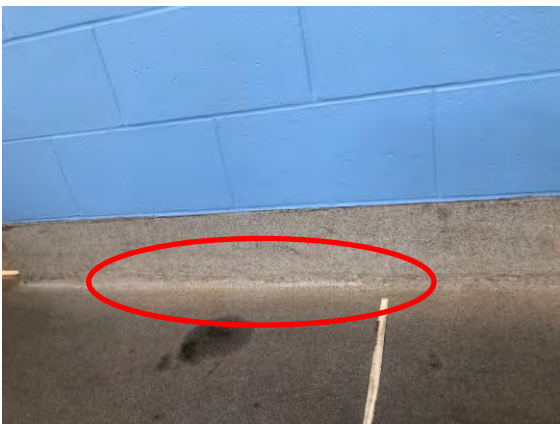
Photo 17 Crack at base of wall

Location: Natatorium – southwest corner

Time Frame: 1-5 years

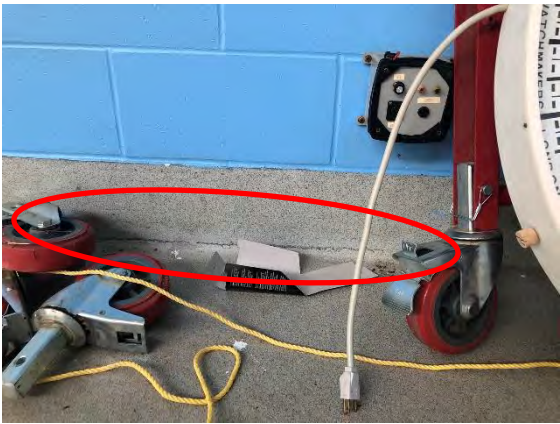
Photo 18 Crack at base of wall

Location: Natatorium – north wall

Time Frame: 1-5 years

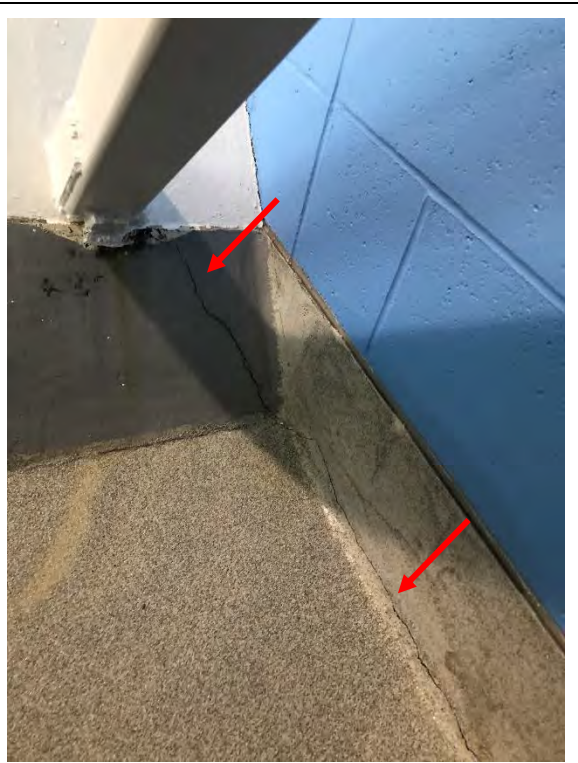
Photo 19 Cracked concrete at brace

Location: Natatorium – north wall

Time Frame: 1-5 years

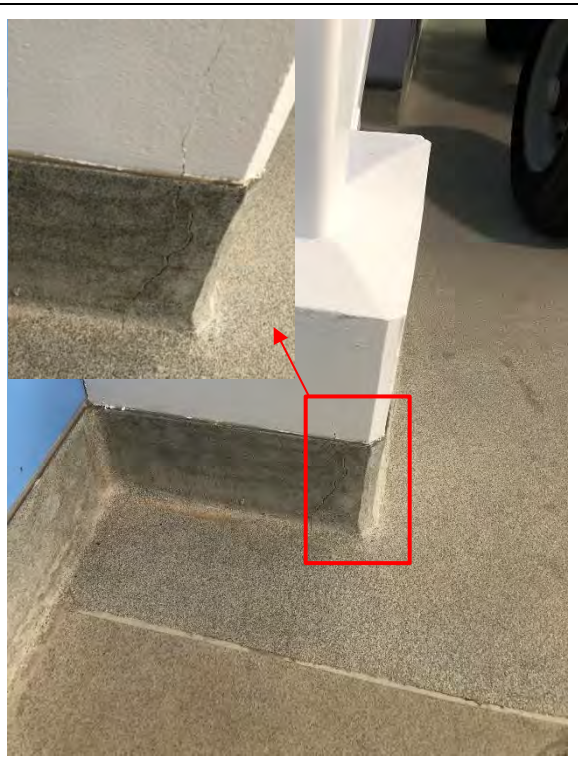
Photo 20 Crack at column base

<p>Location: Natatorium – central pool deck</p> <p>Observation: A crack in the coating and rust staining was observed at the base of a steel column. It is possible that the crack was caused by corrosion and expansion of underlying steel structure.</p> <p>Recommendation: Repair crack at time of pool deck renewal</p> <p>Time Frame: 1-5 years</p>

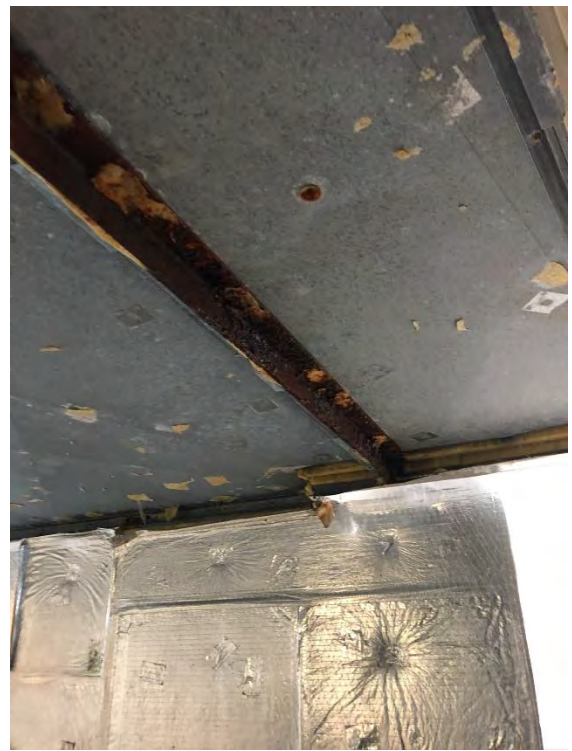
Photo 23 Corroded duct support

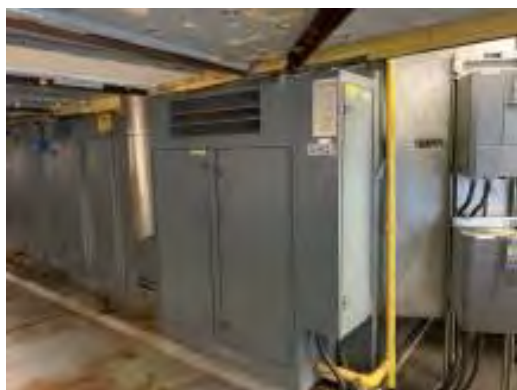
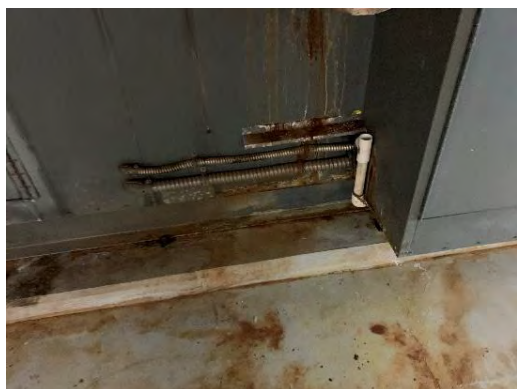
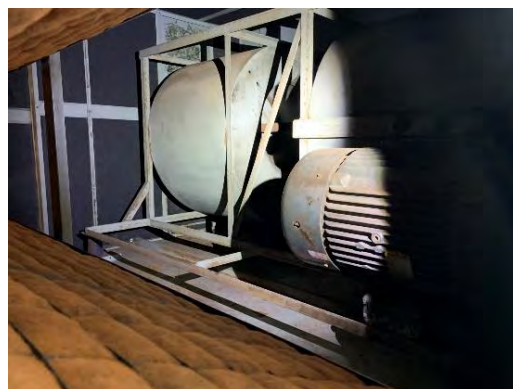
Existing unit is gas fired, 80% efficient. The unit is at its EOL, and replacement is recommended, although VFD's have been added to the Supply and Return fan, there are several options for a new unit that would provide energy efficiency and increased performance. Due to the proximity of the mechanical room to the heating plant we would suggest a passive heat recovery approach would have the lowest life cycle cost. Though it may not have the lowest GHG emissions. An Energy audit should be performed to confirm best suited replacement.

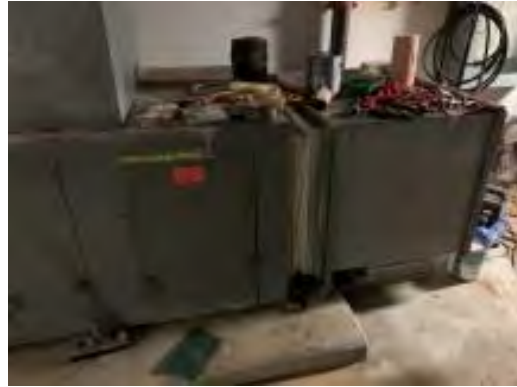
AHU-2 – Changerooms/Offices/Weight Room

Existing unit is gas fired, 80% efficient. The unit is at its EOL, and replacement is recommended. There are several options for a new unit that would provide energy efficiency and increased performance. As part of the AHU replacement, a central heating system approach could be considered. An Energy audit should be performed to confirm best suited replacement. As a minimum we recommend passive heat recovery off the changerroom exhausted areas.

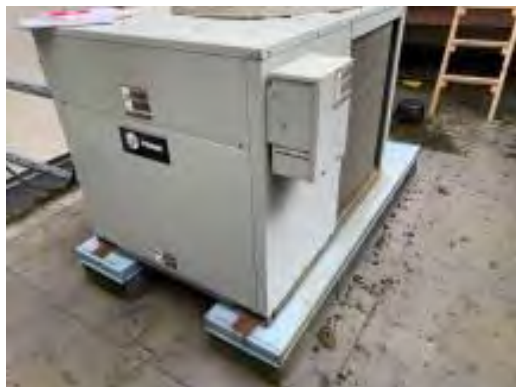
.3 CU-1 – Condenser for AHU-3

Existing outdoor condensing unit on adjacent roof, serving AHU-1. The Unit is at its EOL, and replacement is recommended. There are several options for a new unit that would provide energy efficiency and increased performance. An Energy audit should be performed to confirm best suited replacement.

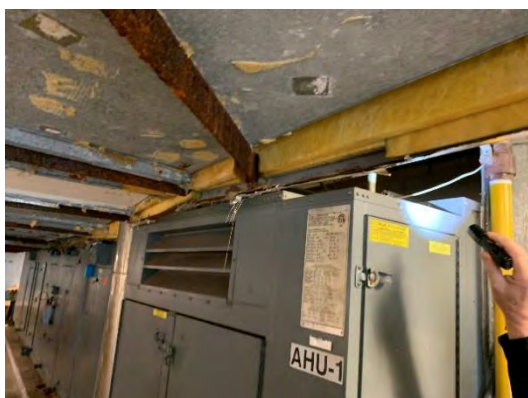
.4 Duct Distribution:

Existing ductwork in the Penthouse Mechanical room will require to be completely insulated, and sealed. At the time of the site visit, the insulation was removed. This would lead to condensation in during winter when there is cold outside air entering the ductwork. Hangers and supports should be inspected to ensure they are not corroded through. Recommend to insulate to Ashrae standards.

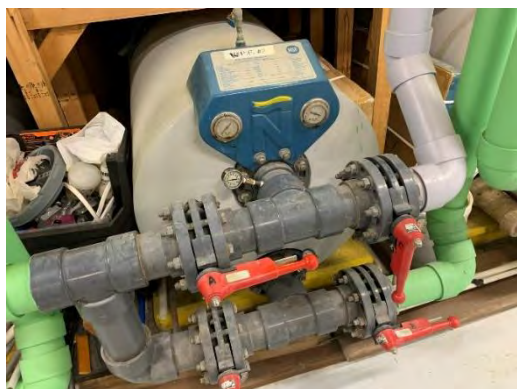
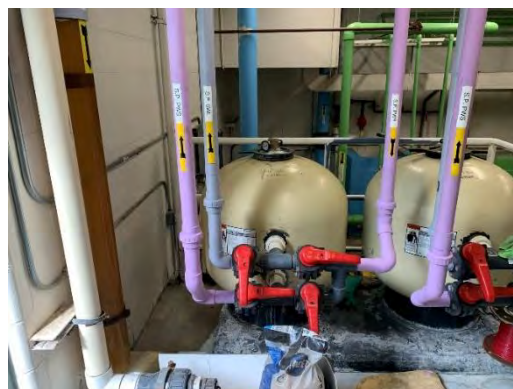
Pool Filters

Existing pool filters are at EOL, replacement recommended. There are a number of new technologies that have become available since the facility was built, that would improve water quality, potentially save water and energy. Some filter options would include Vertical deep bed sand filters, Regenerative Filters, and drum filters, all should be reviewed to determine what is best for the choice for the client needs. In Further discussion with Facility staff, interest was towards Regenerative filters, as these would have the lowest water consumption, as well require less space that traditional sand filters. A pool design matrix can be reviewed to narrow down preferred system, as well energy audit to confirm best suited options.

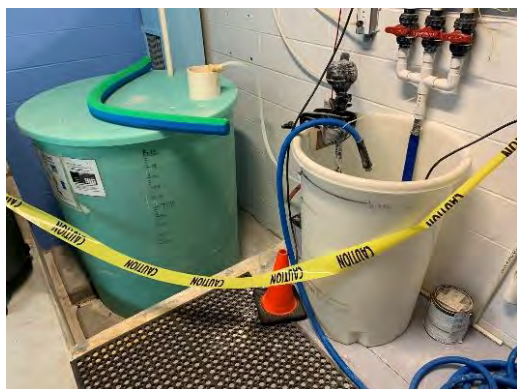
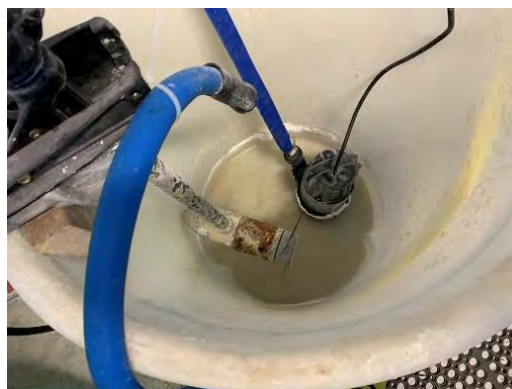
Bulkfeed tank w/Agitator & Sodium Hypochlorite

A sump pump was used as a bulk feed pump for the pools (shown in Pic above), this type of pump is not suitable for chemicals, and will corrode quickly. Further review required and discussion with CVAC & staff to determine best suited options, as per worksafe guidelines noted above.

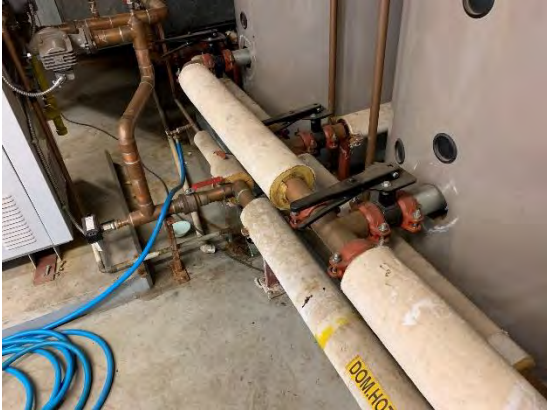
Piping between Domestic Hot Water Tanks, missing insulation

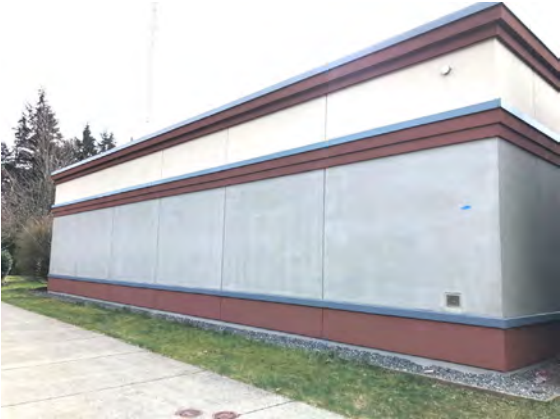
<p>Photo 1 EIFS Cladding at east elevation</p>
<p>Location: Exterior</p> <p>Observation: Minor instances of damage at the EIFS cladding are present. Holes as shown in the photo are a risk for water ingress and should be patched. All EIFS panel joints where sealant is provided are also vulnerable to water ingress. Sealant joints should be replaced on a regular maintenance cycle.</p> <p>Recommendation: Repair holes and voids in EIFS wall cladding, and replace all sealant joints on EIFS.</p> <p>Time Frame: 0-2 years</p>

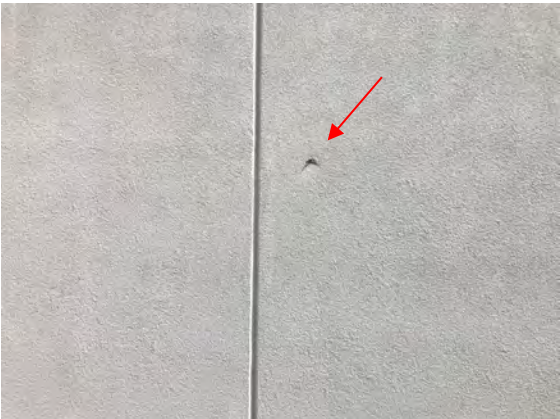
<p>Photo 2 West elevation (next to transformer)</p>

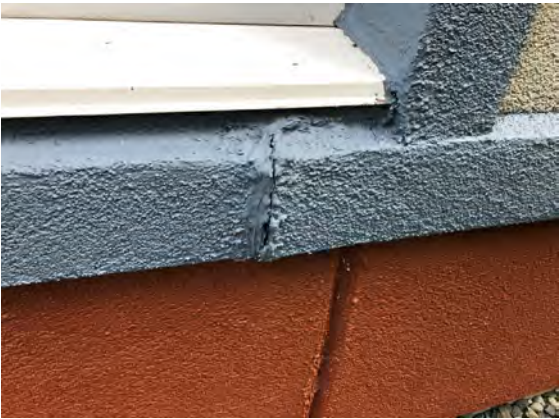
<p>Location: Exterior</p> <p>Observation: Window sill joint separating. This appears to be an isolated condition with low risk. However, it is recommended that similar joints be reviewed and repaired.</p> <p>Recommendation: Repair joints and seal with appropriate exterior sealant</p> <p>Time Frame: 0-2 years</p>

<p>Photo 3 West elevation (classroom 130)</p>

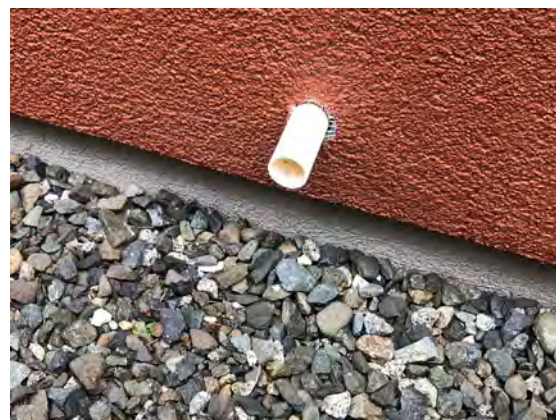
Photo 4 New pipe penetration at electrical room, west elevation

Time Frame: 0-2 years

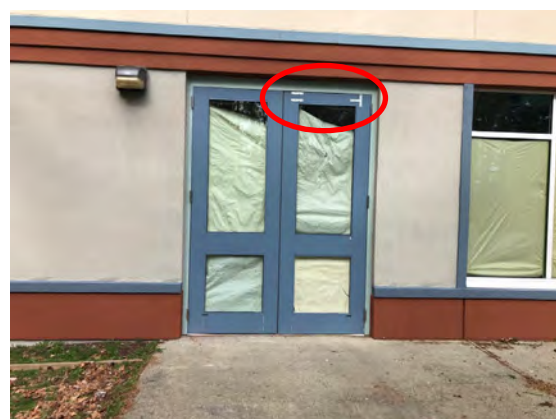
Location: Exterior – south elevation

Photo 5 South elevation natatorium exit door

Time Frame: 2-5 years

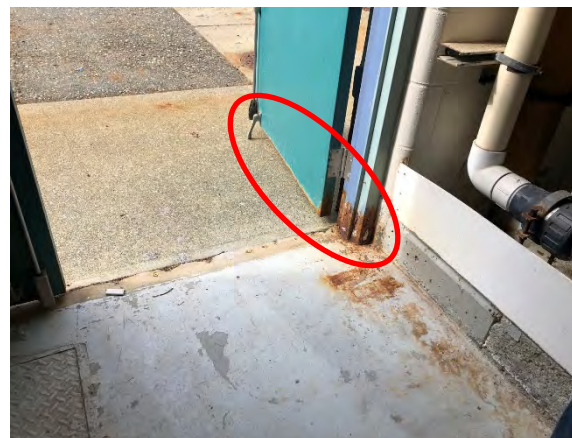
Location: Mechanical room – South elevation

Photo 6 Mechanical room, south elevation

Time Frame: 2-5 years

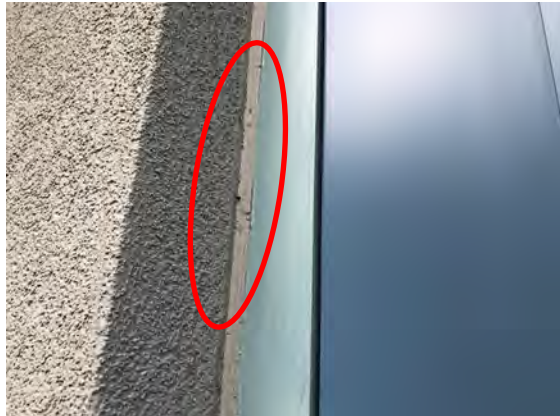
TABLE A1 – GENERAL OBSERVATIONS	
<p>Location: Exterior</p> <p>Observation: Door and window perimeter sealants are showing signs of ageing and cracking.</p> <p>Recommendation: Replace all perimeter sealant around the doors and windows.</p> <p>Time Frame: 2-5 years</p>

<p>Photo 7 South elevation natatorium exit doors</p>
<p>Location: Exterior – South elevation</p> <p>Observation: Base of wall at the south elevation, along the hardscape, is in close proximity to the concrete slab. Minor instances of wall damage is present.</p> <p>Recommendation: Repair instances of damage, and ensure debris along the wall is cleared to facilitate drainage away from the walls.</p> <p>Time Frame: 0-2 years</p>

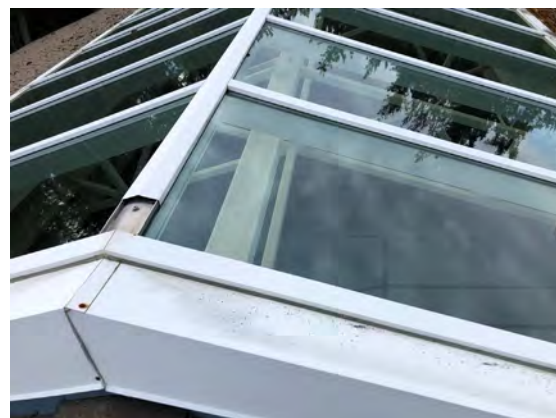
Photo 10 Skylight

Time Frame: 5-10 years

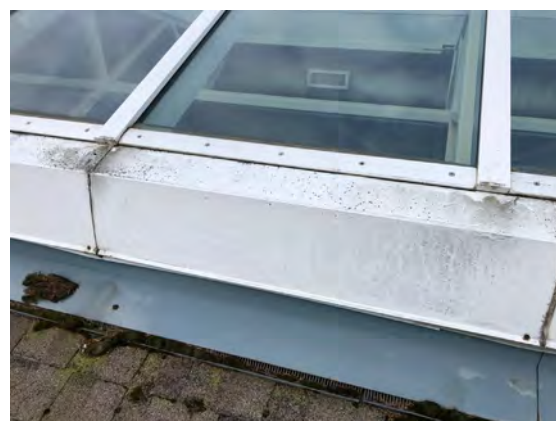
Location: Skylight

Photo 11 Skylight flashings

Time Frame: 2-5 years

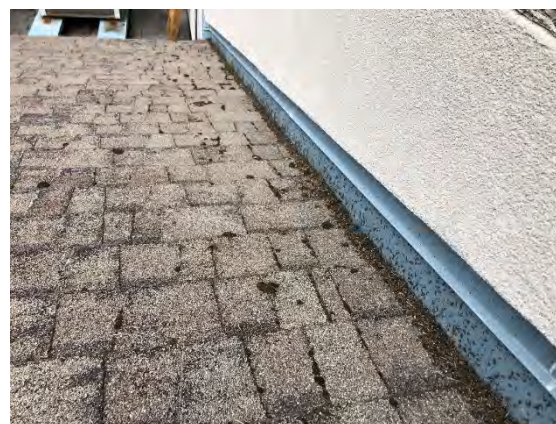
Location: Roof Shingles

Photo 12 Staining on roof truss

Time Frame: 0-2 Years

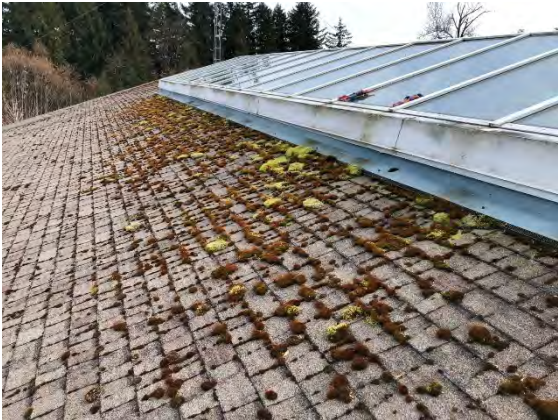
Photo 13 Organic growth at section of roof

Time Frame: Routine maintenance

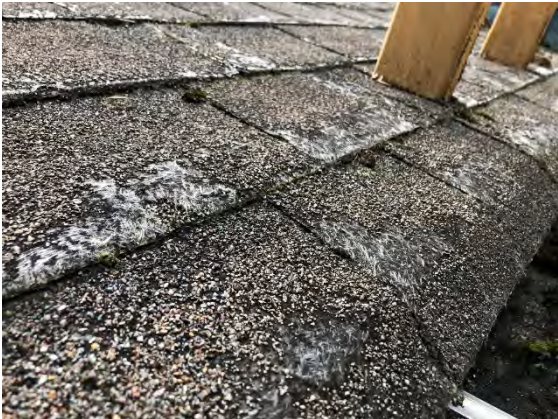
Photo 14 Exposed fiberglass core on shingles

Time Frame: 0-2 years

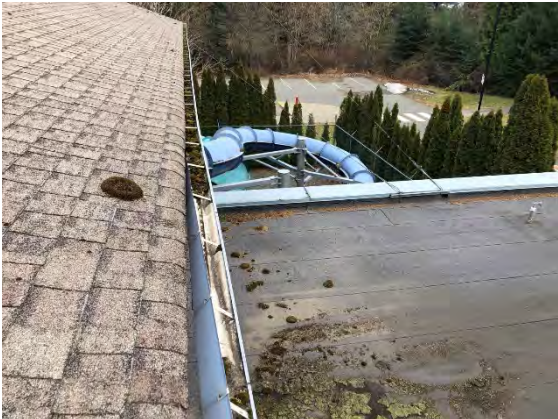
Photo 15 Damaged gutter on south elevation

Time Frame: 0-2 years

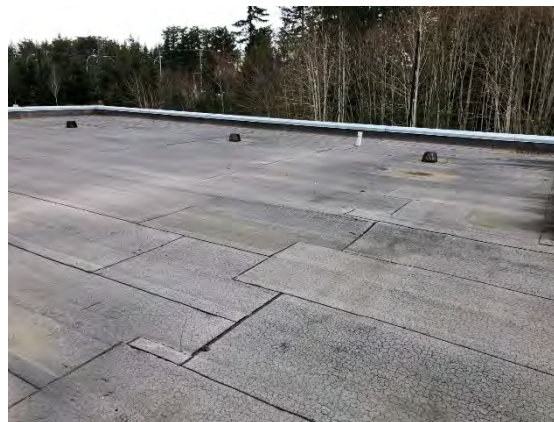
Photo 16 Ageing roof membrane at flat roof

Time Frame: 0-2 years

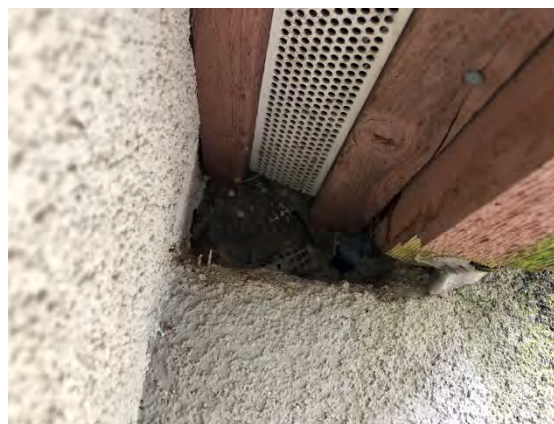
Photo 17 Gap in EIFS membrane at fascia detail

Time Frame: 0-2 years

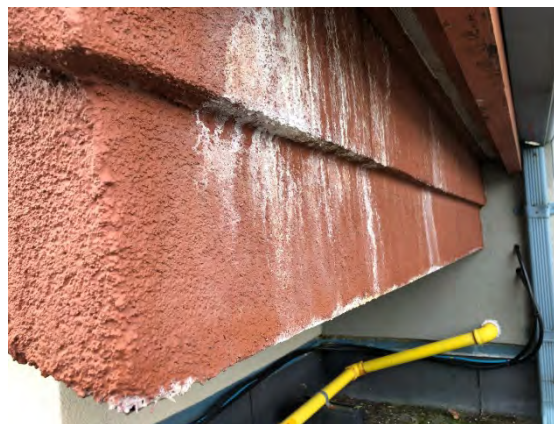
Photo 18 Efflorescence at roof eave (at gutter locations)

Time Frame: 0-2 years

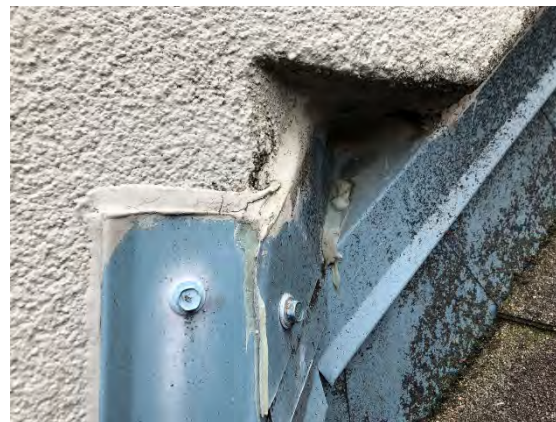
Photo 19 Typical roof saddle detail

Time Frame: 0-2 years

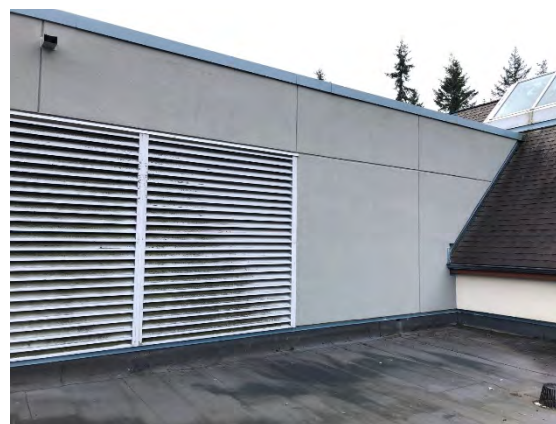
Photo 20 Vent at roof mechanical wall

Time Frame: 0-2 years
