RE: Recreation Facilities Condition Assessments and Lifecycle Report

Recreation Facility Condition Assessments and Life Cycle Report

Comox Valley Regional District

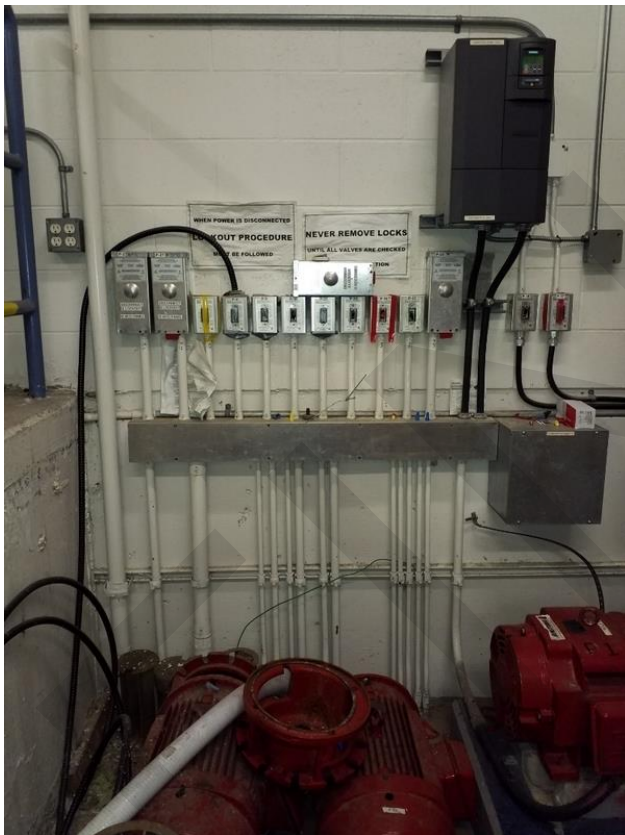
Figure 1. Bypass Overview

Fig. 1) Depicts a code violation to 2-308(1) (as shown in **Fig 2**); the wall mounted equipment is blocked by the motors. A good/typical design practice suggests that there should be room/clearance for accessibility and maintenance purposes.

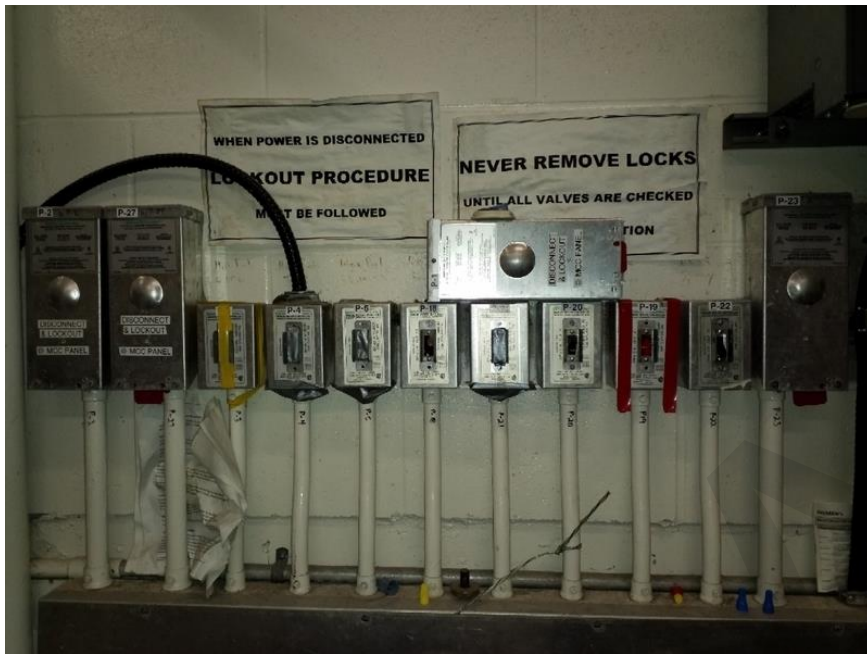
Figure 3. Bypass cables

Fig 3) The Teck cable on the left isn't supported. Should be supported with cable supports similar to the other ones on the wall. In addition, there is a spare disconnect just placed on top of the other equipment.

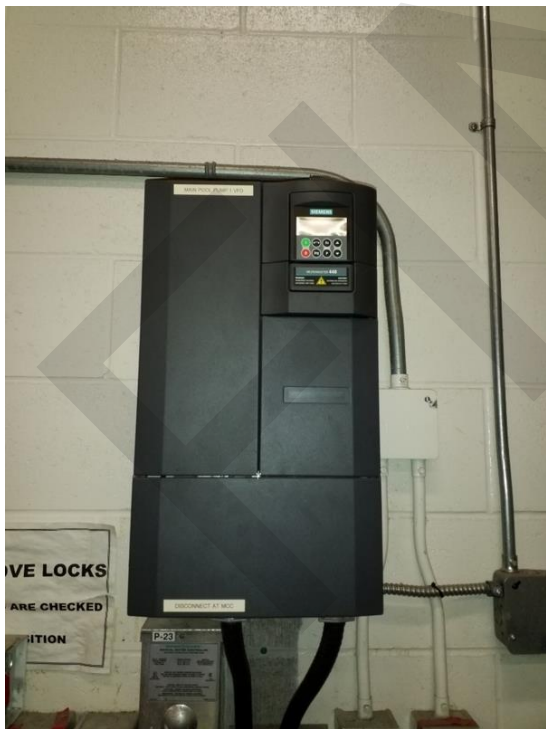
Figure 4. VFD with no protection

Fig 4) 600V VFD should be protected with a NEMA enclosure offering waterproof protection due to the location because a pipe could burst and damage the VFD.

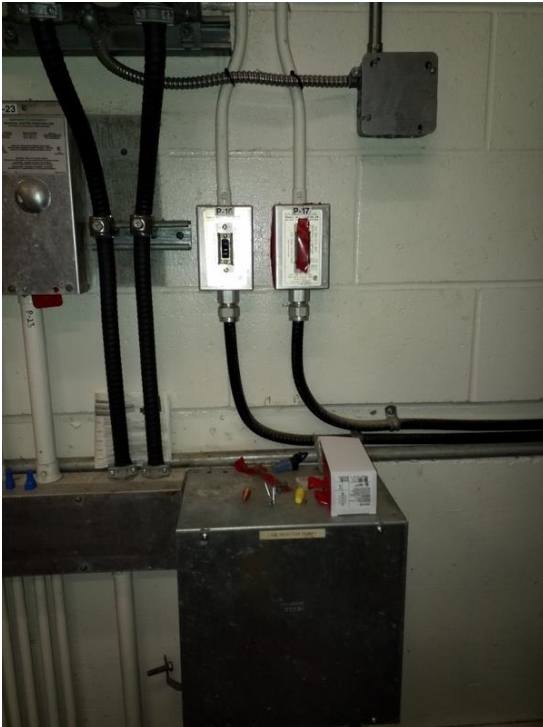
Figure 5. Switches

Fig 5) It appears that the switches aren't lockable which does not provide adequate precautions according to code 2-304(3) (as shown in **Fig 6**). 600V VFD is connected to the splitter box along with all ancillary devices - these devices also appear to not be the appropriate IEC Measurement Category.
