Infrastructure Improvements Discussion

COMOX VALLEY CYCLING COALITION

NOVEMBER 2020

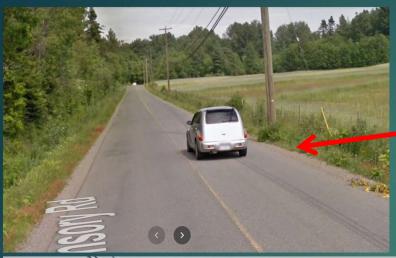
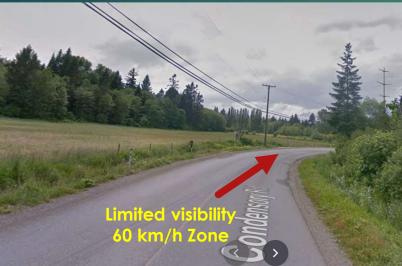
Condensory Rd – near Cessford Rd

- No Shoulder for Cyclists
- Ditches, utility poles and KFN Lands add a degree of difficulty to any solution
- Should also include extension of One Spot Trail to Bridge

<u>Work Required</u>	<u>Interim</u>	<u>Other</u>
1	Condensory Road	1.5 km of shoulder upgrades and paving	Reduce speed limit to 50kph, install No Passing signage and line paint	Extension of One Spot multi-use trail to Condensory Bridge
2	Knight Rd (Airport)	2.6 km of shoulder upgrades and paving (Knight Rd)	Reduce speed limit to 50kph, install No Passing signage at left turns	1.6km also requires shoulder upgrades in Town of Comox (Lazo Rd)
3	Anderton Road	1.4 km of shoulder upgrades and paving	Reduce speed limit to consistent 60kph, add shoulders when repaving Greenwood sewer line portion	
4	Union Bay - Buckley Bay	~8 km of shoulder upgrades and paving	Improved signage - "Share the Road"	Possibility of building out E&N Trail as a multi-user path
5	Seal Bay (Bates/Coleman)	6.5 km of shoulder upgrades on Bates and Coleman Roads	Reduce speed limit to 50kph, install No Passing signage and line paint at Seal Bay parking	Crosswalk for Seal Bay parking lot area

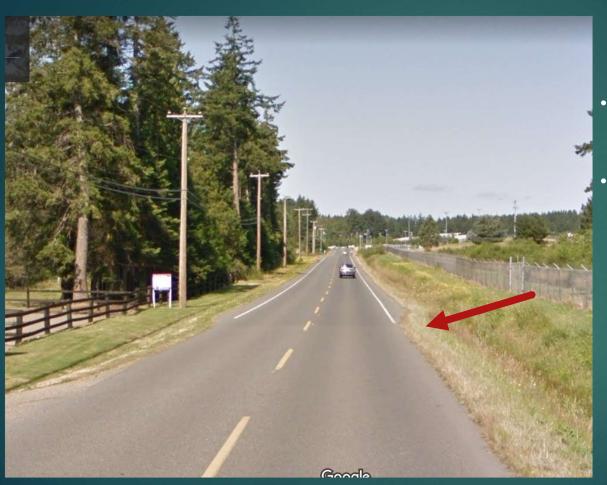
<u>Lack of Shoulder – Knight Road</u>

- Streetview of westbound Knight Rd near airport where road changes to having a shoulder for cyclists
- Note speed limit near airport (with shoulder) is 50 km/h while portion of road with no shoulder is 60 km/h??

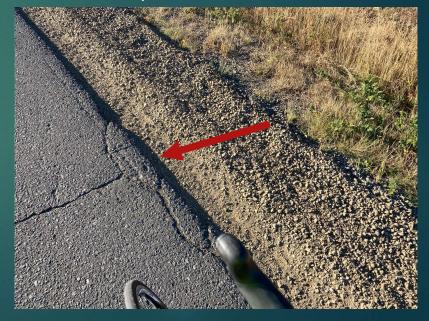
<u>Dangerous Shoulders – Knight Road</u>

Knight g
 - July 2020 email A friend from Nanaimo broke 6 ribs when she fell off her bike on Knight Road, Comox, between Glacier Greens golf course and Sieffert's Farm market. There is virtually no room to ride when cars are passing, and her tire went off the asphalt onto the lower gravel, and she fell. The gravel shoulder there has eroded and is well below the asphalt level.

- Sharp edge on shoulder is a severe hazard to cyclists
- Two serious incidents reported to CVCCo in July 2020 (one crash with broken ribs, one with bruising /contusions)

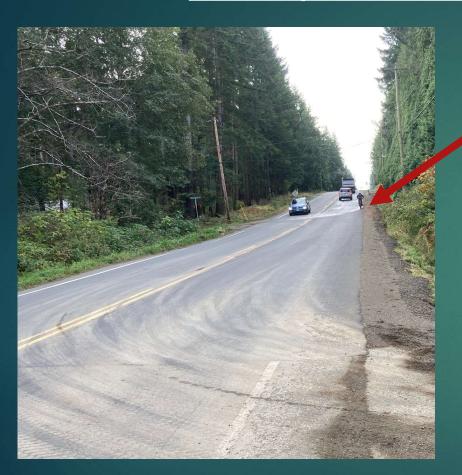
Extremely Poor Shoulder on Hill near Ryan Road

- Shoulders are narrow to begin with on hill and have degraded with use, as well as due to access road gravel movement
- Very dangerous situation for cyclists in a high speed/high volume traffic area

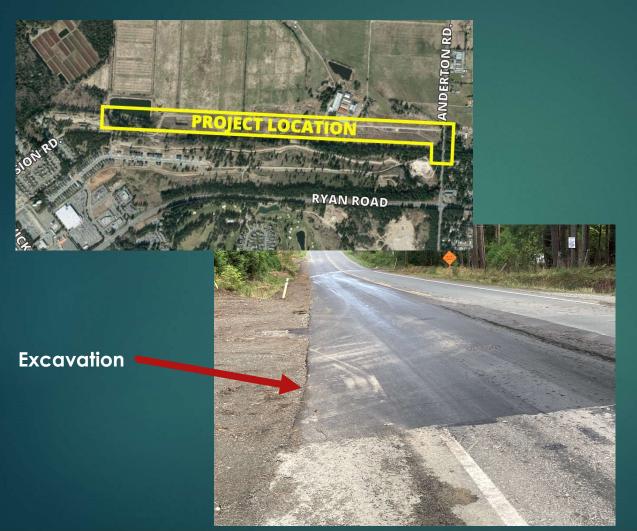
Sewer Line Work – Timing for Re-Paving

- Greenwood sewer line was extended in Sept 2020 by City of Courtenay and a portion of Anderton Road was excavated in the process
- When the road was repaved, it would have been an opportune time to also widen and repave the shoulders on the hill portion of Anderton. This is a perfect example of where CVCCo hopes to see better co-operation between road jurisdictions.

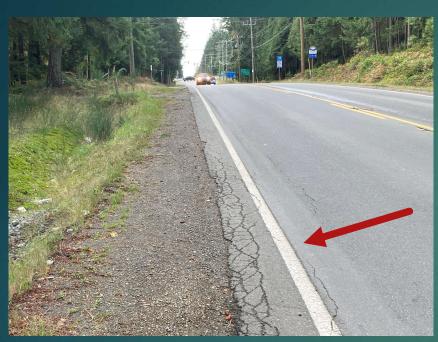
Narrow Shoulders – Anderton Road

Shoulder is very narrow and degraded to point of being dangerous

- Both shoulders are very narrow from Hamilton Rd north to Ellenor Rd intersection
- At 80 km/h, current shoulder width is definitely not safe to allow vehicles to pass cyclists

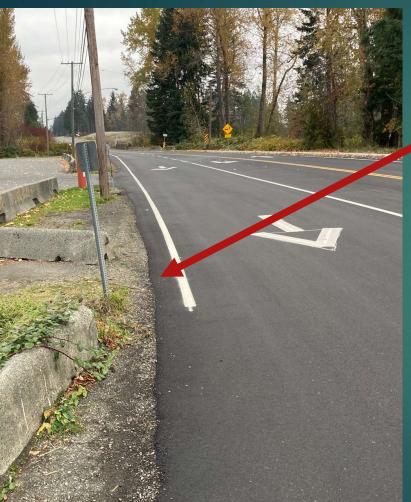
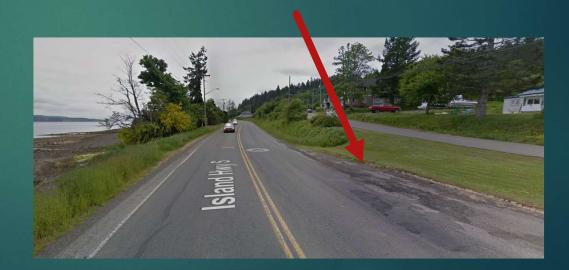
Inconsistent and Degraded Shoulders

- Shoulder on both sides of 19A through Union Bay is inconsistent and dangerous
- Too narrow for cyclists in many place.
 Where it widens, it is often severely degraded and includes numerous access roads.

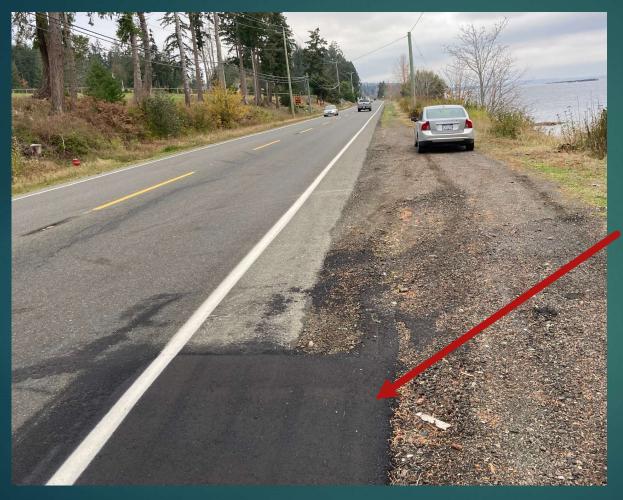
2020 Paving Project

- 2020 shoulder paving project.
- Completed 2.9km going north from Tsable River (Ferry) to Baynes Sound on east side of HWY 19A.
- Much safer (wider and smoother) riding surface

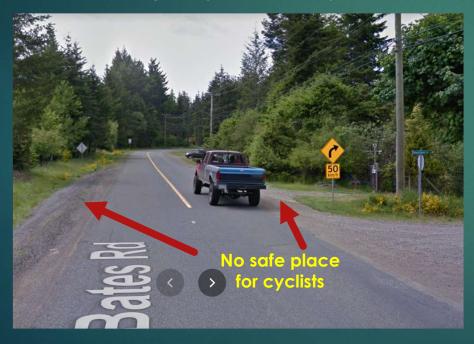
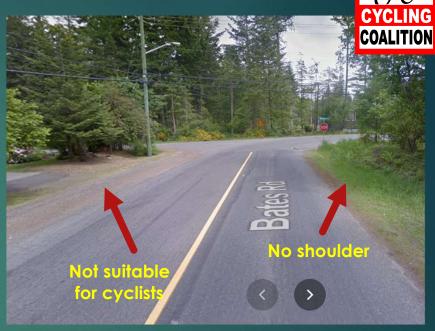
<u>Poor Shoulder – Bates Road</u>

- Shoulders on Bates Rd are either nonexistent or unpaved and dangerous for cyclists
- Speed limit is 70 km/h
- Poor visibility, very shaded in spots

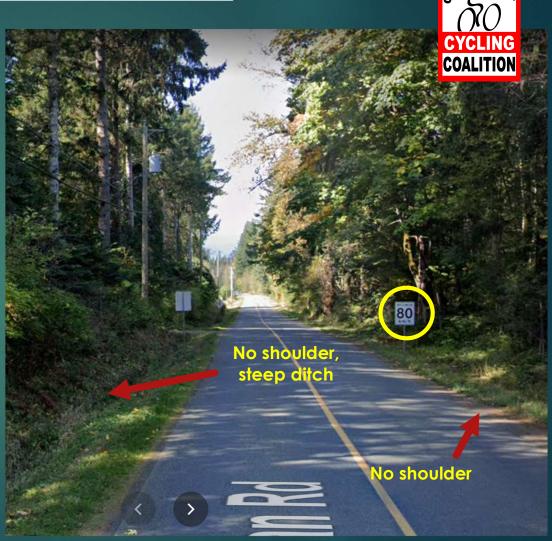
<u>Coleman Road – Bates to Left Road</u>

- No Shoulders on Coleman Rd from Bates Rd to Left Rd intersection
- Speed limit is 80 km/h
- Poor visibility due to shading and corners

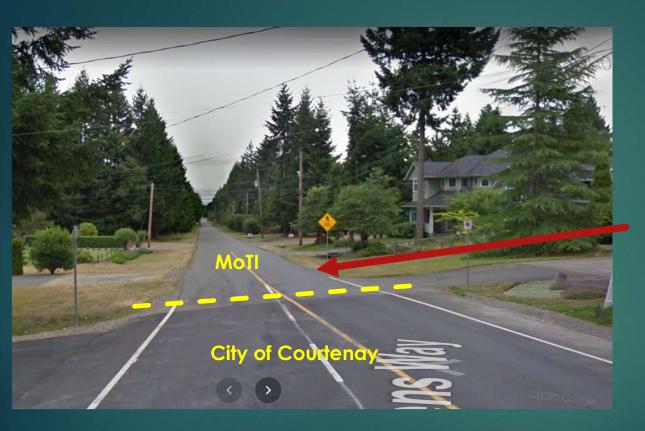
<u>Lack of Shoulder – Idiens Road</u>

- MoTI portion of Idiens Road has no accommodation on shoulder for cyclists or pedestrians
- 2018 Hudson Sewer Trunk
 Line Expansion along Idiens
 provided for a gravel
 shoulder on the south side
 but it was not paved and is
 unsafe for cycling

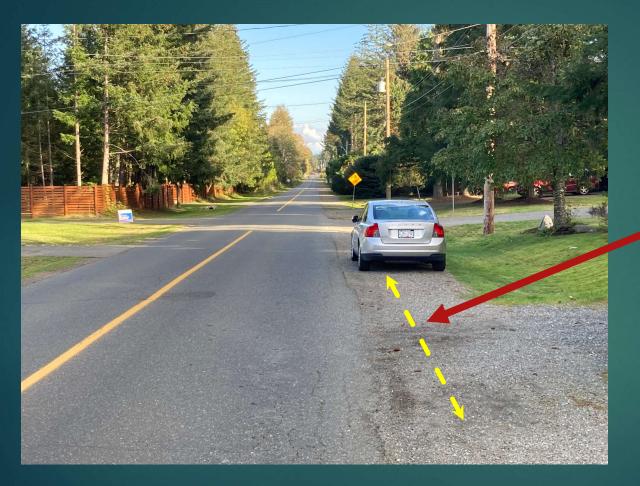
2018 Hudson Sewer Trunk Line

Unpaved sewer trunk line from 2018 provides an area to extend road pavement – may be enough to provide for safe cycling shoulders on both sides of the road?

6	Idiens Road	0.8 km of shoulder upgrades from CoC boundary to Anderton Rd	Repairs to potholes	Hudson sewer trunk extension was not paved (Comox)

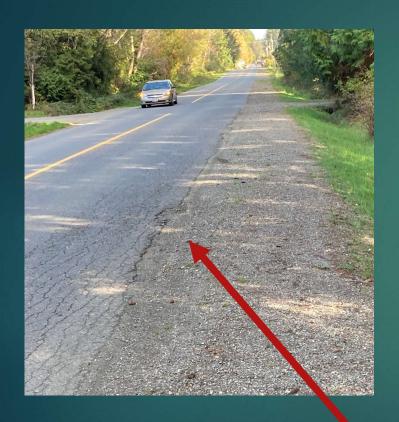
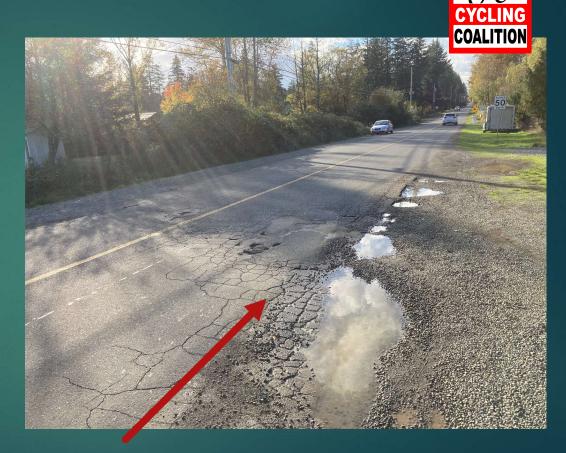
Road is Unsafe for Cyclists

• Edges of Idiens Road are in extremely poor shape
