Beaufort Watershed Stewards - 2021

Hydrological Health Report Card on Four Watersheds

Nov. 4, 2021

by Dave Weaver - Retired Professional Forester
Vice President Beaufort Watershed Stewards

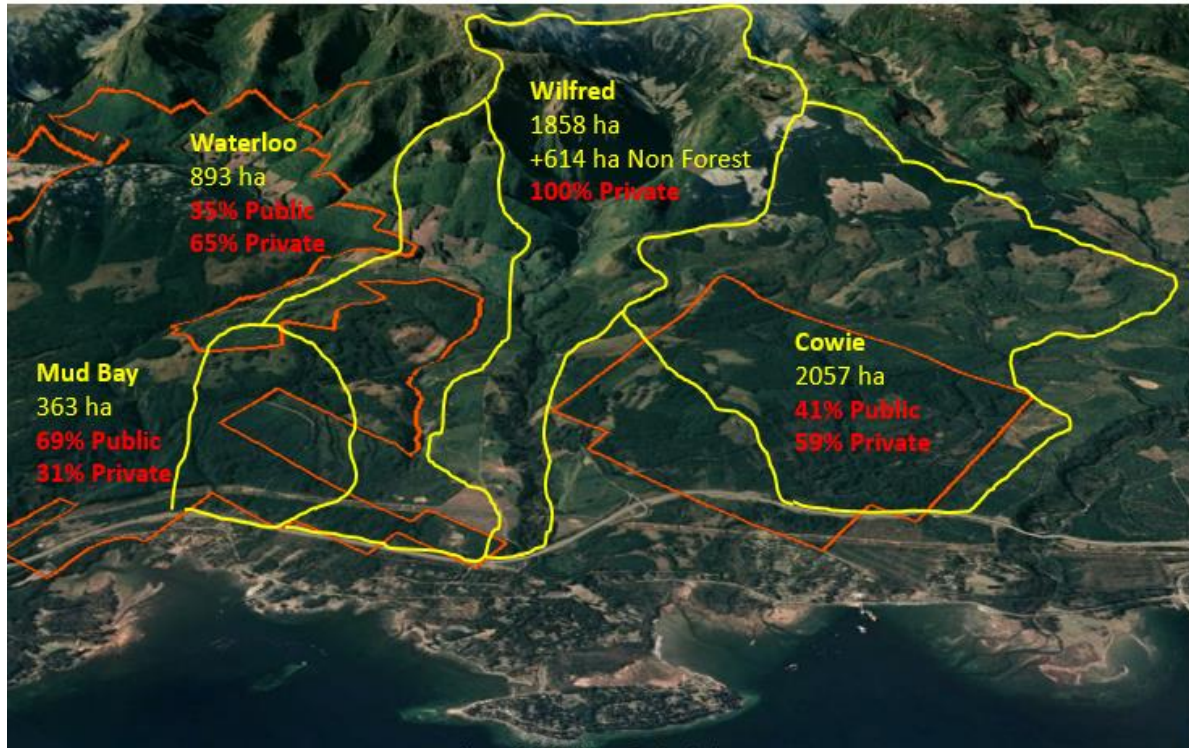
Figure 1 below is an oblique Google Earth image showing all four watersheds located on the east side of the Beaufort Range peaks. The caption explains boundaries and public/private land ownership. It is important to note that the Mud Bay Creek watershed is less than 500 ha in size. This is technically too small of a drainage area to perform a meaningful ECA assessment hydrologically (as recommended in the BC Coastal Watershed Assessment Procedure Guidebook (2)). Therefore, the Mud Bay Creek assessment data in this report are only for comparative value and not absolute value. The Report Card scores for Mud Bay Creek are also only presented for comparative reasons.

Figure 1: Oblique 2020 Google Earth image of the 4 studied watersheds (Watershed boundaries and areas are in yellow; public land boundary is in orange; percent public and private land are in red).

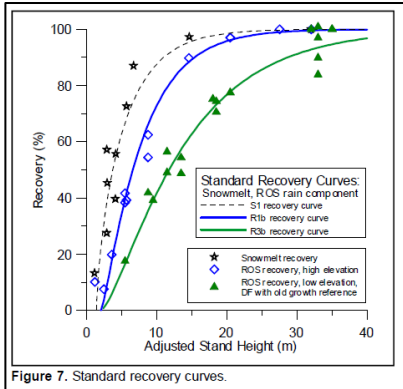
Figure 7. Standard recovery curves.

Figure 3: From Hudson 2007 (6), “Standard Recovery Curves” describing snow melt recovery under average conditions on Vancouver Island.

Figure 4: Translated from Hudson above (Figure 3), the *Hydrological Recovery Factor* table relative to regeneration height, used for this project for DUs in the *snow zone*.

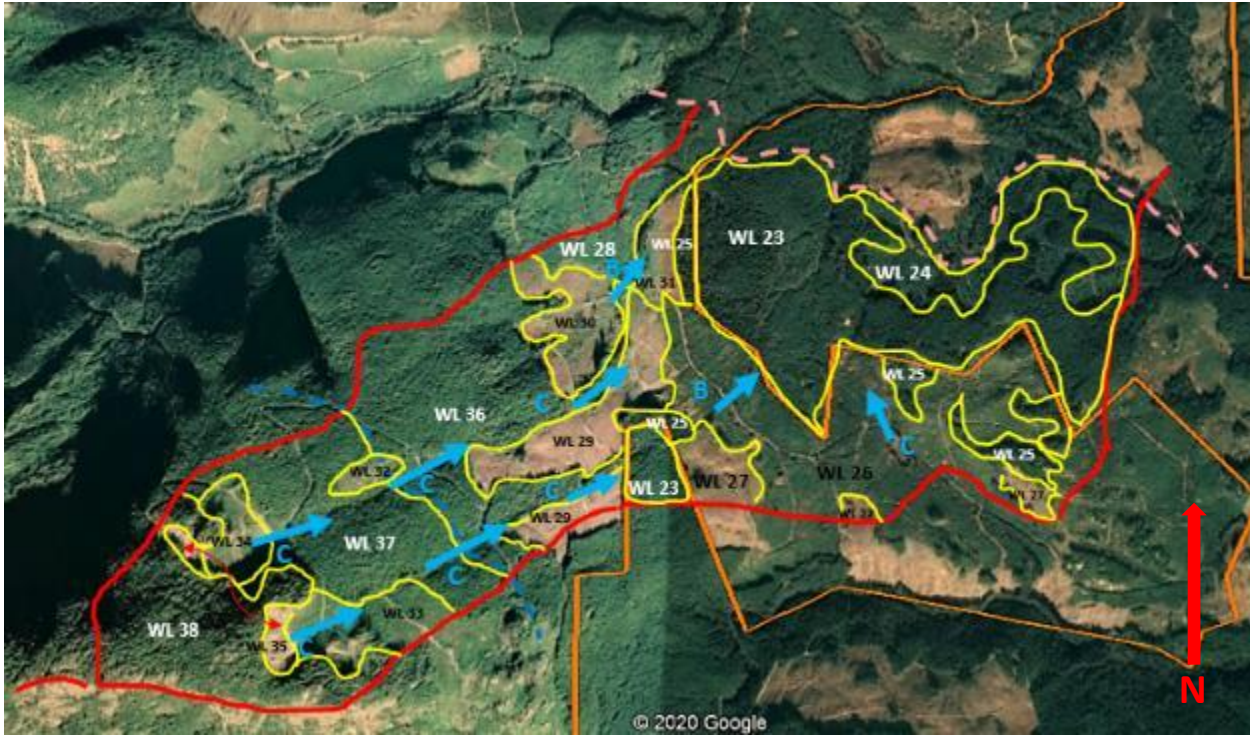
Figure 7: Waterloo Creek Disturbance Unit Map Transition and Snow Zone – Example Map

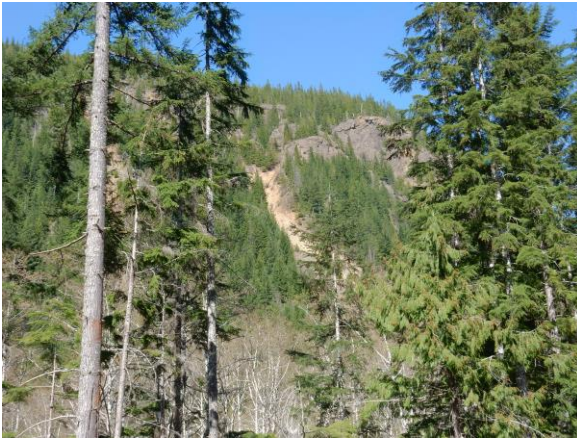
Photo 3: Older natural slides 1 and 2 (slide 2 is behind the tree cover to the left).

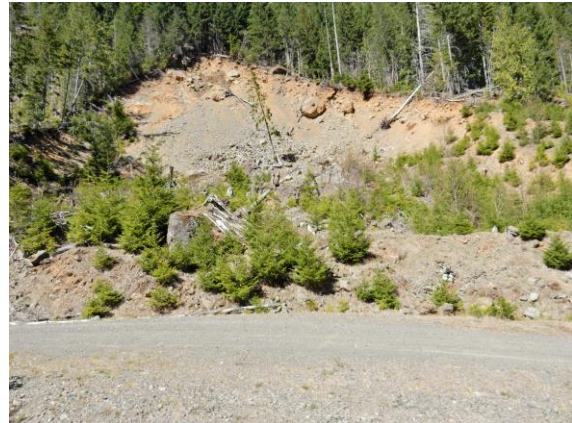
Photo 4: Newer slide 3 (circa 2017) which has its headwall above the road, and the slide was observed to have crossed Wilfred Creek during the failure event.

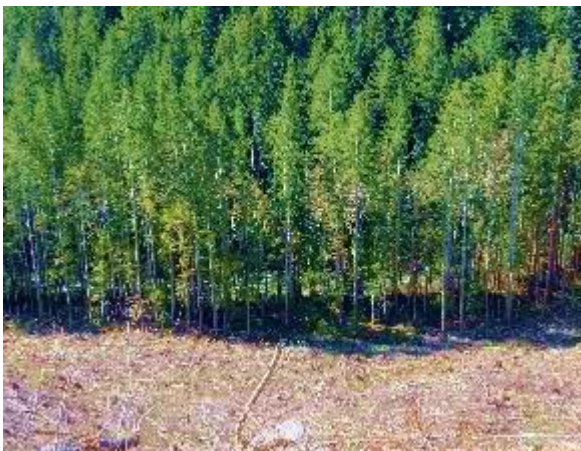
Photo 5: Example of adequate Riparian protection.

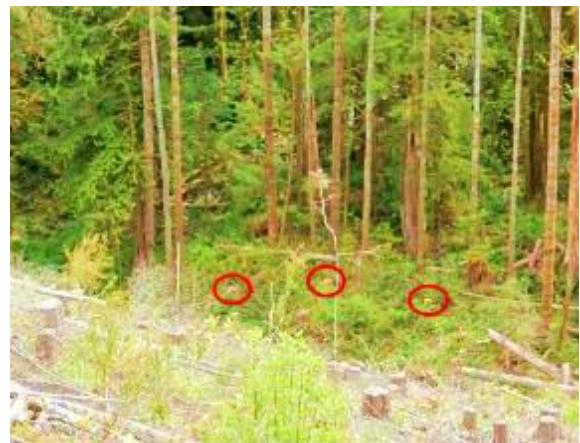
- Generally, all of the riparian protection observed in all harvested blocks on public and private land appeared to comply with FRPA and PMFLA, respectively.
- Notably it appeared that on the private land areas, primary creek channel protection exceeded the legislative requirements - with at times very large gullies being well protected with very wide intact unlogged buffers (see Photo 5 below).
- Minor cases of harvesting within the riparian protection zone were observed on 2 occasions on private land, but these appeared to be isolated incidents. Under the PMFLA, some removal of specific trees is permitted under that Act (see Photo 6 below).

Photo 6: Example of harvesting within Riparian protection, with cut stumps circled in red.

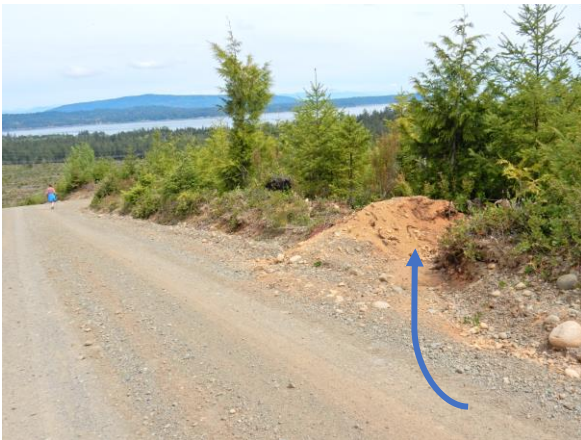
| Road Aspects Observed | Private Forest Roads | Public Forest Roads |
|---|---|--|
| Road side sediment runoff measures | <ul style="list-style-type: none"> • Long steep stretches of active roads all had side <i>diversions drains</i> regularly graded into the side cast (see Photo 7 below) | <ul style="list-style-type: none"> • Very few if not any observed <i>diversions drains</i> graded into the side cast. |

Photo 7: Example of good road maintenance practice in making *diversions drains* graded into the side cast, on private roads – Hastings Main.

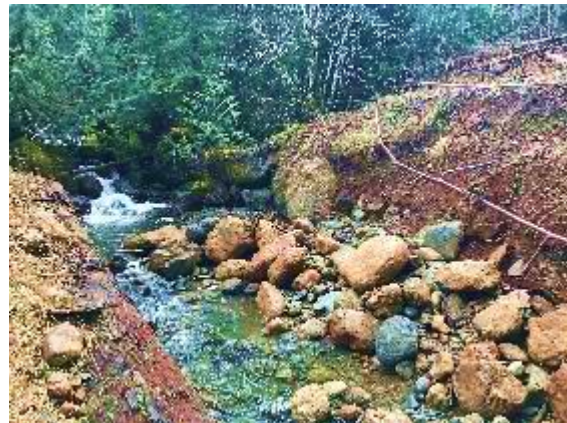
| Road Aspects Observed | Private Forest Roads | Public Forest Roads |
|---|---|--|
| Road deactivation after use | <ul style="list-style-type: none"> • Majority of inactive roads were deactivated well. • One bridge removal on Cowie Creek appeared to expose high amounts of side cast soil which could contribute to sediment runoff (see Photo 8 below). | <ul style="list-style-type: none"> • Majority of inactive roads were deactivated well. |

Photo 8: Cowie Creek deactivated bridge site with exposed side banks.

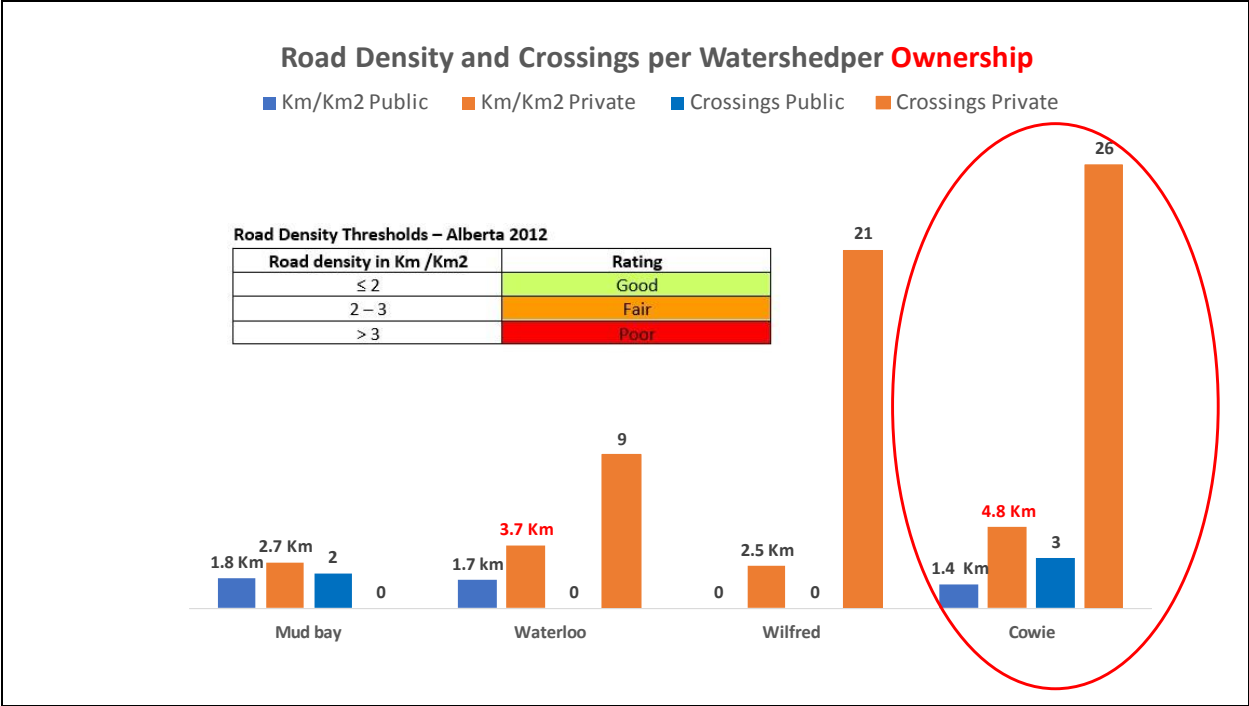
Figure 12: Road density and number of road crossings per watershed per land ownership.

Overall, two trends are evident from these Figure graphics:

1. **Risk ratings vary according to land ownership.** Most private land metrics had greater risk ratings than public lands. Land ownership was the most predictive metric. This difference may be due to FRPA and PMFLA having very different requirements/restrictions for rate of harvest.
2. **Cowie Creek watershed had the highest risk for elevated peak flows.** This is primarily due to ECA% levels being in the moderate to high-risk category, and higher road densities in the poor rating.

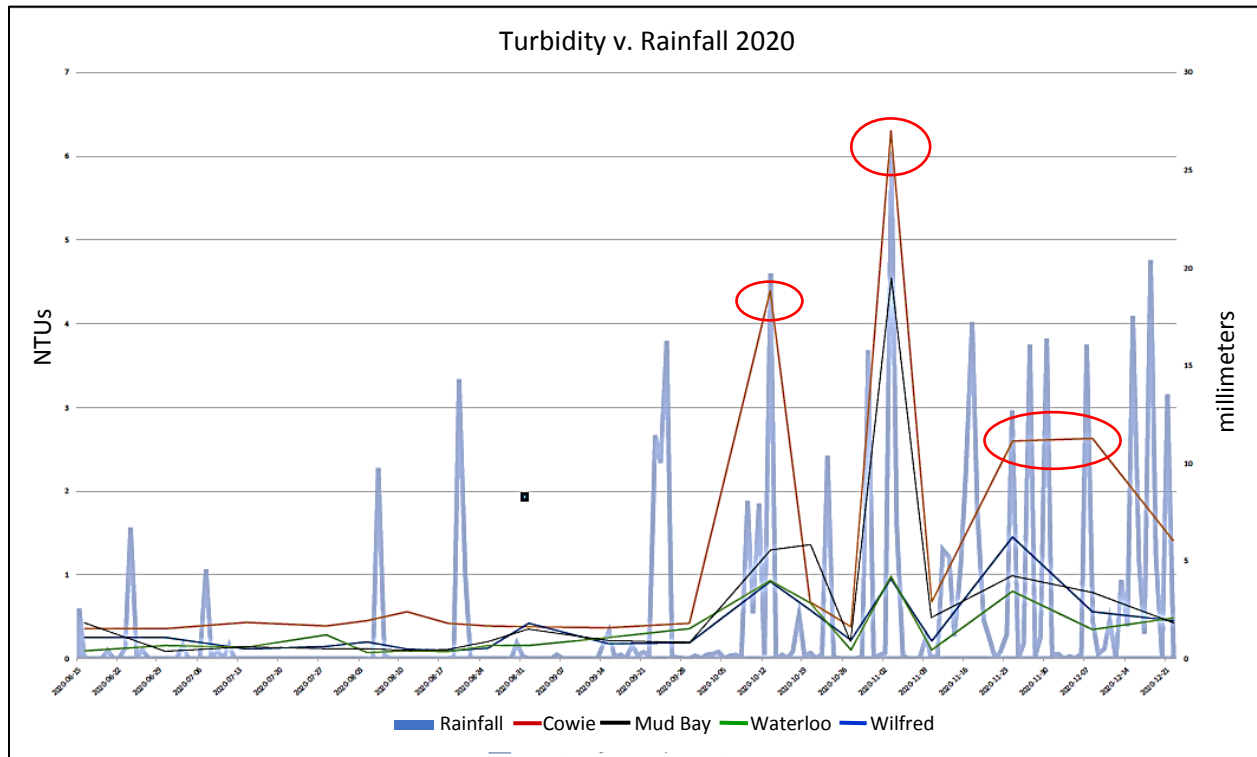
Turbidity v. Rainfall per Watershed 2020: Turbidity measurements are from BWS data (Turbidity is in NTUs on the left axis of graph) and Rainfall measurements are from the BC Forest Service fire weather station in Bowser, BC (Rainfall is in millimeters on the right axis of the graph). Cowie Creek data is highlighted with **red circles**.
