DATE: February 11, 2016

RE: 2015 Saratoga Beach – Puntledge Black Creek (Area ‘C’) – Groundwater
Monitoring Program

In February of 2015, the CVRD retained Payne Engineering Geology (PEG) to evaluate the performance of onsite sewage systems within the Saratoga Beach Study Area (or settlement node), by assessing groundwater quality within sub-areas of the node for evidence of contamination from failing onsite sewerage systems. This Study Area includes approximately 600 properties, with potential for further development. This study identifies areas within the Saratoga Beach settlement node where onsite systems are functioning as intended, and other areas experiencing a significant rate of failure. Section 2.2 of this report reviews relevant conclusions of the Regional District's Stage 1 Liquid Waste Management Plan (LWMP).

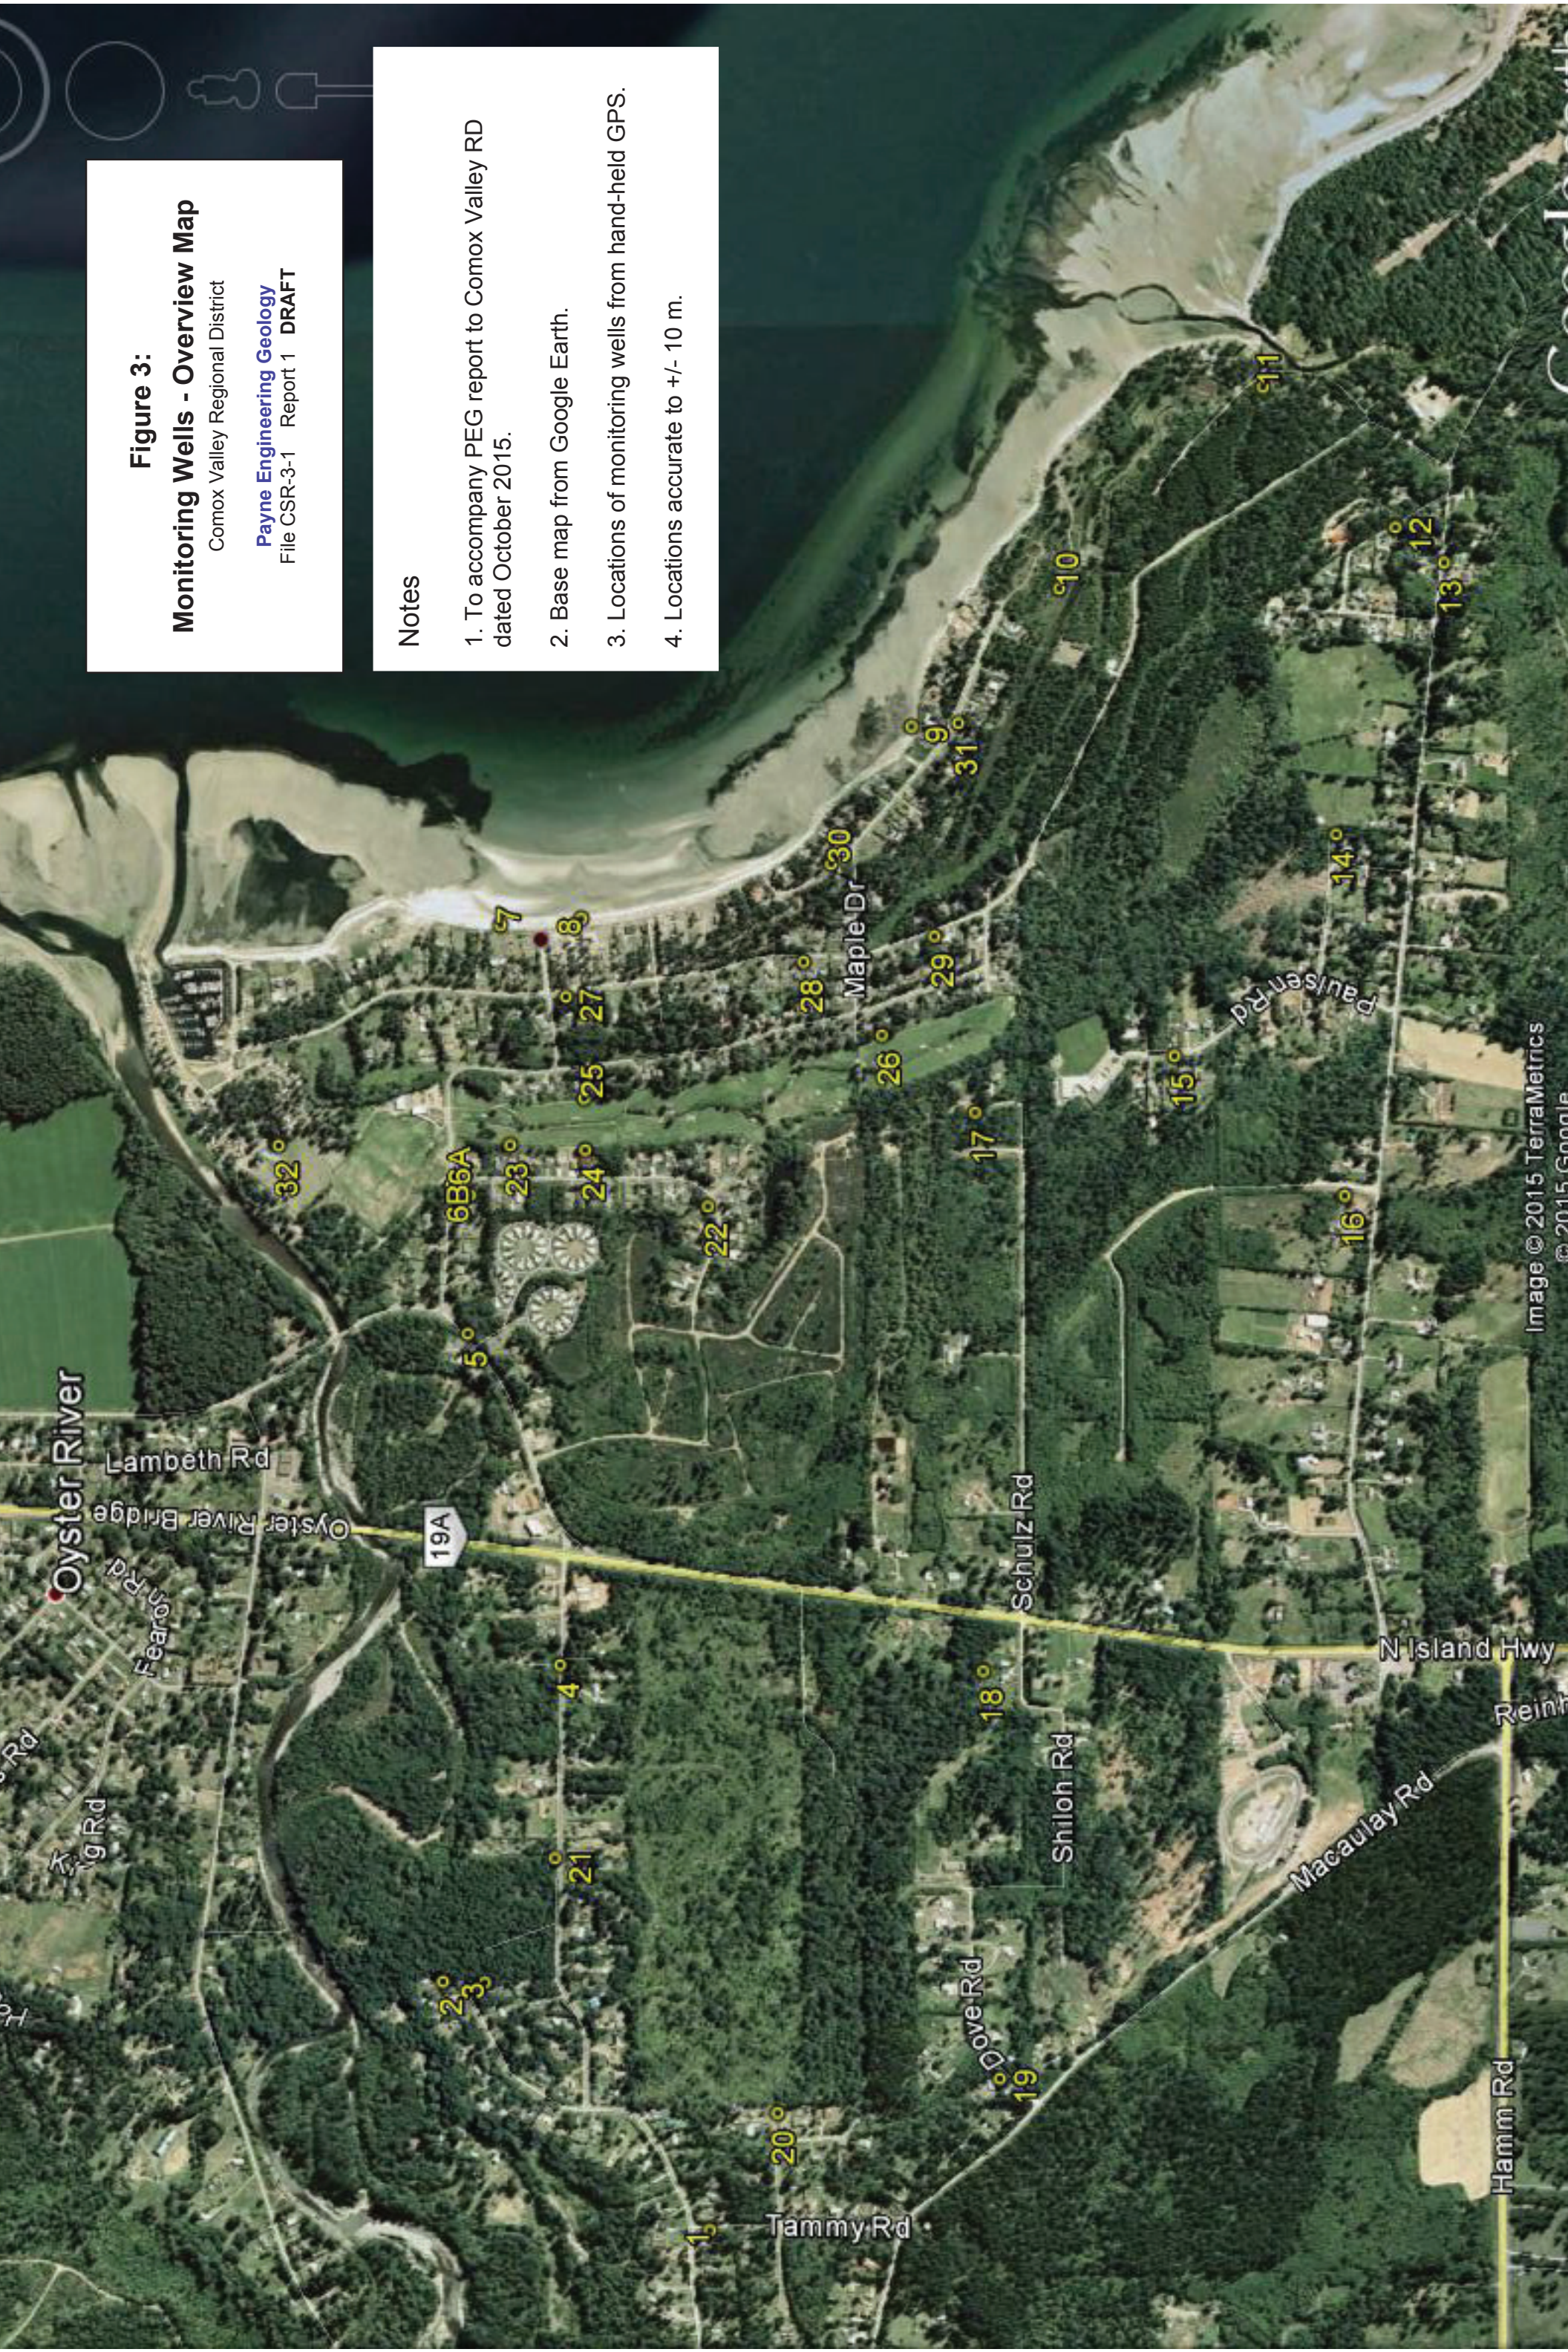
1. To accompany PEG report to Comox Valley RD dated October 2015.
2. Base map from Google Earth.
3. Locations of monitoring wells from hand-held GPS.
4. Locations accurate to +/- 10 m.

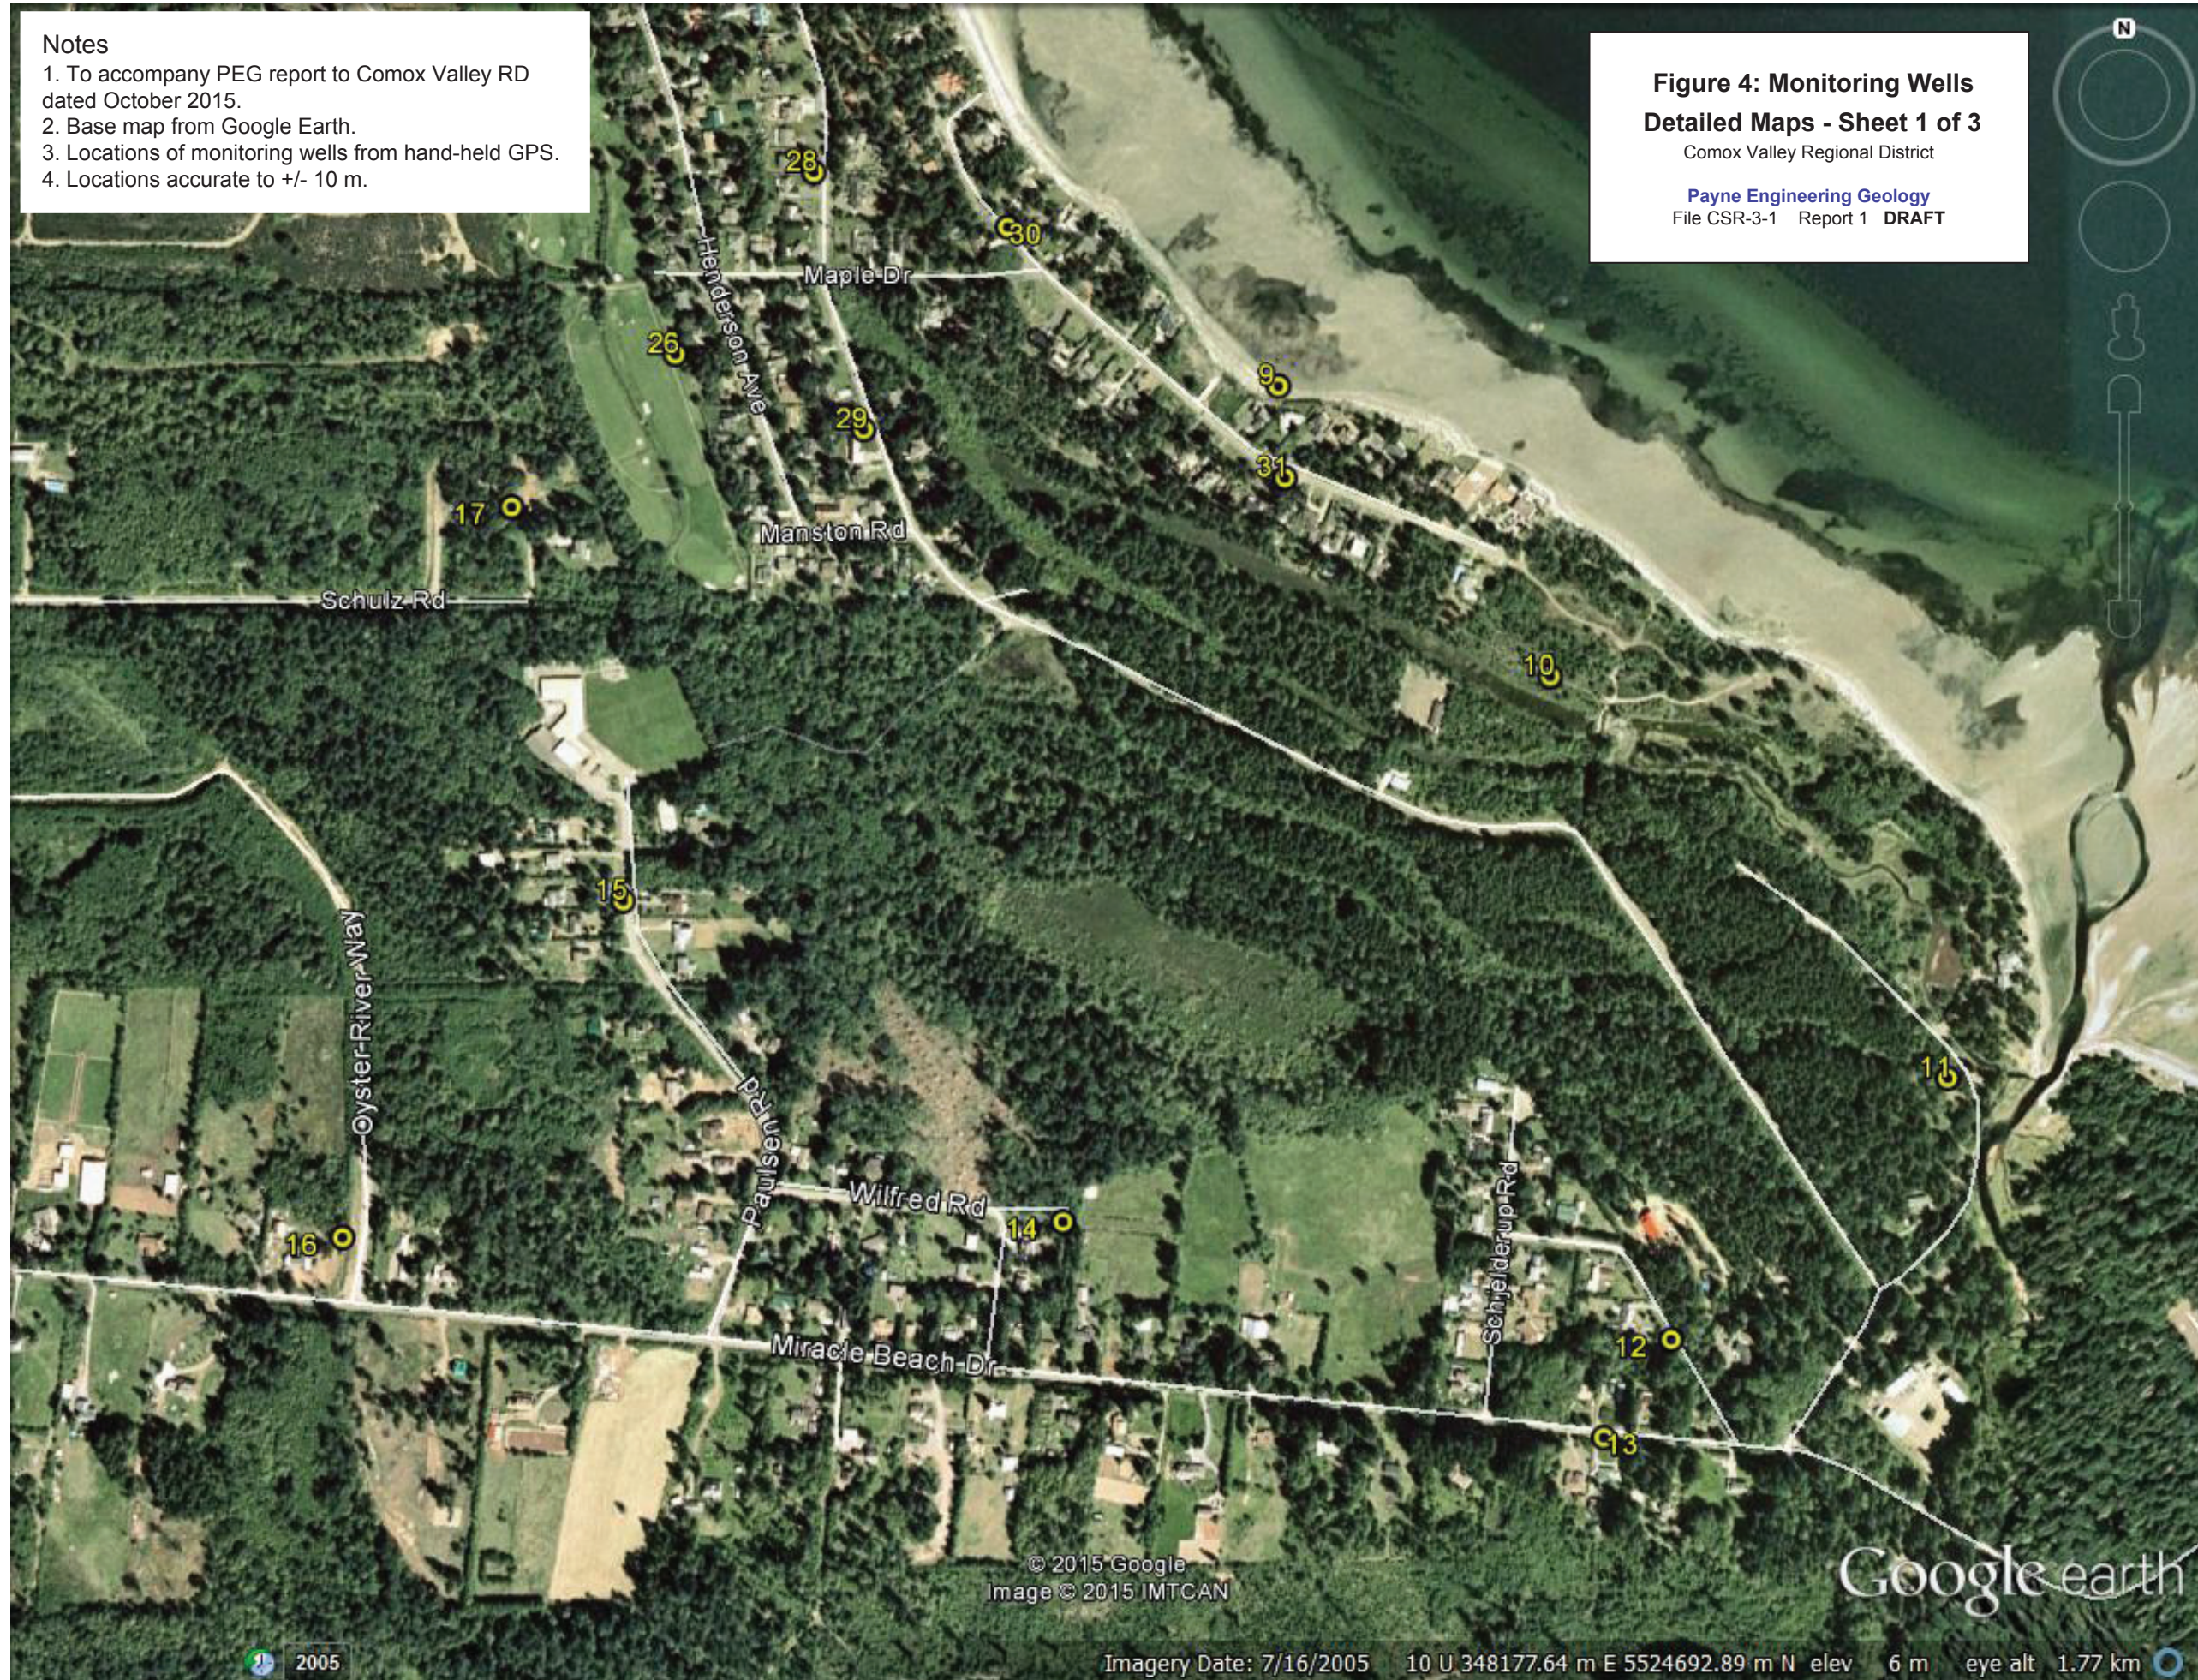
- Digital Road Atlas - Labels
 - Integrated Cadastral Fabric
 - Outline of Sub-Areas
 - 15** Sub-Area Number
 - Failed wells
 - Water table shallower than 100 cm
 - Water table deeper than 100 cm
 - Designated Area - Note (3)
- 0 0.41 0.81 km
1: 20,000

- (1) To accompany PEG report to CVRD dated October 2015.
- (2) Base plan from iMapBC.
- (3) The Designated Area has the least favourable conditions for on-site sewage systems, based on the 2015 groundwater monitoring and PEG data interpretation.
