RE: **AMENDMENT - Aquatic and Riparian Habitat, Blue Heron Nest and Steep Slopes Development Permit (DP 14A 17)**
Baynes Sound – Denman/Hornby Islands (Electoral Area A)
7652 Ships Point Road (Adams)
Lot 14, District Lot 26, Newcastle District, Plan 17305, PID 003-923-011

To provide information about a request for reconsideration of a Comox Valley Regional District (CVRD) officer's decision to refuse an amendment to Aquatic and Riparian Habitat, Steep Slopes and Blue Heron Nest Development Permit (DP) DP 14A 17 to include a beach access staircase.

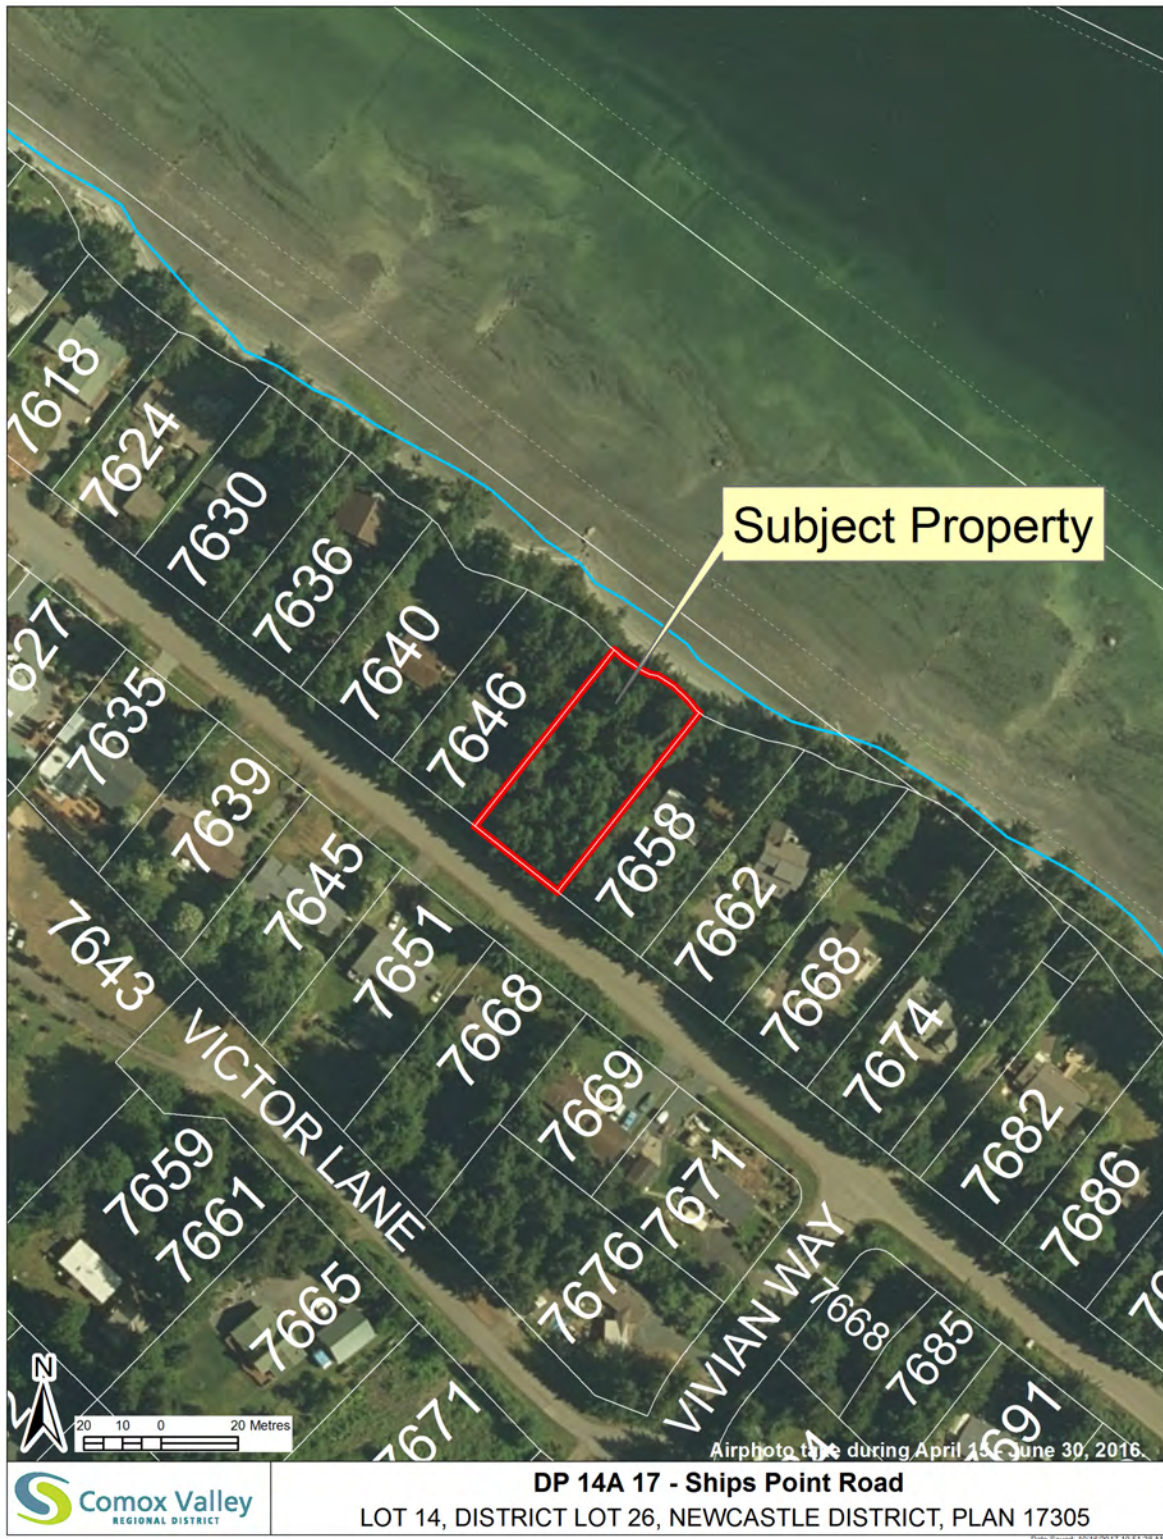
Figure 2: Aerial Photo

The subject property (Figures 1 and 2) was issued an Aquatic and Riparian Habitat, Blue Heron Nest and Steep Slopes DP on November 27, 2017 for the residential development of the lot including removal of existing buildings, land clearing and construction of a dwelling, driveway, septic and drainage trench. The applicants would like to amend DP 14A 17 to include a beach access staircase in the development proposal. The staircase will be made of light materials such as old growth cedar to limit the weight on the slope. The design includes a hinged drop set of stairs from the final landing that can be raised when not in use (Figure 3). A survey of the property indicates there is adequate space for a staircase without encroaching onto public property. No tree removal would be required to construct the staircase.

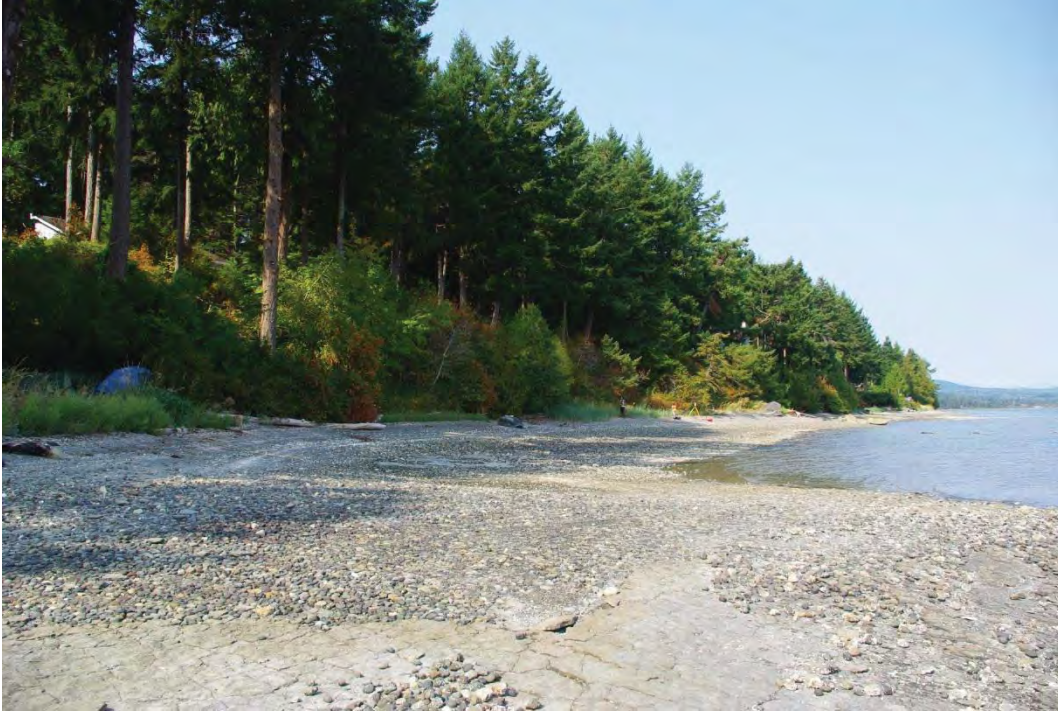
Photograph 1: Marine shore below the property looking west from a shallow point to the south.

The property was visited on 29 August 2017. The property fronts on 27m of marine shore (Map 1). The marine shore consists of a shallow bay of sand and cobbles (Photograph 1) between a shallow natural point to the south (Photograph 2) and a grouping of large boulders to the north (Photograph 3). The boulders were likely placed at some time in the past to act a beach groyne. While I am not qualified to report as a geotechnical engineer, my understating of landscape processes suggest the geo-physical structure of the shoreline is functioning such that sediments are being deposited and not eroded. There is no apparent need for shoreline armoring.

The physical shoreline characteristics / backshore habitat are shown in Photograph 1. The proposed staircase would not touch the beach surface influenced by the marine tides. The mentioned “eel grass and fish spawning habitat” is well below any point of contact with the staircase. Eel grass is off shore, typically just below the low tide mark, though occasionally exposed at lowest tides. Spawning habitat for some fish species (herring) is within the eel grass. Other species (smelt and several species of “baitfish”) spawn in the beach sands and gravels near the shore and will not be touched by the proposed staircase.

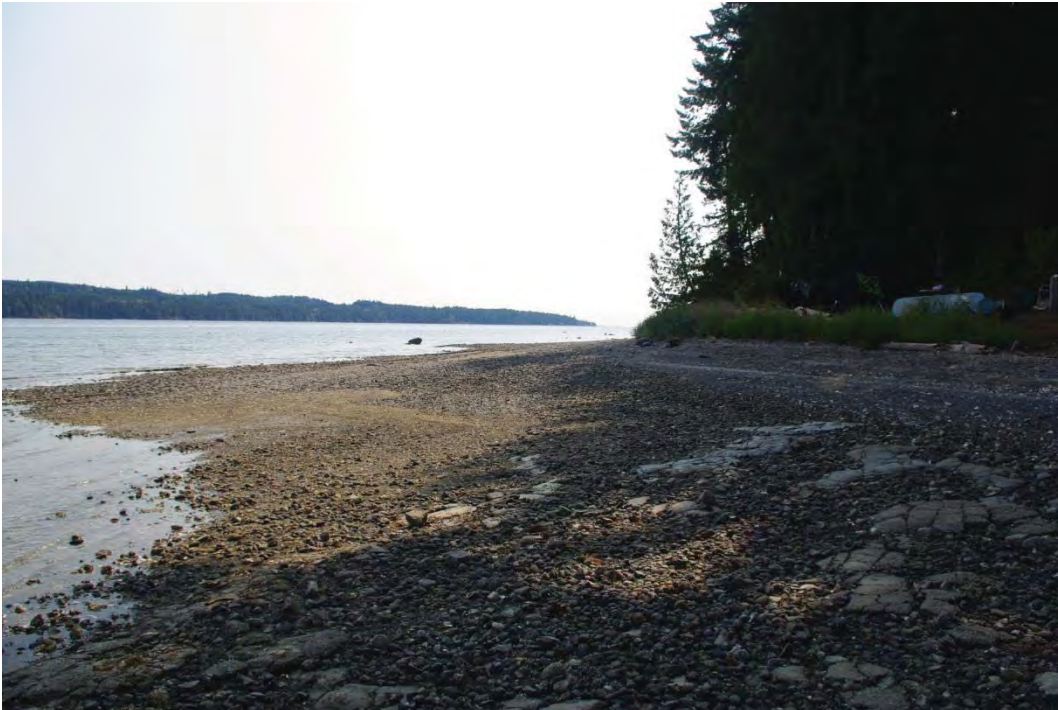
Photograph 2: Marine shore below the property looking east towards a shallow point.

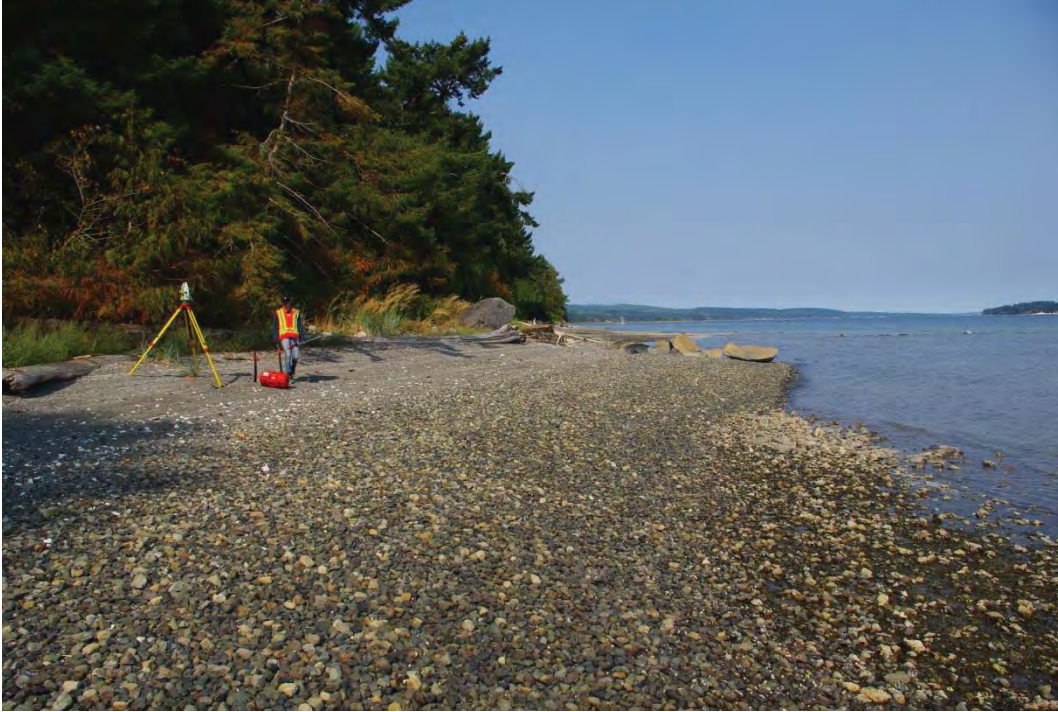
Photograph 3: Marine Shore, looking west towards boulders serving as a beach groyne.

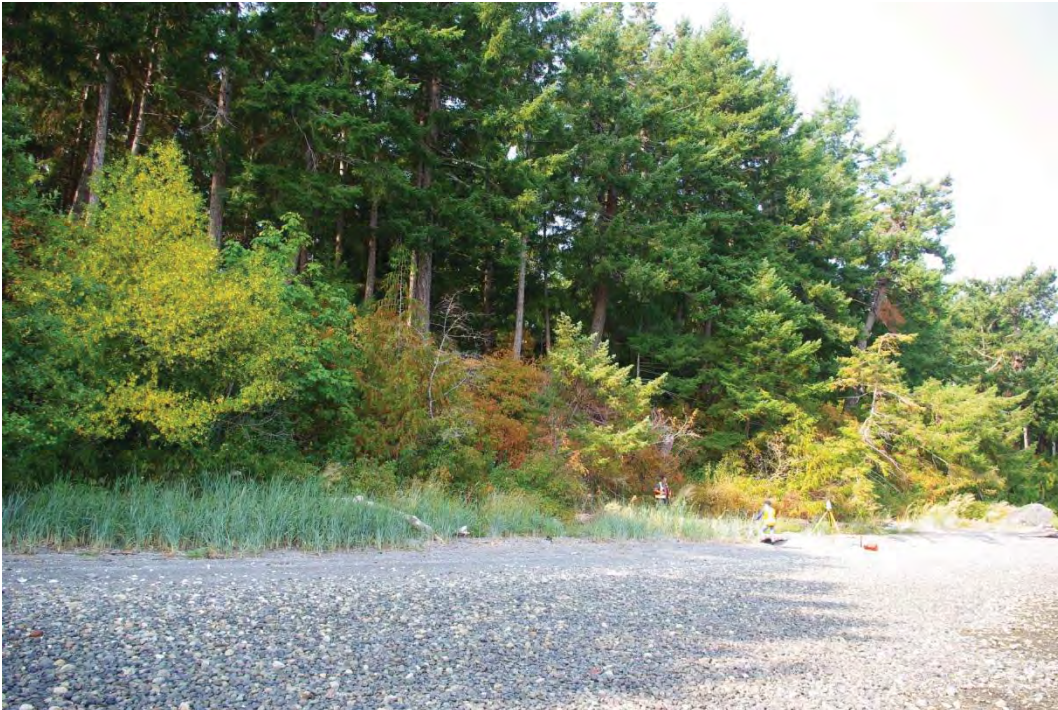
Photograph 4: Marine shore and vegetated bank.

Inland of the marine shore is a sloping vegetated bank at an angle of approximately 45°, extending approximately 7.5m inland (Photograph 4). Vegetation growth at the base of the slope indicate shoreline stability (vegetation has not eroded in recent years). There was no evidence of the bank being unstable; no clumps of soil or vegetation were seen at the base of the slope. Douglas fir along the top of the bank, estimated age 30 to 40 years, growing straight up and down also suggests bank stability. The tree on the right hand side of Photograph 5, growing directly at the crest of the slope, shows a slight bend near its base from its first few years for growth indicating the top of the bank has not moved since that time.

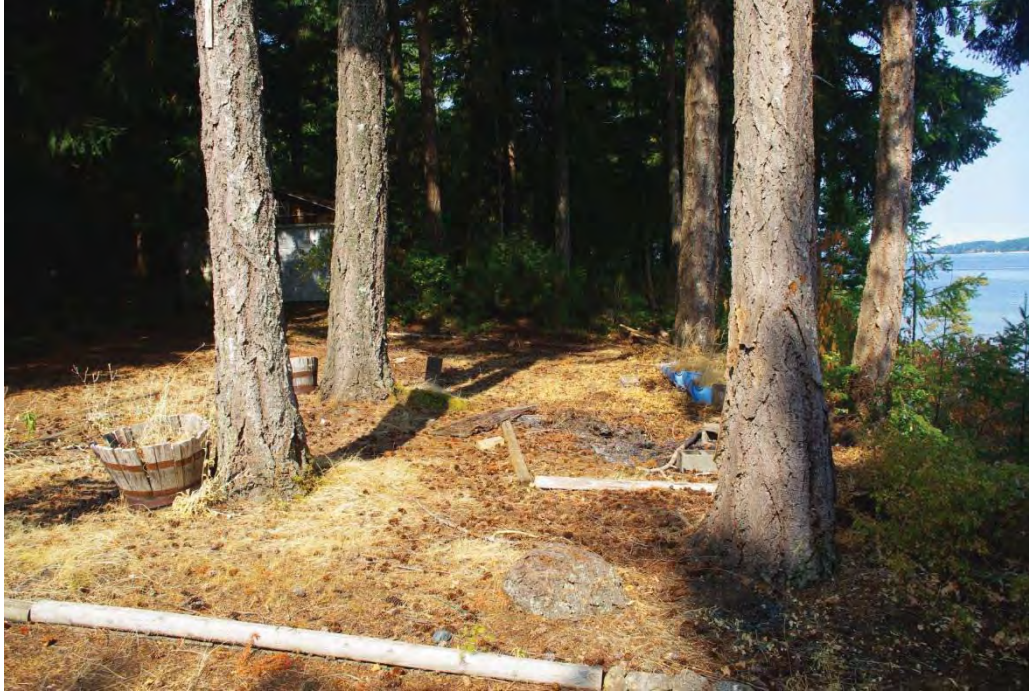
Photograph 5: Top of bank looking north-west.

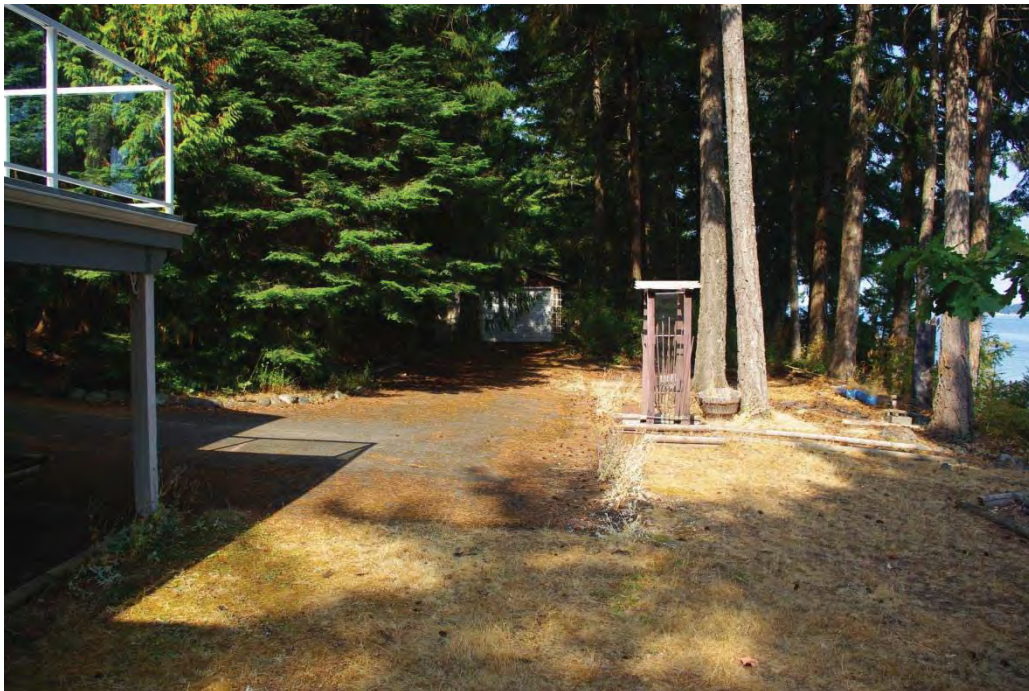
Photograph 6: Cleared area at the top of the bank, looking north-west, as viewed from the neighbouring residence to the south.

Extending from the top of the bank inland for approximately 12m is relatively level ground cleared of understory vegetation (Photograph 6). This area has a garage and a small shed that were part of the lot to the south when there was one owner for the two lots. The grassy area was used as a driveway to the garage and as a residential garden. In the grassy area, just inland of the top of the bank and within 15m of the marine shore are 16 “maturing” Douglas-fir trees (shown on Map 2). Between the grassy area and the rear of the property is a Douglas-fir forest with natural understory vegetation. This area includes the four heron nest trees, three of which are shown flagged in Photograph 6.

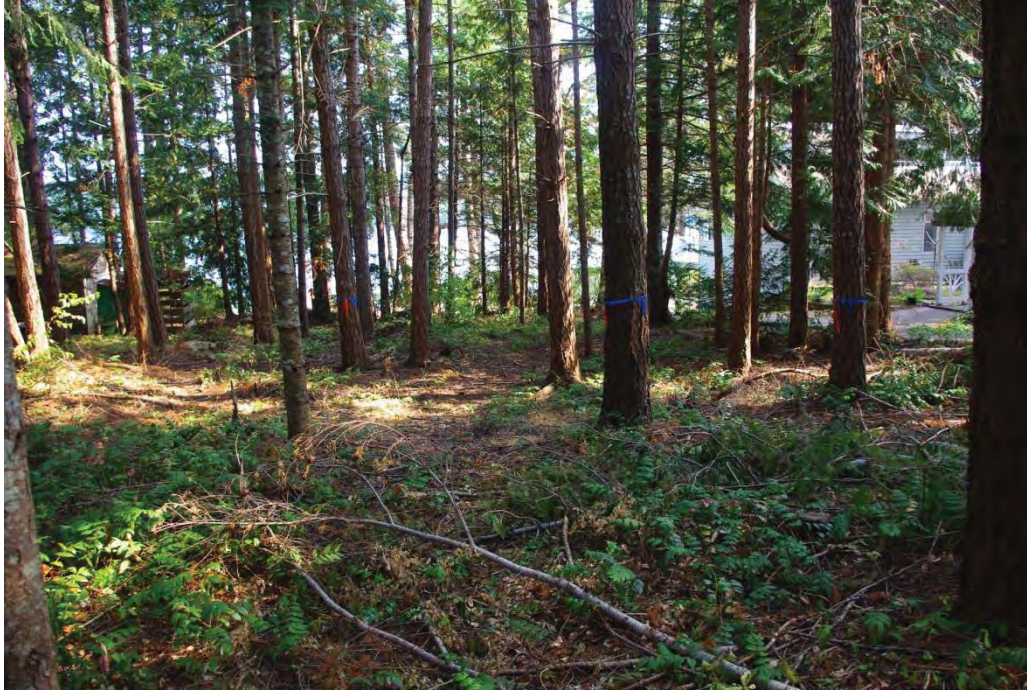
Photograph 7: Looking north-east towards the shore, showing the natural forest vegetation (three heron nest trees are flagged with blue ribbon).

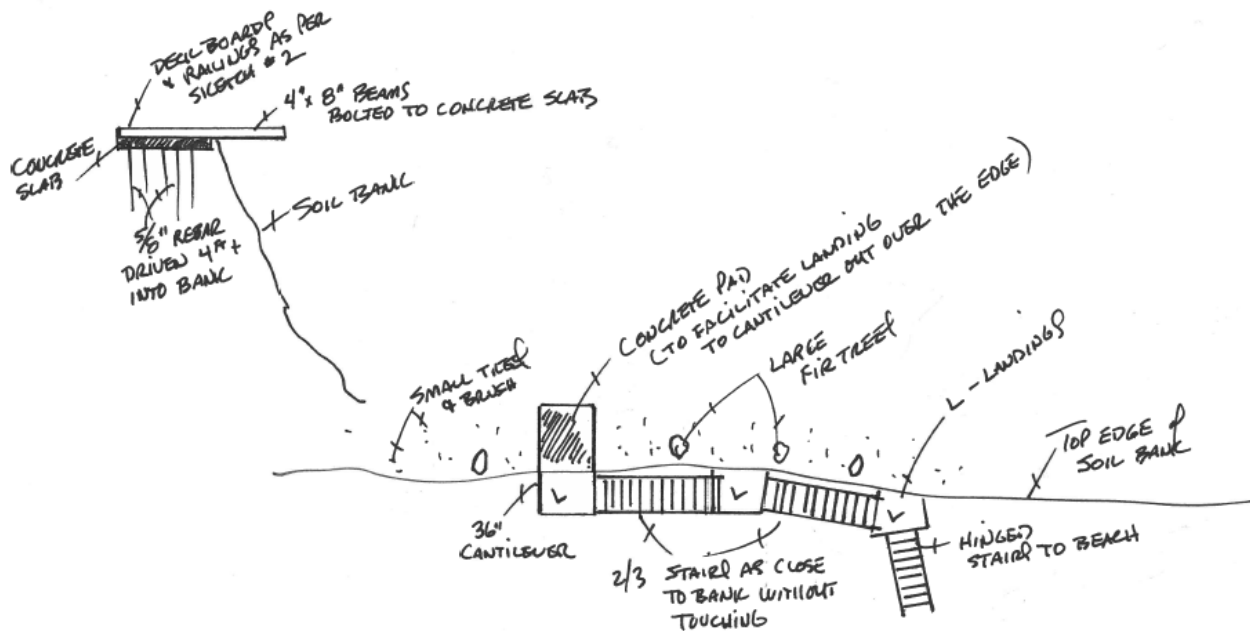
With the **area of the proposed staircase**, the drop from the level surface at the top of the bank to the shore is approximately 13 feet (4m) at a 45° slope. The proposed staircase as shown in the sketch design (shown below) includes eight concrete posts in the ground (supporting two landings) and a concrete pad at the upper start of the staircase. My calculation for the surface area of what touches the ground for these features, once installed, is 22 sq. feet (2m²) [based on 2 sq. feet for the combined eight posts + 20 sq. feet for the upper approach]. It is recognised that there would be additional disruption of the soil when installing the posts for the two landings, but once in place the concrete supports would be considered as environmentally inert (like rocks).

To calculate the **area of trail to the beach** I have used the BC Ministry of Forests manual for recreational trail management (BCMF 2018). The manual discusses various slopes and suggests that safe walking trails at less than 10% (6°) should not encourage erosion. The bank at this site is approximately 13 feet high at a 45° slope. An ideal trail would need to be approximately 130 feet (40m) in length. Given that the width of the property is 27.4m wide this would require a switchback. A two foot wide trail (0.6m) at 130 feet plus 5 feet for a switchback would cover an area of at least 270 sq. feet (25m²). This is over 12 times that of the proposed staircase. To excavate the bank to achieve a level trail surface would likely require an additional, but temporary, disruption of the vegetation about four times the foot print of the trail (another 100m² of disturbance). I suggest that when building a beach trail it would be extremely difficult to achieve a satisfactory regeneration of natural vegetation without further erosion.

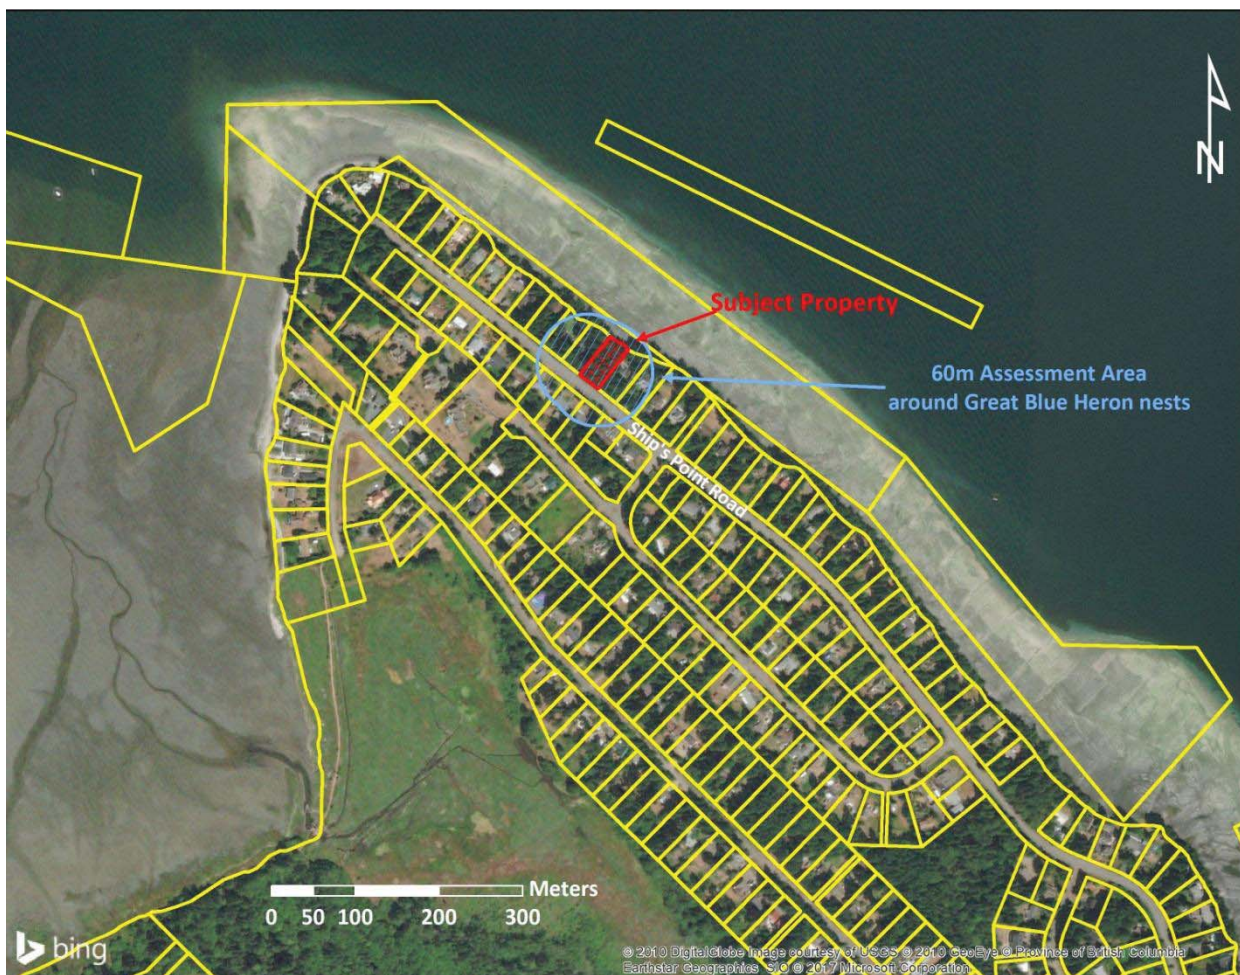
Map 1: Subject Property on Ship's Point Road showing the 60m Great Blue Heron nest tree assessment area.

The property was visited on 29 August 2017 (an earlier visit was made on 4 July 2017 while in contract with the CVRD). Five heron nests were observed in four trees (Map 2; Photographs 1, 2, 3, and 4). Tree number four is a tree that had not been identified on 4 July. A tree that had been identified as a possible nest tree on 4 July (shown as an X on Map 2), by evidence of excrement at the tree base, was ruled out as a heron nest tree. Tree X was viewed from many angles and no nest was visible. Egg shell fragments were located under all of the four trees shown on Map 2 (See example in Photograph 5) but none were seen under Tree X. All egg fragments were found beneath ground debris and would have been from nesting attempts earlier than 2017. A few heron feathers were located; these would have been from the 2017 nesting season.

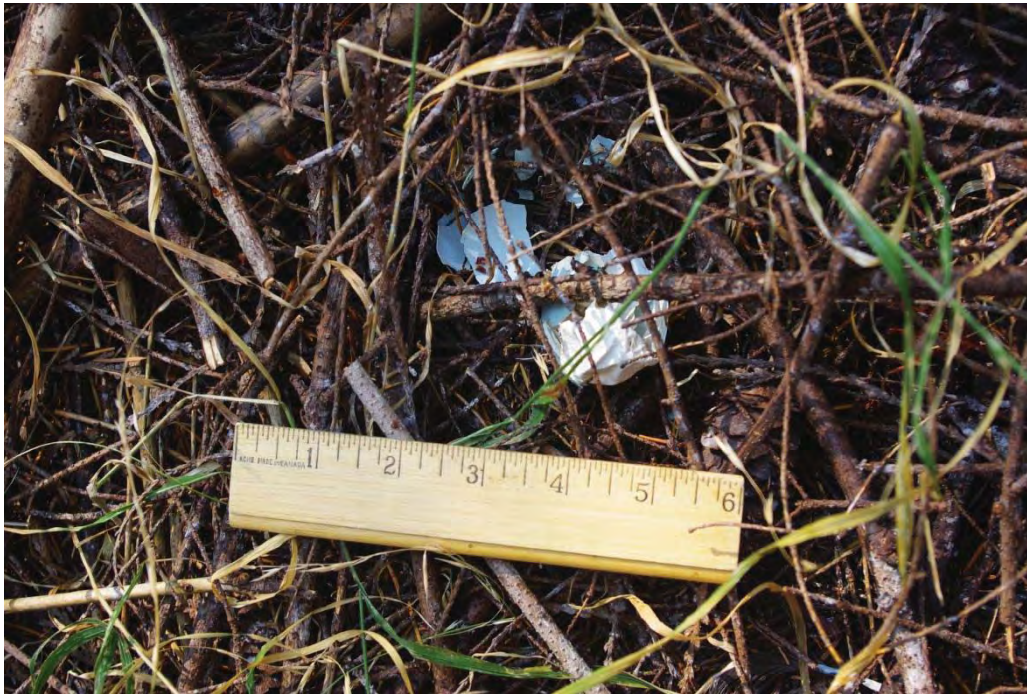
Photograph 5: Heron egg shell under forest debris.

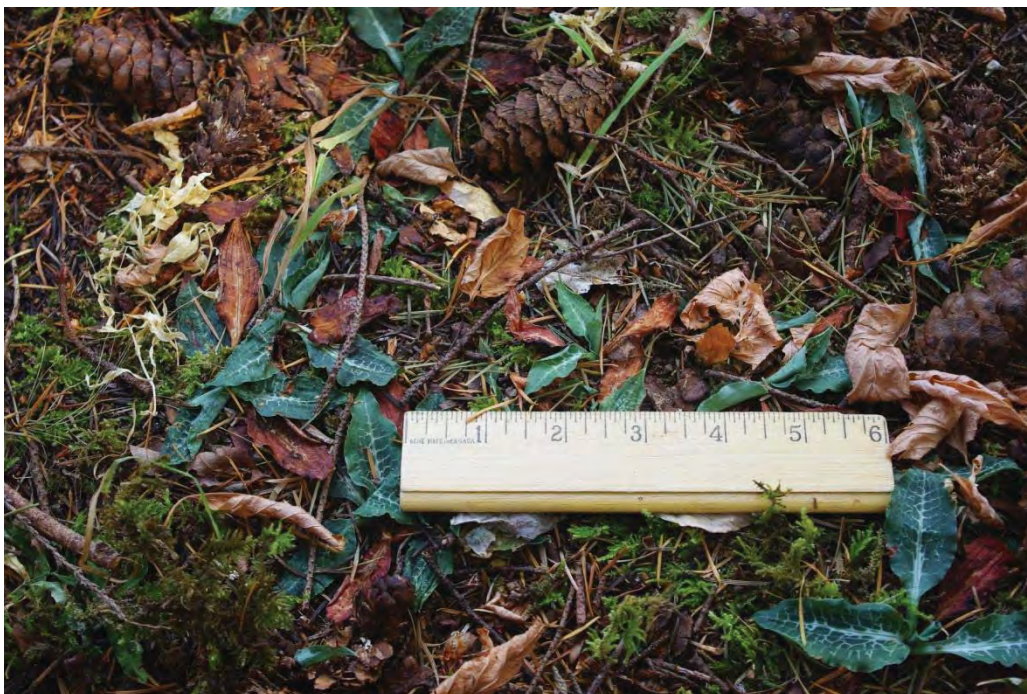
Photograph 6: Rattlesnake Plantain found along the top of the bank.
