**RE:** Update on curling centre

# Comox Valley Curling Rink Renovation Study Report **DRAFT**

Comox Valley Curling Rink, 4835 Headquarters Road, Courtenay, BC

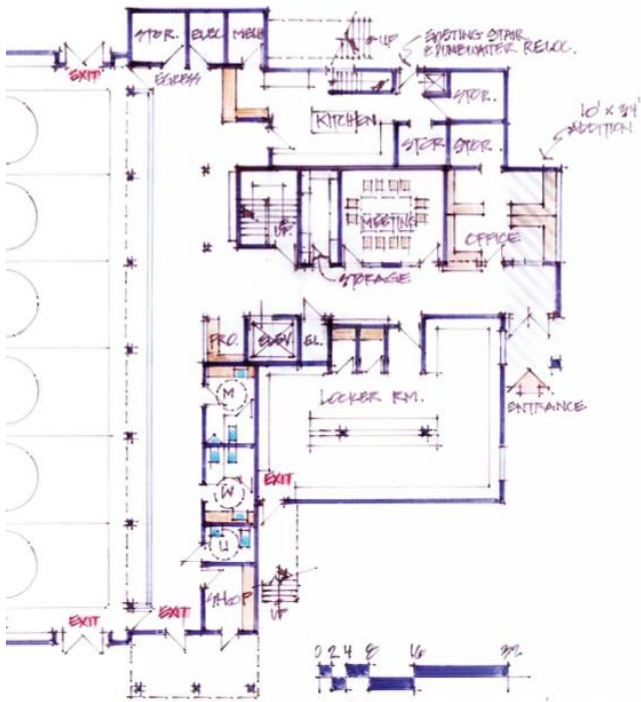
OPTION: SOCIAL 2 - MAIN FLOOR PLAN SK-1

Install an elevator.

Add 340 sq. ft. on each floor.

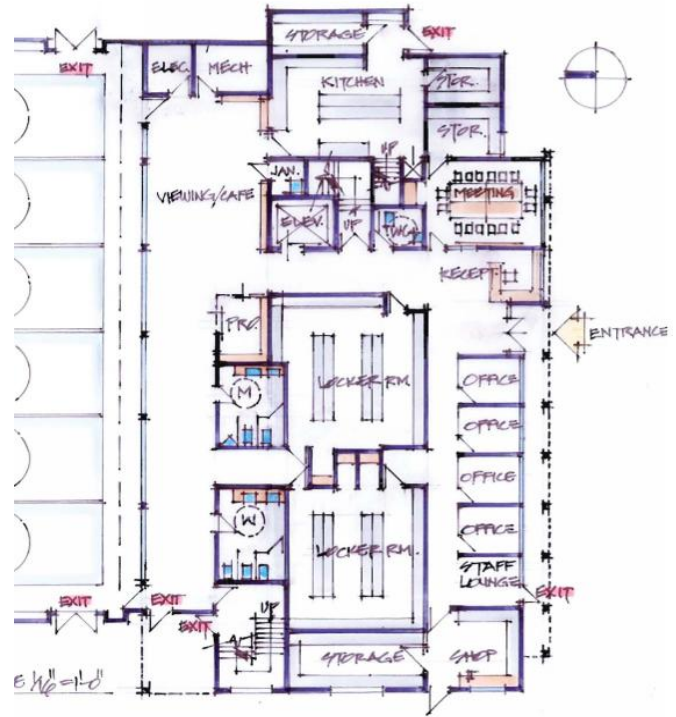
OPTION: SOCIAL 3 - MAIN FLOOR PLAN SK-4

Although the initial intention was to consider a replacement option of approximately the same area as the current Social Component, the concept presented for Social-3 is 30% larger than the current Social Component. This represents the reality that, if the Social Component is replaced, its design and area should be optimized for the functions that it is to address. That has led to the realization that a larger Social Component is likely the best solution.

New construction to current standards.

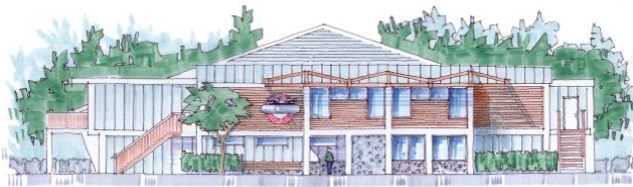
COMOX VALLEY REGIONAL DISTRICT      OPTION: SOCIAL 2 - SOUTH ELEVATION SK-3  
 CURLING RINK RENOVATION STUDY      October 13, 2012

- Work related to the reconfigure program will require the removal and disposal of asbestos containing ground floor kitchen drywall joints and upstairs bar sink anti-sweat coating. The areas affected are not extensive and, as a result, are anticipated to add only minor expense to the project.
- To allow for better functionality, the layout is re-configured generally within the current footprint. There is a small area increase for efficiency purposes and to make up for space lost to an elevator and expanded washrooms.
- Building code upgrades are performed such as the installation of a sprinkler system throughout the space plus fire protection of the common wall / glazing with the curling rink.

- All floor, wall, and ceiling finishes, including associated mechanical and electrical components, are replaced.
- Major structure work is required to upgrade the Social Component to current building code requirements for seismic and snow loading and to accommodate interior layout revisions. The work includes, for example, upgrading or replacing the existing unreinforced concrete block walls and adding new wood frame shear walls and concrete foundations.
- The structural work noted above will affect the perimeter walls. This presents an opportunity to upgrade the walls of the building enclosure and interior and exterior finishes to those walls. Upgraded walls will result in greater energy efficiency (lower operating costs) and more comfortable interior conditions.

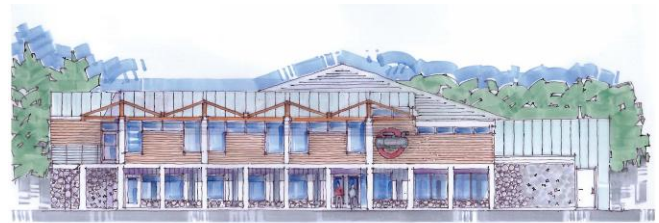
COMOX VALLEY REGIONAL DISTRICT      OPTION: SOCIAL 3 - SOUTH ELEVATION SK-6  
 CURLING RINK RENOVATION STUDY      October 13, 2012

- Architectural, structural, mechanical, electrical, and building enclosure aspects of the building will be new construction to current standards.
- Although the initial intention was to consider a replacement option of approximately the same area as the current Social Component, the concept presented for Social-3 is 30% larger than the current Social Component. This represents the reality that, if the Social Component is replaced, its design and area should be optimized for the functions that it is to address. That has led to the realization that a larger Social Component is likely the best solution.
