**RISK ANALYSIS OF
CVRD FORCEMAIN
ON BALMORAL BEACH**

DRAFT REPORT

Comox Valley Regional District

19 September 2016

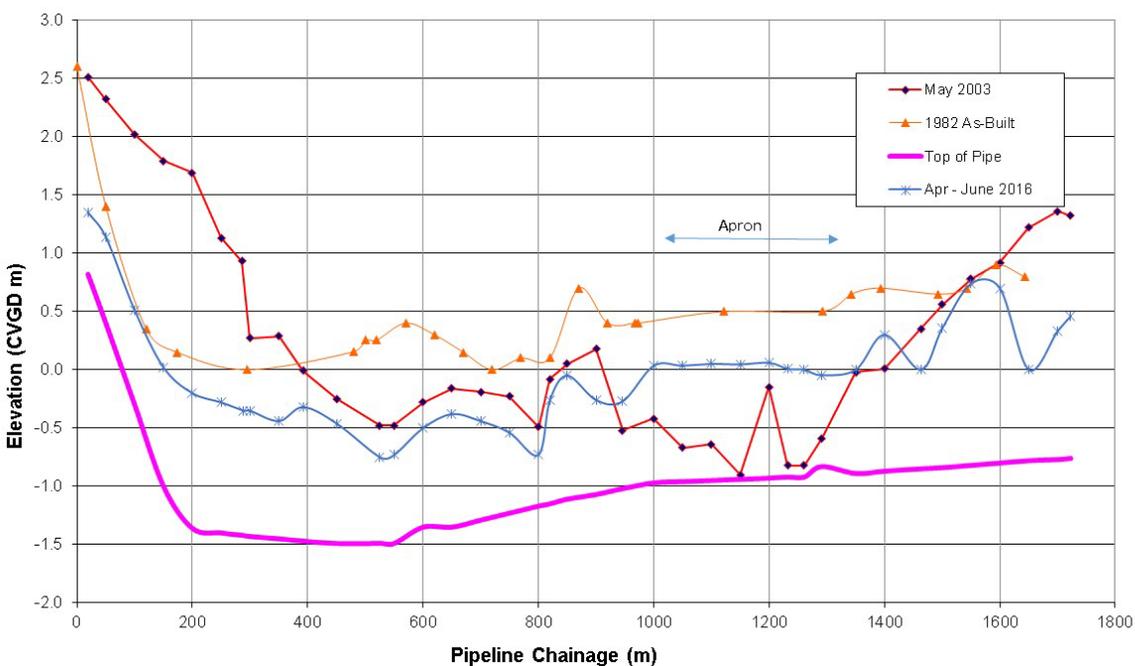
Figure 8: Profile along forcemain and beach level in 1982, 2003 and 2016 (chainage is from south to north)

Monitoring by the CVRD in 2003 indicated that the depth of cover over the forcemain was less than 0.5 m in some locations (Figure 8). In May 2003, inspections showed that portions of the line were exposed (Photo 5). The study concluded that the forcemain was vulnerable to scour and undermining due to long-term lowering of the beach profile and identified four alternatives to prevent a failure of the forcemain:

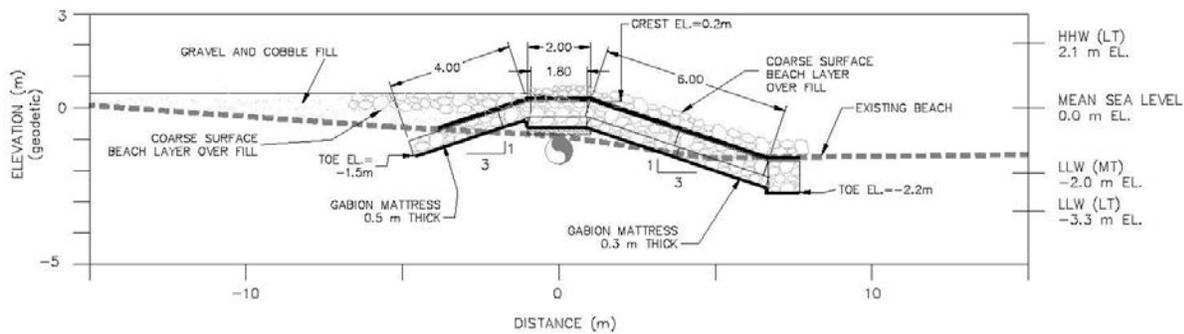
Figure 9: Cross section of erosion protection

- A 0.25 m thick (minimum) granular filter blanket over the pipe.
- Two layers of gabion mattress (0.5 m and 0.3 m) totalling 0.8 m in thickness. The mattress extended 6 m seaward and 1.8 m below the forcemain to prevent undermining by scour.
- A cobble/boulder cover over the mattress, typically 0.3 m thick.

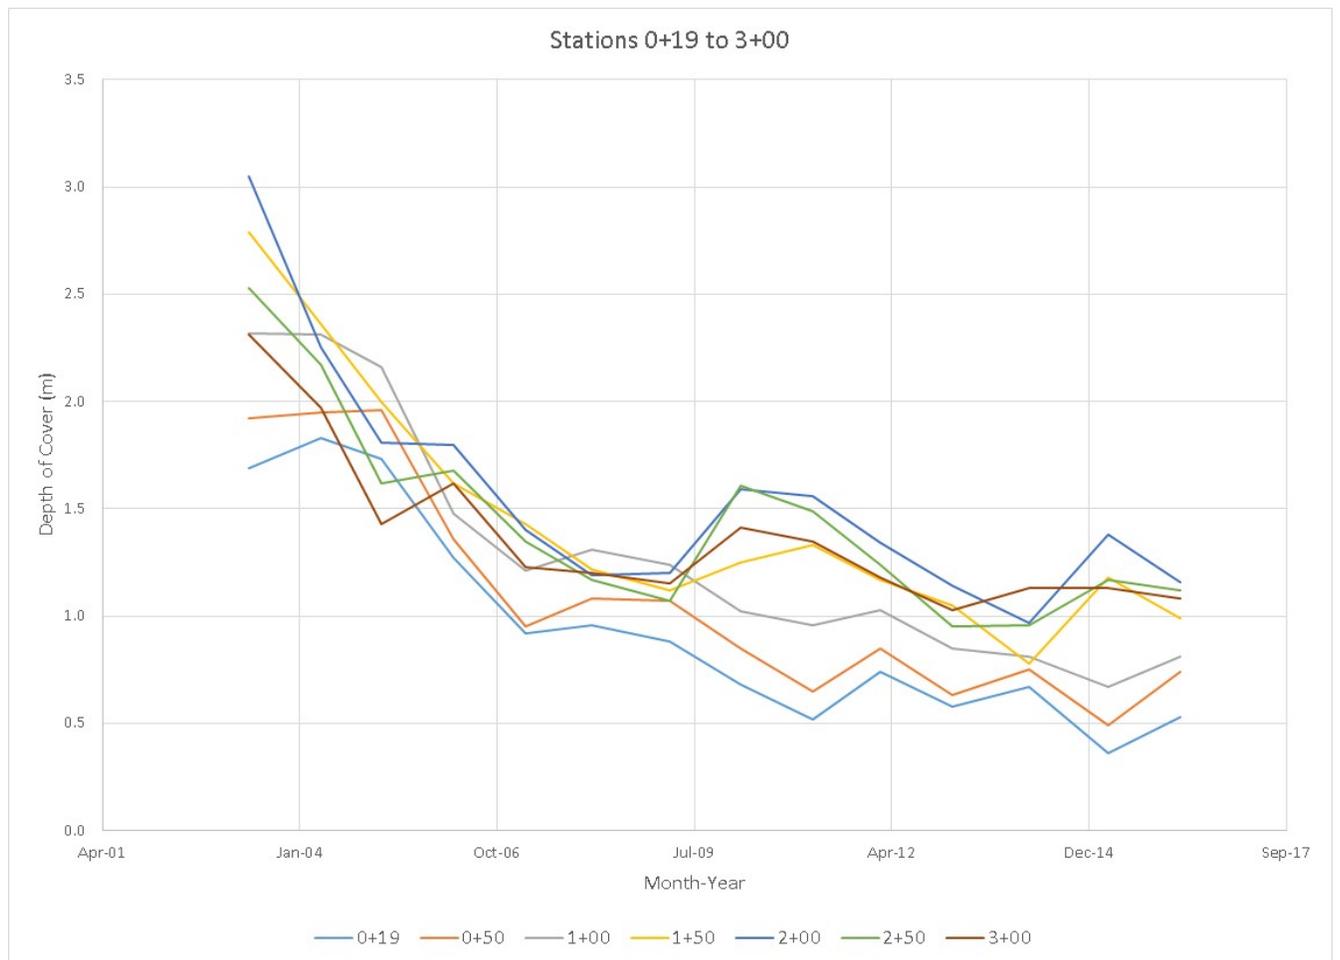
Figure 10: Depth of cover over forcemain near southern end of Balmoral Beach from 2003 to 2016

Figure 10 shows the depth of cover over the forcemain between 2003 and 2016 at 11 stations along the southern end of Balmoral Beach close to Goose Spit. The depth of cover lowered relatively rapidly between 2003 and 2009 and has fluctuated randomly since then at most stations. The greatest changes occurred between Station 1+50 to 2+50 where the depth of cover decreased from between 2.5 and 3.0 m in 2003 to 1 m by 2016. The average rate of bed change was -0.1 to -0.15 m/year. Another area of significant beach lowering occurred at the extreme south end (Station 0+19 and 0+50) where the depth of cover has decreased from between 1.7 and 1.9 m in 2003 to less than 0.5 m by 2015. The rate of beach lowering averaged approximately -0.11 m/year in this location.

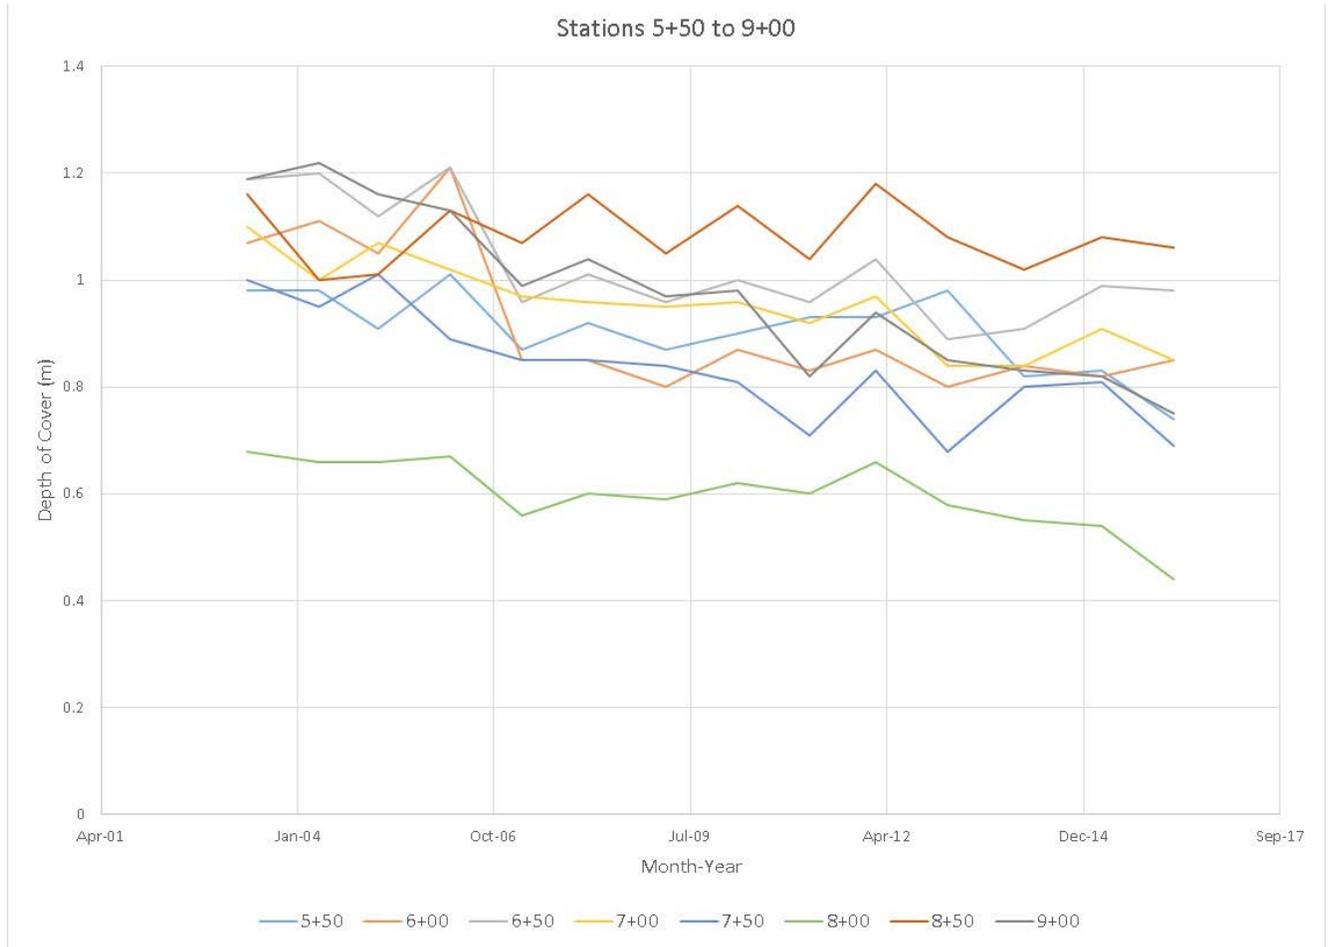
Figure 11: Depth of cover over forcemain in middle section of Balmoral Beach from 2003 to 2016

Figure 11 shows the depth of cover has remained between 0.8 m and 1.2 m at most locations along the middle section between Station 5+52 to 9+46. There appears to be a slow trend of decreasing cover over time (typically -0.015 m/year) at most locations. The lowest depth of cover occurred near Station

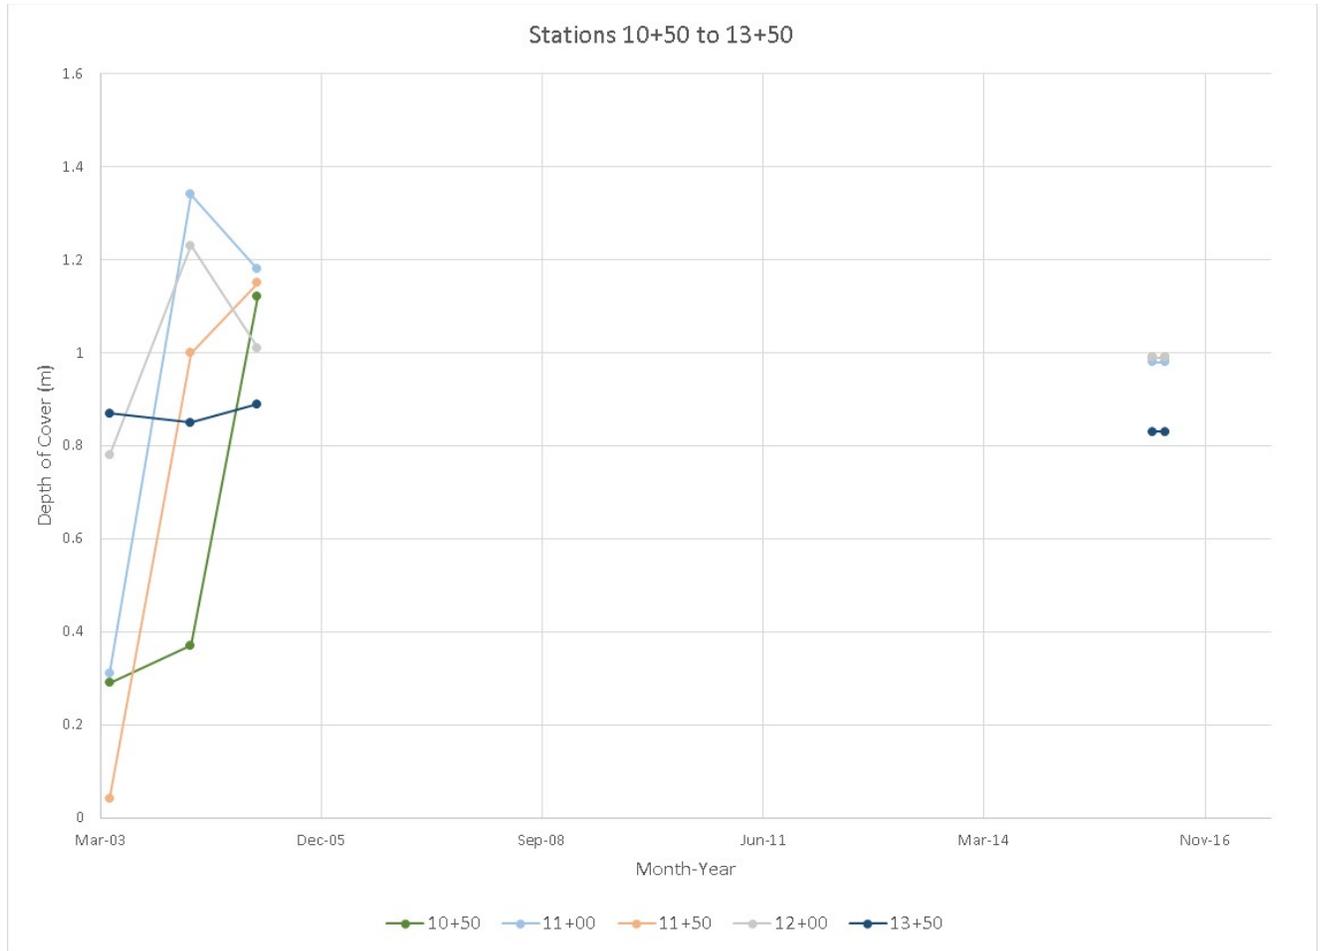
Figure 12: Depth of cover over forcemain along section covered by mattress from 2003 to 2016

Figure 12 shows the depth of cover over the forcemain has remained between 0.8 m and 1.0 m after the mattress protection was installed. The reduction in the cover at some stations (11+00) reflects the erosion of the cobble/boulder cover layer that was placed over the mattress (Photo 6).

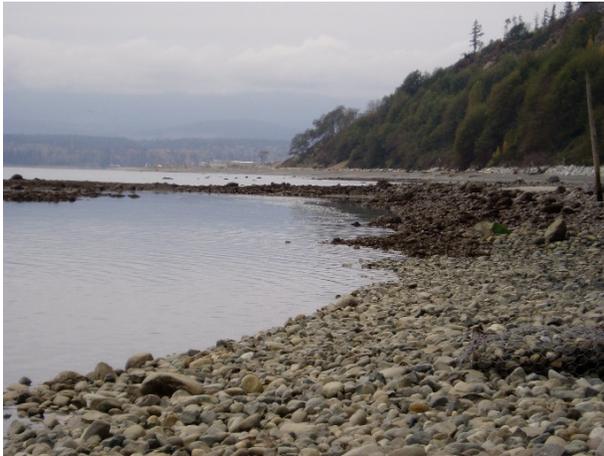
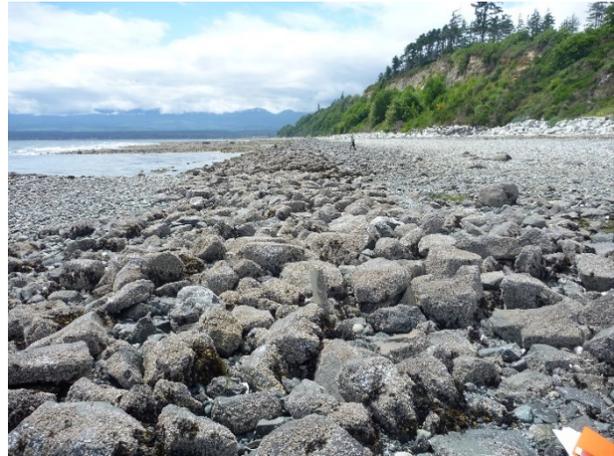
Photo 14: Near Station 13+00, viewing southwest along intact boulder/cobble cover over forcemain

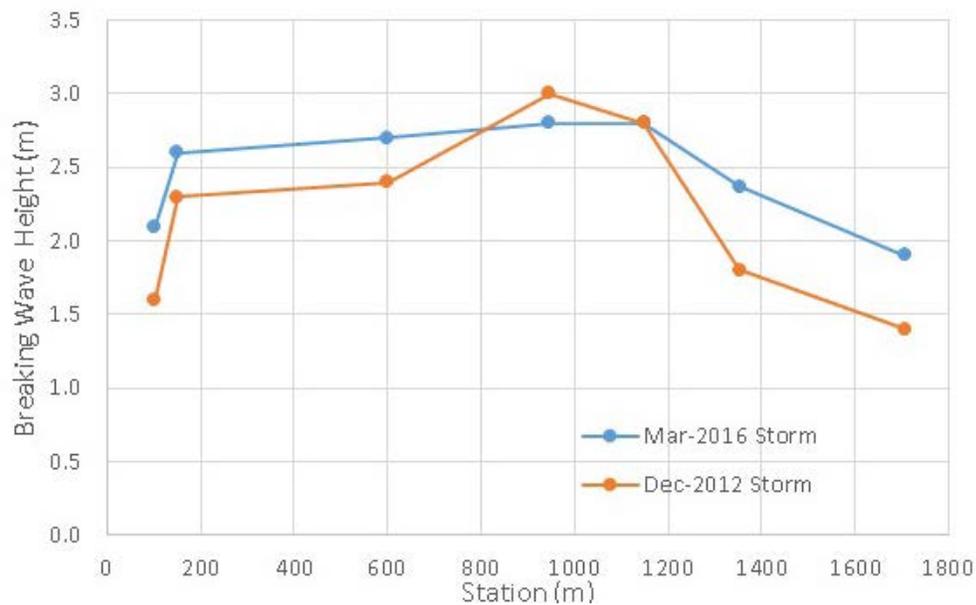
Figure 15: Variation in breaking wave height over forcemain along Balmoral Beach for two storm events

Figure 15 shows the variation in breaker height along the forcemain for the December 2012 storm and March 2016 storm. The incident deep water wave heights were 3.0 m for the 2012 event and 2.6 m for the 2016 event (Table 2). The variation in wave height over the forcemain is governed mainly by the variation in water depth and offshore beach slope, which affect the maximum breaker height (H_b). This plot shows that the most severe wave conditions occurred between Station 9+00 and 12+00, which corresponds to the section, that became exposed in 2002 and the site of the 2003 emergency protection works. This section has the highest breaking wave conditions because the ground level is generally lower (water depth is greater) and the offshore beach slope is steeper than at other sections.

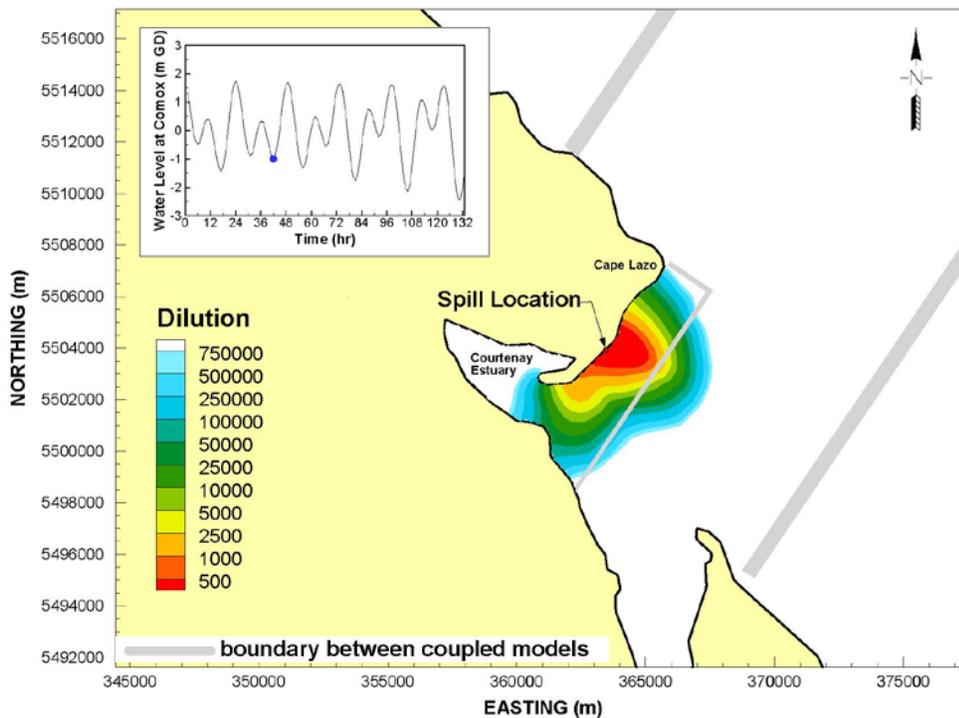
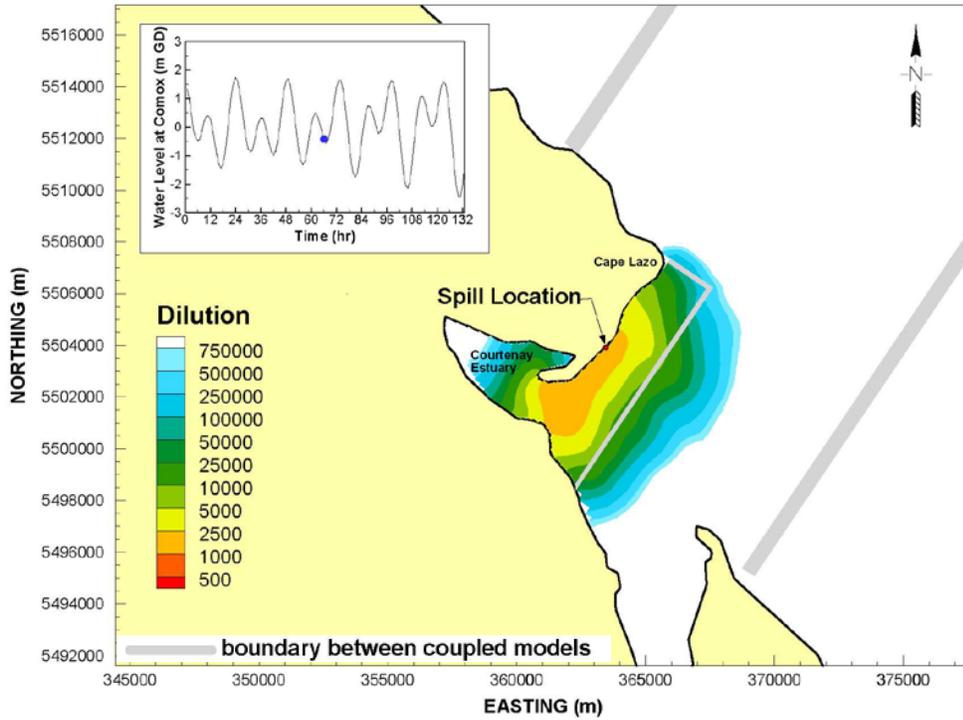
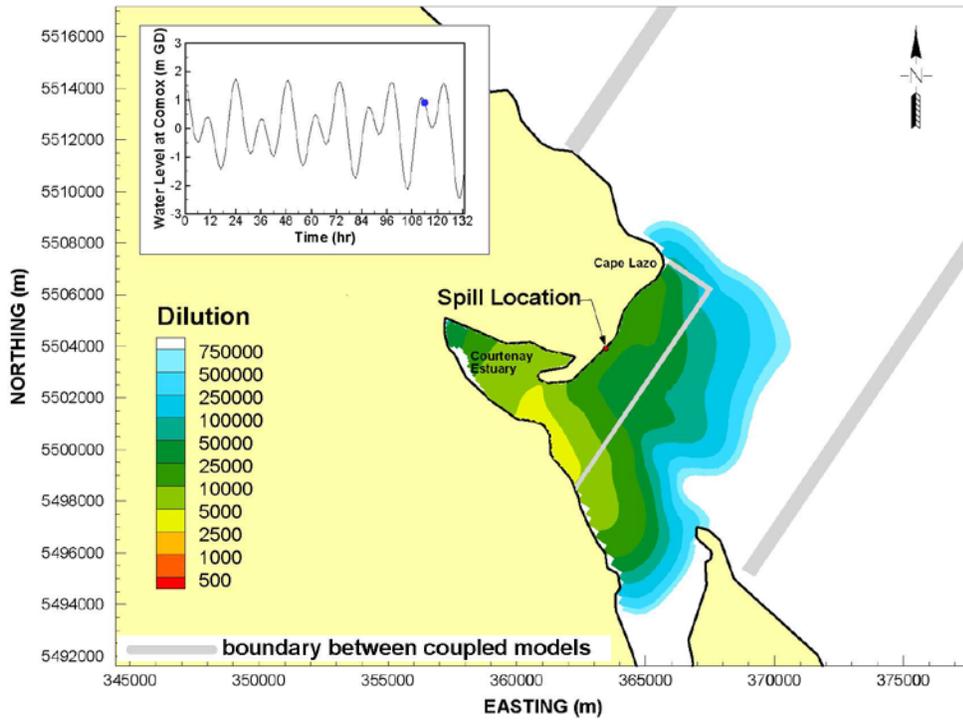
A worst-case scenario in terms of conditions in the Courtenay River Estuary and Baynes Sound is the situation of a forcemain break during calm winds and low inflows from the Courtenay River (Run 2). Figure 18, Figure 19 and Figure 20 show the extent of the effluent plume at an elevation of -2 m CGVD 24 hours, 48 hours and 96 hours after discharging on the beach.

After 24 hours, the discharge from the forcemain will be diluted by a factor of between 100 and 500 along most of Balmoral Beach. Dilution rates inside the Courtenay River Estuary-Comox Harbour were in the range of 4,000 to 5,000 after 48 hours. At this time, the plume will extend over a 2 km wide, 8 km long band that covers the tip of Cape Lazo to the northern end of Baynes Sound. After 96 hours, the effluent will be diluted by a factor of approximately 100,000 at the north end of Baynes Sound. However, coliform counts will still be in the range of 300 to 1,600 counts per 100 ml. It should be noted that threshold coliform levels for shellfish in coastal BC waters is presently in the range of 14 to 40 counts per 100 ml. Therefore, the potential impact zone shown on Figure 20 is expected to be much greater.

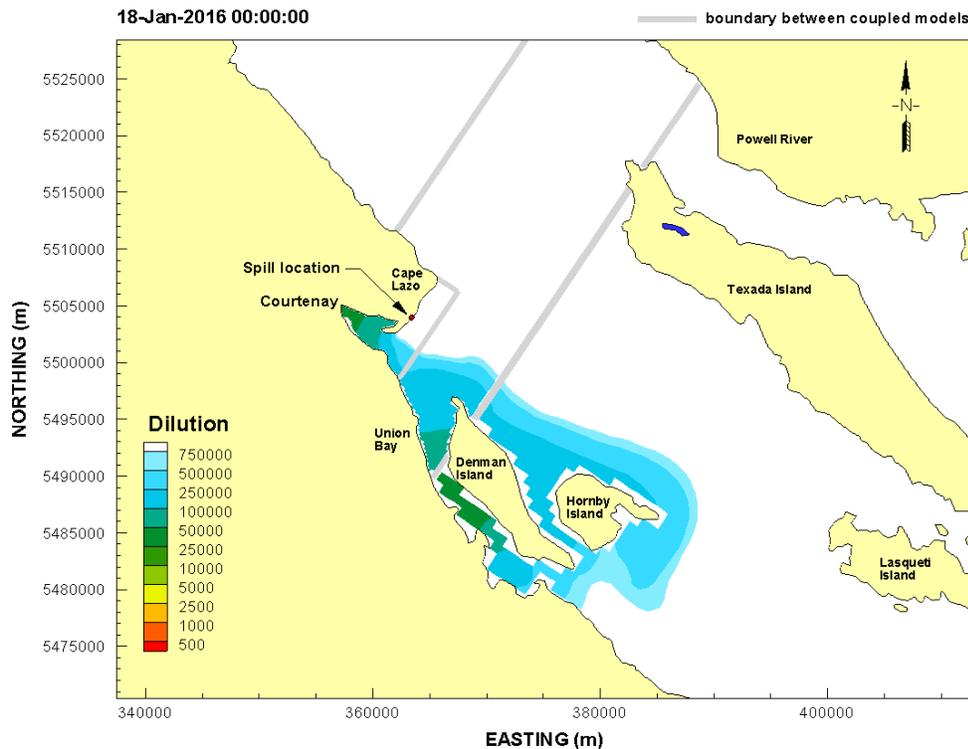
Figure 21: Run 2 – Dilution map 30 days after discharge, calm winds, low Courtenay River inflow

Figure 21 shows the extent of the effluent plume at an elevation of -2 m CGVD 30 days after the release for Run 2 (calm winds and low Courtenay River inflow). This plot shows that the effluent would persist in the region for a long period under these conditions. The dispersion process in the system is limited by Comox Bar and minimal dilution of about 50,000 was predicted in the Courtenay estuary and in the Bayne Sounds region. The coliform counts would still be in the range of 600 to 3,200 counts per 100 ml.

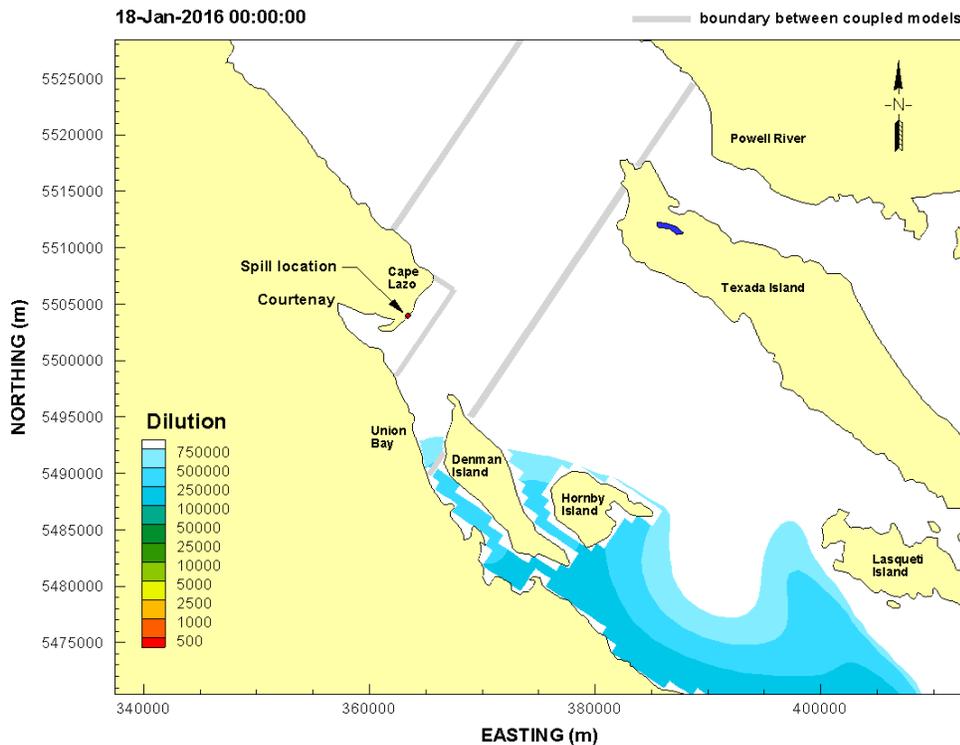
Figure 22: Run 3 – Dilution map 30 days after discharge, calm winds, typical Courtenay River inflow

Figure 22 shows the effect of winter Courtenay River discharge on the effluent dispersion process under calm winds. The plot represents the extent of the effluent plume at an elevation of -2 m CGVD 30 days after the release. In this scenario, the freshwater from the Courtenay River impedes the amount of saline-effluent mixture from crossing Comox Bar. Subsequently a portion of the effluent was kept to the

east of Comox Bar where the tidal currents are faster. The figure shows the freshwater input from the Courtenay River to the region resulted in greater dilution in the Courtenay River Estuary (>750,000) and the minimal dilution in Bayne Sounds is about 240,000 after 30 days. The coliform counts would still be in the range of 220 to 650 counts per 100 ml after 30 days.

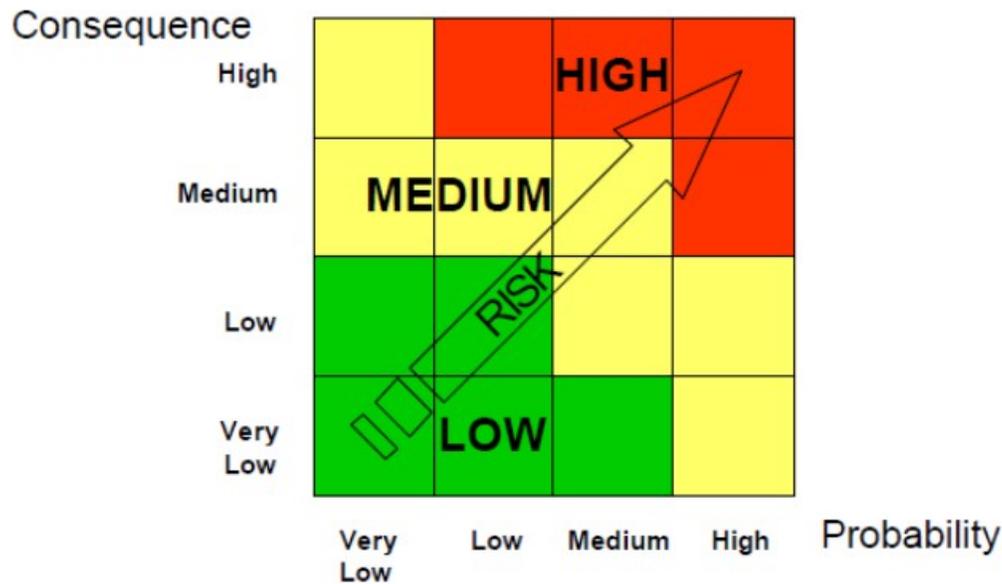
Figure 23: Comparison of consequences and hazard probability to define risks

Figure 23 shows a generalized representation of the relation between hazard probability, consequence and the resulting risk. The plot represents the following situations:

- There is a high probability (approximately 90%) that the depth of cover over the unprotected portion of the forcemain will be reduced to unacceptable levels (less than 0.3 m) during the next five years. Assuming emergency repairs are carried out in a timely manner this would be a low consequence event (Scenario 1), resulting in a cost of approximately \$600,000 per event. It is expected that these types of events will be recurring. This situation is classified in Figure 23 as a “medium” risk.
- There is a medium probability (roughly 50%) that a high consequence event (Scenario 2 involving a failure and a discharge on the beach lasting 24 hours) will occur at least once over the next 5 years. The approximate costs associated with this event are expected to be in the order of \$2 to 3 million per event. This situation is classified in Figure 23 as a “high” risk.

- There is a low probability (approximately 10 %) that a more severe consequence event (multiple failures along the forcemain and a wastewater discharge duration lasting more than 24 hours) will occur at least once during the next five years. This situation is also classified in Figure 23 as a “high” risk situation.
