RE: Comox Valley Aquatic Centre Facility Condition Assessment

Comox Valley Aquatic Centre Facility Condition Assessment
377 Lerwick Road, Courtenay, BC V9N 9G4
Weather: 8 °C, Mostly Cloudy

Structural Condition Assessment

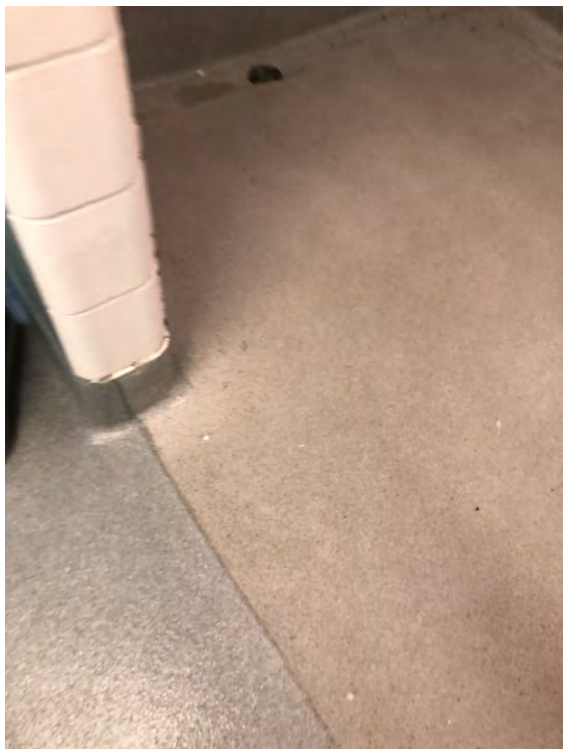
Photo 7 Joint in coating at changeroom

Location: Natatorium – west pool

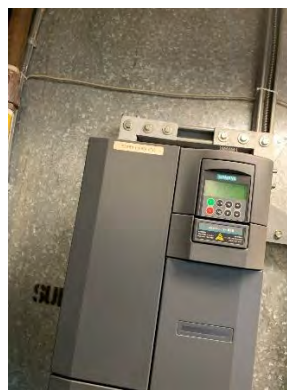
.1 AHU-1 – Main Pool Air handler

Existing unit is gas fired, 80% efficient. The unit is at its EOL, and replacement is recommended, although VFD's have been added to the Supply and Return fan, there are several options for a new unit that would provide energy efficiency and increased performance. Due to the proximity of the mechanical room to the heating plant we would suggest a passive heat recovery approach would have the lowest life cycle cost. Though it may not have the lowest GHG emissions. An Energy audit should be performed to confirm best suited replacement.

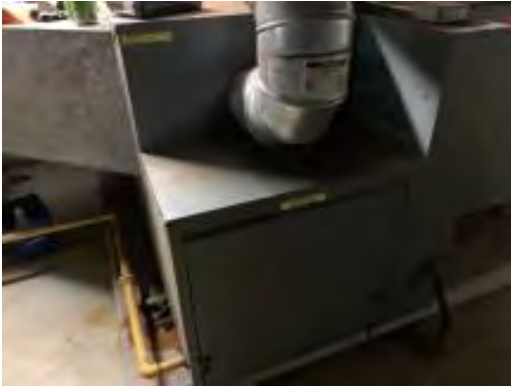
AHU-2 – Changerooms/Offices/Weight Room

Existing unit is gas fired, 80% efficient. The unit is at its EOL, and replacement is recommended. There are several options for a new unit that would provide energy efficiency and increased performance. As part of the AHU replacement, a central heating system approach could be considered. An Energy audit should be performed to confirm best suited replacement. As a minimum we recommend passive heat recovery off the changerroom exhausted areas.

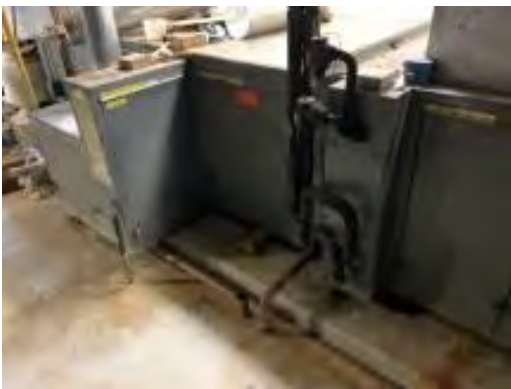
.2 AHU-3 – Offices

Existing unit is gas fired, with DX cooling, 83% efficient. The unit is at its EOL, and replacement is recommended. There are several options for a new unit that would provide energy efficiency and increased performance. An Energy audit should be performed to confirm best suited replacement.

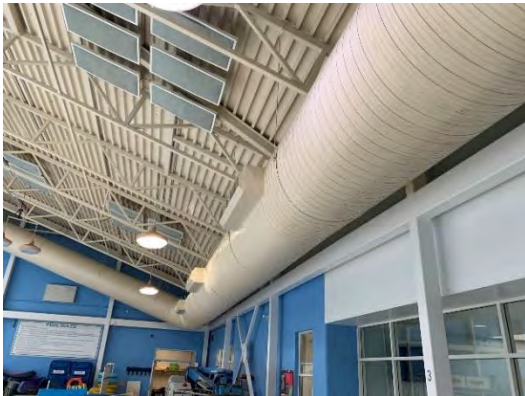
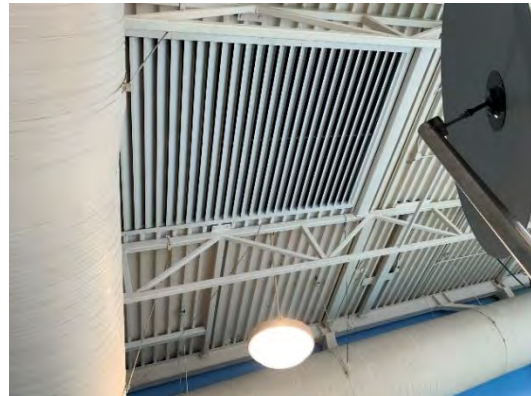
Natatorium Ductwork:

Ductwork throughout the Natatorium appeared in good condition, and was understood regular cleaning was performed. Recommendation to maintain schedule and perform inspections inside the ductwork to ensure duct is not corroding from inside out.

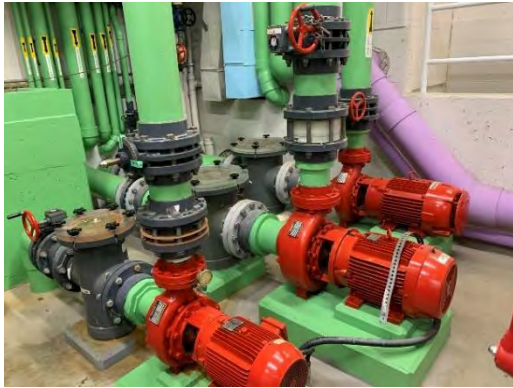
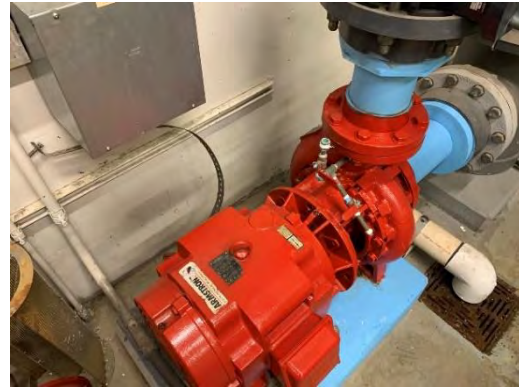
Filtration pumps:

The main pool has had a VFD added while the Wave Pool & Whirlpool are set speed. The Filter pumps age were determined to be: Main filter pump @ 8yrs, Water pool @ 10yrs, and Hot tub @ 5yrs old. Follow up discussion included that the pumps receive regular maintenance. They are monitored for sequels, squeaks, if accidental breaker trips occur, and/or identified water leak, and investigation is performed, and repair as required. Also noted in discussion, is that more recently if new pump impellers are deemed to be replaced, they have been epoxy coating the pump volutes, and powder coating pump parts to extend their life. Further investigation can be reviewed should addition VFD's to the other filter pumps and water pumps would be warranted, as an energy audit could be performed to confirm best suited options and energy savings.

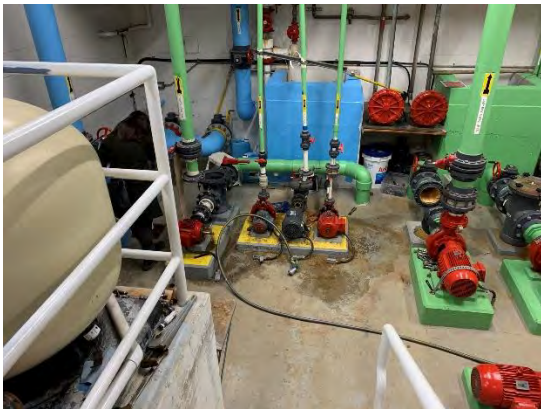
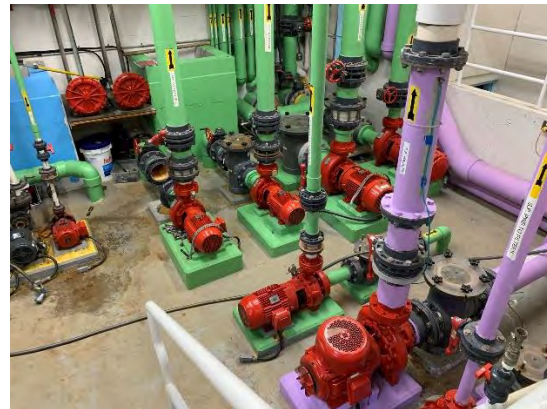
Water Feature pumps:

The water feature pumps as per above with the filter pumps regular maintenance has been performed, and pump seals, and or bearings are replaced as required, with pump volutes being epoxy coated if deemed necessary to replace. The pumps serving WF-6 & 9, were indicated to have some operation issues losing pump prime during some start stop cycles. One options could include adding a check valve and/or replacing with self priming pumps. VFD's could be an option for pumps requiring adjustable flow, such as the Lazy river should more control be required. The Wave generator currently has it's original motor, but new volute & impeller in 2020. Energy efficient options can be reviewed and consulted with White water. Further investigation should be done, and energy audit performed to confirm best suited options and energy savings.

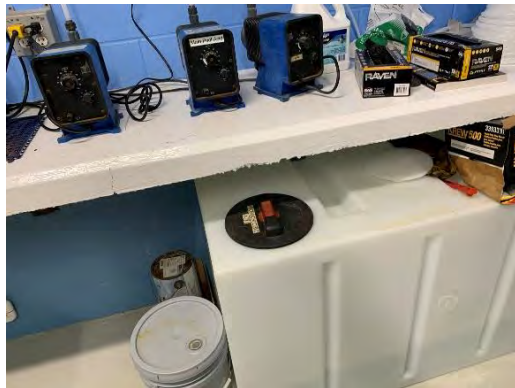
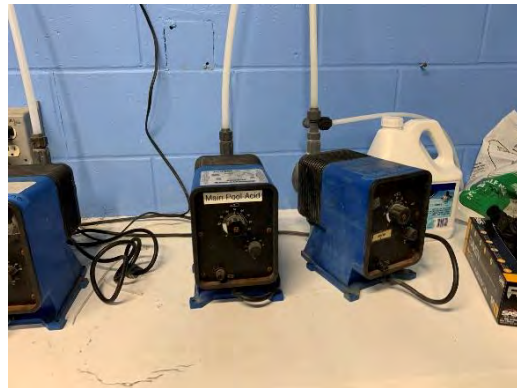
Chemical Injection pumps:

Existing injection pumps are diaphragm type. No issues were identified at time of site visit. Should upgrade of the pool system be considered, and connectivity to the BMS, options could include going to a DDA pump for more accurate injection and controllability. Further review can be performed to determine options for the facility.

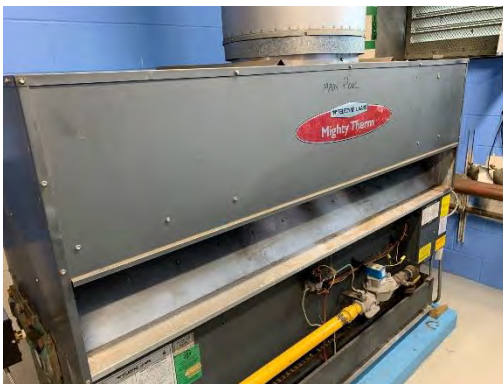
Main Pool Heater

The pool heaters were not noted as having any issues. The Main pool heater had the heat exchanger replaced in 2017, the Wave pool was done in 2020, and the Whirlpool heater is from 2019. While no significant issues were identified at the time of the site visit, remaining life expectancy would be approx. 3 years, 5 years and 7 years for the Main, Wave and Whirlpool. You may want to consider implementing a central low temperature plant which would provide pool heat, domestic hot water heat as well as heating for building and ventilation. This eliminates pool water from corroding the heaters and provides better opportunity to increase building efficiency. Further investigation with pool design should be reviewed to confirm preferred system, as well energy audit to confirm best suited options.

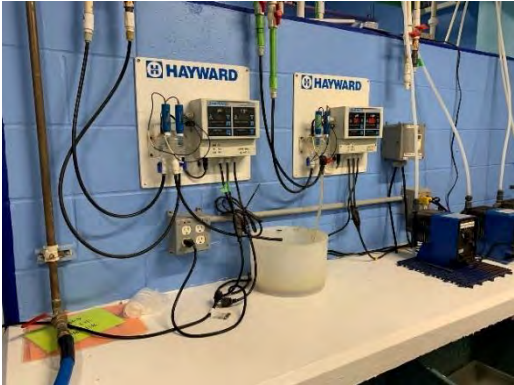
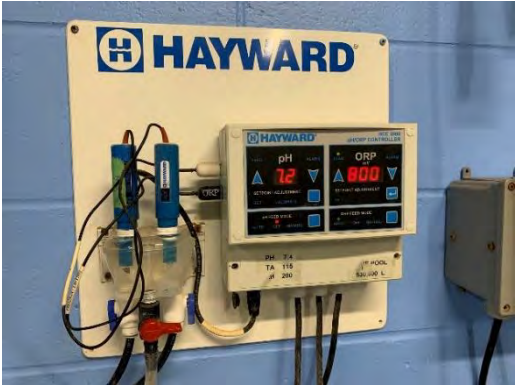
Chemical Controllers:

The existing chemical controllers were not known to have any issues, appear to be relatively new. Options could include as part of the pool automation system, with Newer chemical controllers that are available that would be capable of connect ability to a DDC, this would allow for either the building automation to control or at minimum and remote monitoring.

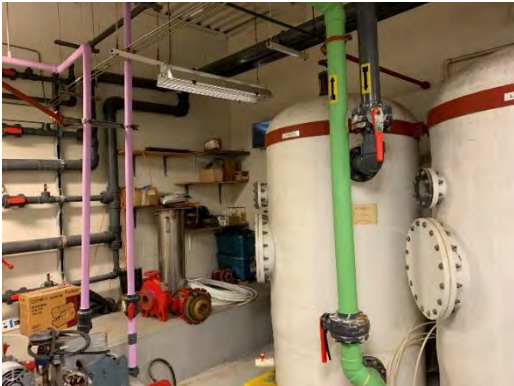
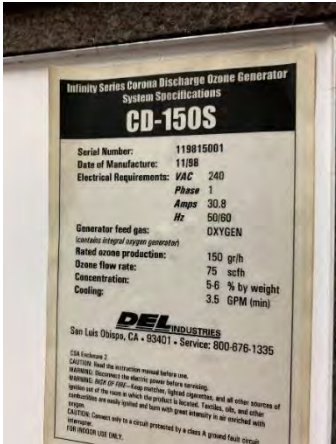
Ozone Generator

The existing Ozone system is past EOL, and recommendation to remove entirely. Secondary disinfection should be considered to replace the Ozone. There are many options, that can be evaluated. Further investigation with pool design can be reviewed to confirm the preferred system.

UV filters, Wapotec Hydroxan - Hydrosan and clear comfort are all secondary treatment options that should be evaluated as a potential replacement for ozone. The most common in BC is UV.

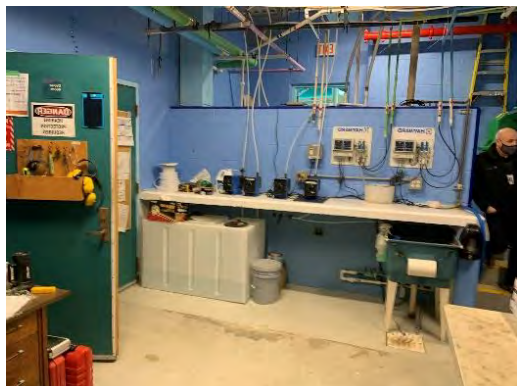
Chemical Room

Chemical tanks at time of site visit had no containment. During site visit it was discussed the process of how chemicals were mixed and transferred. The Bulk feed and Sodium Hypochlorite tanks were located next to the door leading to the pool deck. While the Sodium Hypochlorite tank was recessed in a containment area, the Bulk feed tank was on top the floor. The larger Sodium Hypochlorite tanks located in the upper pool mechanical room had no containment nor were the tanks double wall. Nearest eye wash/drench shower was not measured for distance but does not meet work saft guidelines.

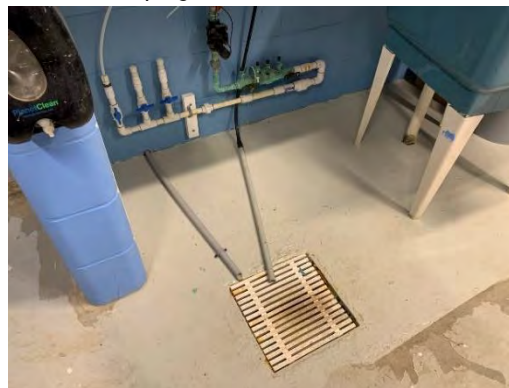
Piping from Bulkfeed Tank

A sump pump was used as a bulk feed pump for the pools (shown in Pic above), this type of pump is not suitable for chemicals, and will corrode quickly. Further review required and discussion with CVAC & staff to determine best suited options, as per worksafe guidelines noted above.

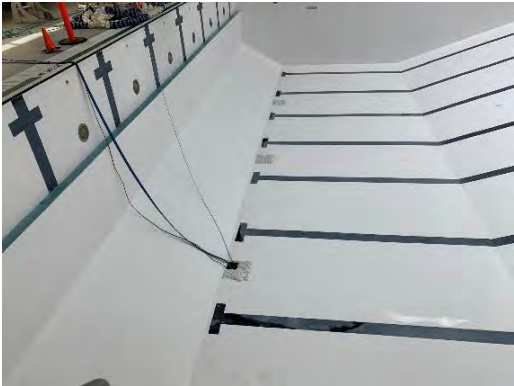
The Lap Pool & Wave pool main drain covers were replaced with VGB compliant covers. no further action required.

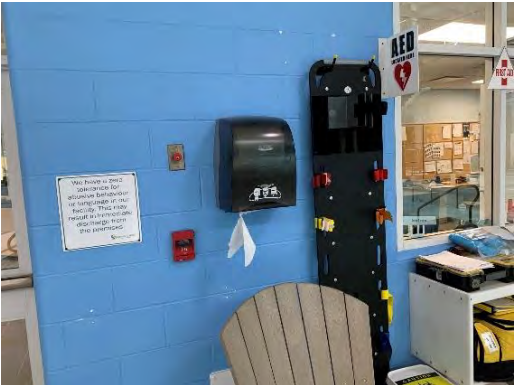
Pool Deck Emergency Stop buttons:

I was observed that the emergency stop buttons were not clearly identified, recommendation would be to provide clear signage.

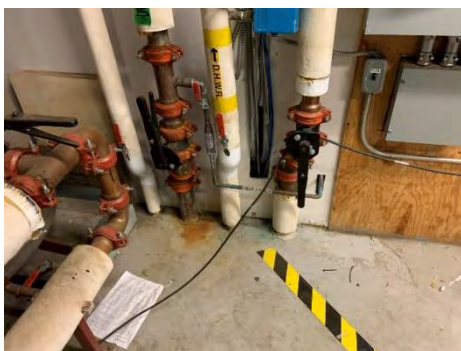
Domestic water distribution

No issues were identified at the time of the site visit, with regular maintenance recommended, and inspection for water leaks or pipe vibration can be performed. Inspection for loose insulation should be replaced to ensure heat loss is minimized, and water hammer arresters replaced if pipe hammering is overserved.

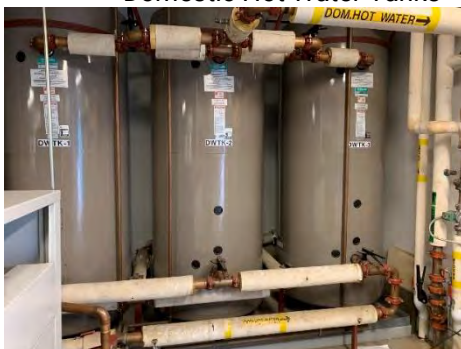
Domestic Hot Water Tanks

The domestic hot water storage tanks are near EOL, and replacement should be planned for. Numerous locations of piping were missing insulation, it was not discussed if this was for inspection purposes or was removed for some other reason. The Domestic hot water boiler was replaced in 2016, therefore no action required. However, should a central heating system be considered, the domestic hot water system should be reviewed at the time. There are several options that could be implemented that have potential for energy efficiency and reduce GHG's. An Energy audit should be performed to confirm best suited design. Refer to central heating plant description.

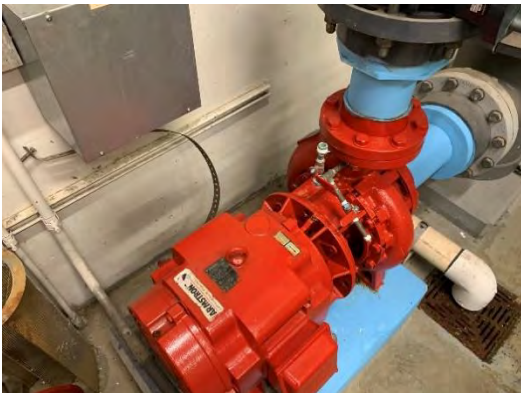
Floor Drains:

Floor drains appeared in reasonable condition throughout the change rooms, not issued were identified at the time of the site visit. Mechanical room floor drains should be inspected, in particularly in the Pump pit, as the drains were very corroded, and inspection and pipe scope should be performed to ensure no leaks in the piping. The drains should be replace with new corrosion resistant fixtures.

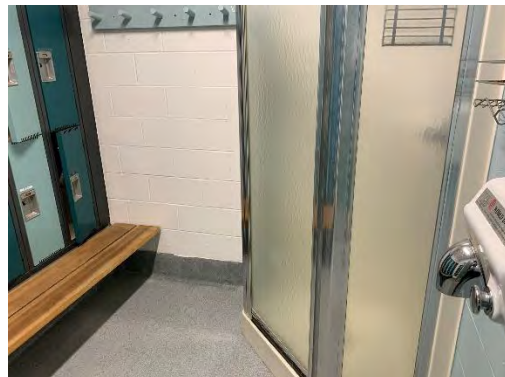
Staff change room shower

No issues were identified at time of site visit, regular maintenance, would require spring return to be inspected as they tend to corrode for push button showers and lavatories. Staff shower should be inspected, and replacement considered for base and enclosure to ensure no leakage. Further review required to identify if other fixtures require replacement or maintenance. Further discussion with facility staff, was indicated that there was no intent to change fixtures. Should this change in the future, consideration could be to limit the amount of contaminants, we would recommend replacement using Hands free technology. This could be by solar rechargeable batteries or hard wired.

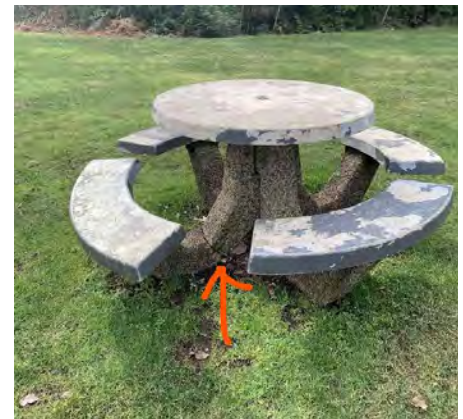
Photo A2 Damaged site furniture

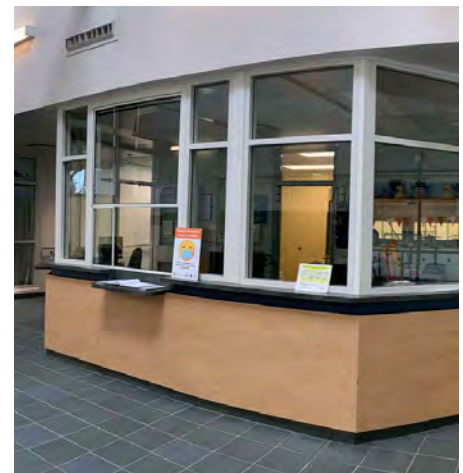
Photo A3 Reception millwork

Component	Description	Comment/Assessment
C1030 Reception Counter (Photo A3)	Service Counter non-compliant to current BCBC Section 3.8 (Accessibility)	BCBC requires at least one section of service counter not more than 865 mm above the floor. Recommended renovation to achieve recommended 760mm compliant counter.
D2010 Plumbing Fixtures - DF-1 (Photo A14)	Drinking Fountain at Public Corridor non-compliant to current BCBC Section 3.8 (Accessibility).	Model does not allow for requisite clearance under fountain. Replace drinking fountain with compliant model.

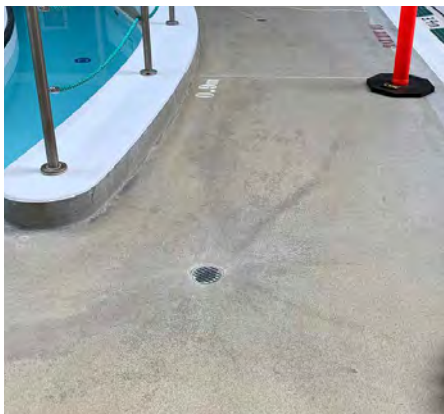
Photo A4 Deterioration at pool deck epoxy flooring

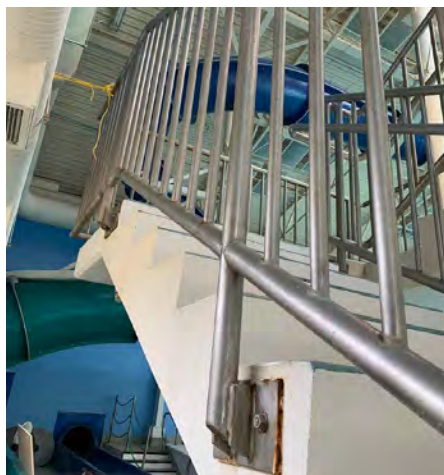
Photo A6 Stainless steel guards at pool

- Minor rusting at stainless steel guard rails, fittings and escutcheon plates, including waterslide stair railings (Photo A6)
- Minor rusting at interior doors at natatorium (Photo A7)
- Rusting at staff room lockers
- Deterioration at 25m pool grates (Photo A13)
- Fading/deterioration of fiberglass water slide flume and exit section

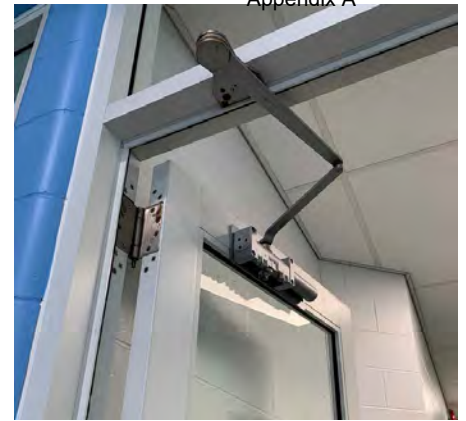
Photo A7 Interior doors at natatorium

Component	Description/Comment	Recommendation
C1020 Interior Doors (Photo A7)	Interior Painted Metal Swing Doors and Glazed Storefront Doors. Minor rusting observed at high humidity areas.	Replace doors and as required to maintain functional performance. Assume 10% for budgetary needs.
C1030 Fittings (Photo A8)	Washroom Partitions - Painted Metal and Plastic/ Phenolic. Deterioration observed.	Replace as required. Full replacement at Men's & Women's Washrooms. At Changerooms, assume 20% for budgetary needs.
C1030 Fittings (Photo A9)	Wood cabinetry, laminate counters and desk at Staff Room and Head Guard Room in poor condition due to high humidity and general use.	Replace millwork counters and cabinets (AWMAC Quality).
C3020 Floor Finishes (Photo A10)	Sports Flooring at Fitness Centre deteriorated at select locations	Replace resilient athletic flooring.
C3030 Acoustic Ceiling Tile (Photo A13)	Lay-in Acoustic Ceiling Tile. Observed staining, damage in various locations.	Replace lay-in exposed grid tiles and investigate leaks. Assume 10% replacement.

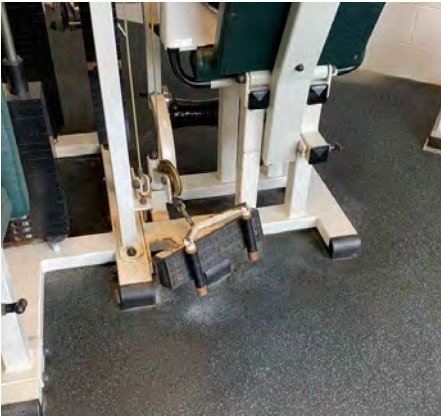
Photo A10 Resilient Sports Flooring at Fitness Centre

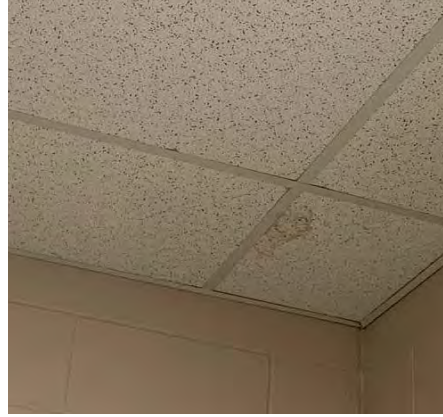
Photo A11 Staining at acoustic ceiling tile at Rm. 138 (Concession).

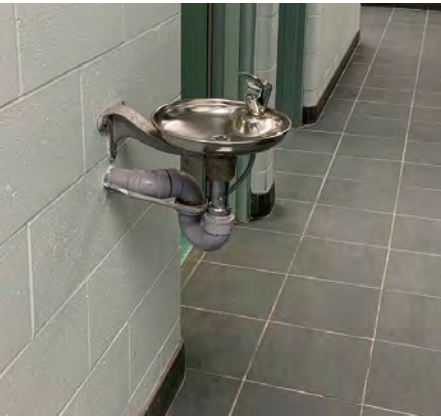
Photo A12 Drinking Fountain at Corridor 135

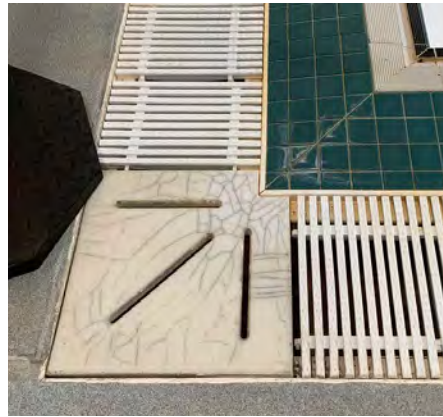
Photo A13 Swimming Pool Grate at 25m pool.
