Infrastructure Improvements Discussion

COMOX VALLEY CYCLING COALITION

NOVEMBER 2020

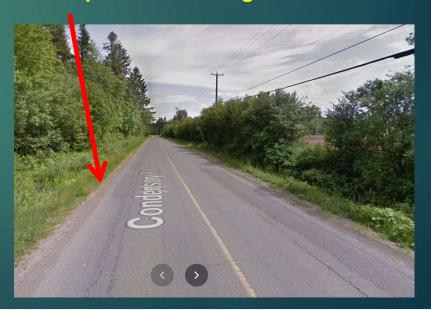
Condensory Rd – near Cessford Rd

- No Shoulder for Cyclists
- Ditches, utility poles and KFN Lands add a degree of difficulty to any solution
- Should also include extension of One Spot Trail to Bridge

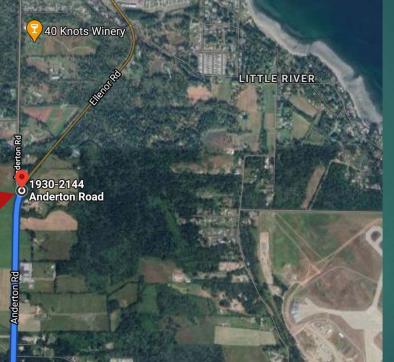
Extremely Poor Shoulder on Hill near Ryan Road

- Busy roadway Highly used by recreational and commuter cyclists, ferry users, and vehicles
- Sept 2020 Courtenay sewer pipeline work
- Shoulders are narrow and in terrible condition on hill
- Shoulders exist from bottom of hill to Ellenor but are very narrow
- Shoulders are in need of maintenance at Ellenor/Anderton intersection

- Shoulders are narrow to begin with on hill and have degraded with use, as well as due to access road gravel movement
- Very dangerous situation for cyclists in a high speed/high volume traffic area

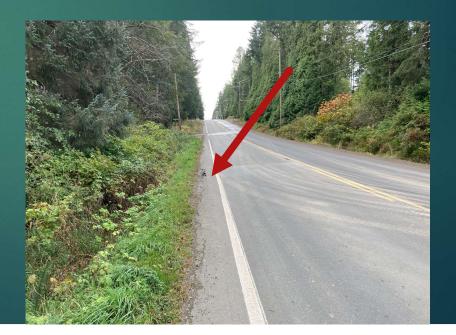
Sewer Line Work – Timing for Re-Paving

- Greenwood sewer line was extended in Sept 2020 by City of Courtenay and a portion of Anderton Road was excavated in the process
- When the road was repaved, it would have been an opportune time to also widen and repave the shoulders on the hill portion of Anderton. This is a perfect example of where CVCCo hopes to see better co-operation between road jurisdictions.

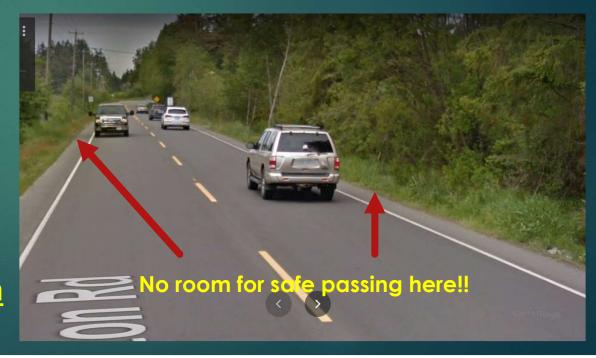
Narrow Shoulders – Anderton Road

Shoulder is very narrow and degraded to point of being dangerous

Speed Limit = 60-80 km/h

- Both shoulders are very narrow from Hamilton Rd north to Ellenor Rd intersection
- At 80 km/h, current shoulder width is definitely not safe to allow vehicles to pass cyclists

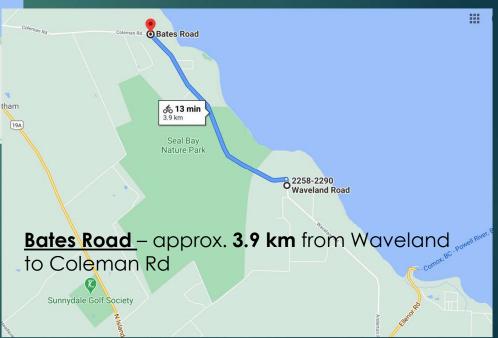
<u>Poor Shoulder – Bates Road</u>

- Shoulders on Bates Rd are either nonexistent or unpaved and dangerous for cyclists
- Speed limit is 70 km/h
- Poor visibility, very shaded in spots

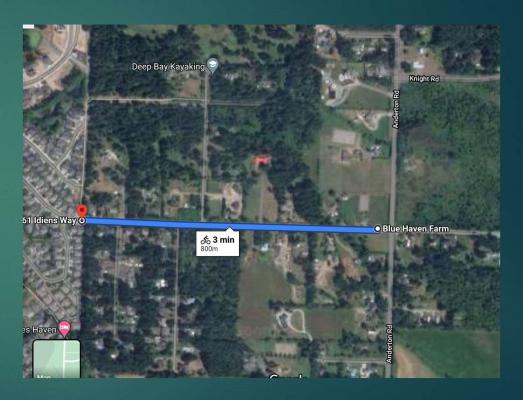
<u>Lack of Shoulder – Idiens Road</u>

- MoTI portion of Idiens Road has no accommodation on shoulder for cyclists or pedestrians
- 2018 Hudson Sewer Trunk
 Line Expansion along Idiens
 provided for a gravel
 shoulder on the south side
 but it was not paved and is
 unsafe for cycling

6	Idiens Road	0.8 km of shoulder upgrades from CoC boundary to Anderton Rd	Repairs to potholes	Hudson sewer trunk extension was not paved (Comox)
