**RE: Shoreline Protection Devices and Steep Slopes Development Permit
Lazo North (Electoral Area B)
955 Balmoral Road (Renooy)
Lot 1, District Lot 140, Comox District, Plan 4043 Except that Part in Plan
16734, PID 006-149-341**

To consider a Shoreline Protection Devices and Steep Slopes Development Permit (DP) for repair of a hard shoreline protection device (rock revetment wall) at the toe of Willemar Bluff (Appendix A).

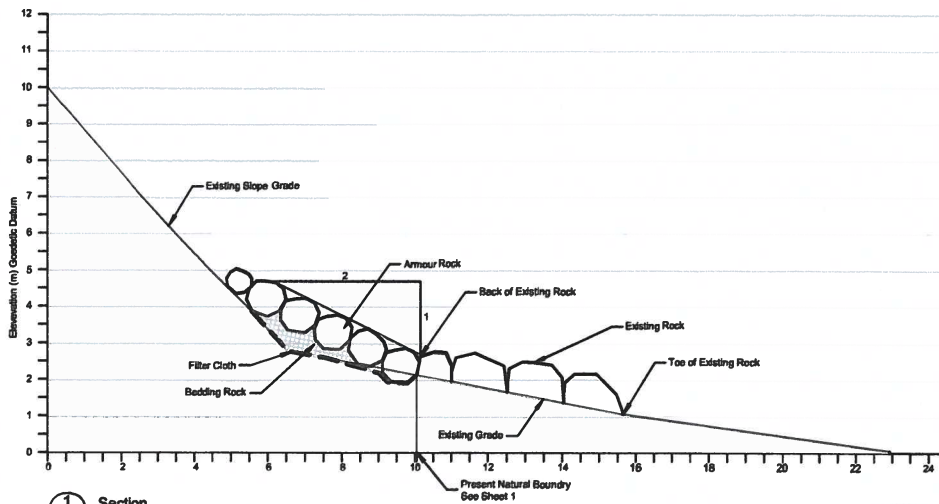
1 Section
3 Scale 1:100

- Remove Woody Debris
- Excavate Trench for Toe of Rock
- Place Filter Cloth Amtec 400 Non - Woven or Equal
- Place Bedding Rock 300mm Minus Angular Rock
- Place Armour Rock 1m ± 0.2m Measured by Average of 3 Perpendicular Directions, No Single Dimension Less Than 0.6m
- Rock Shall Be Hard Dense Granitic or Basaltic Rock

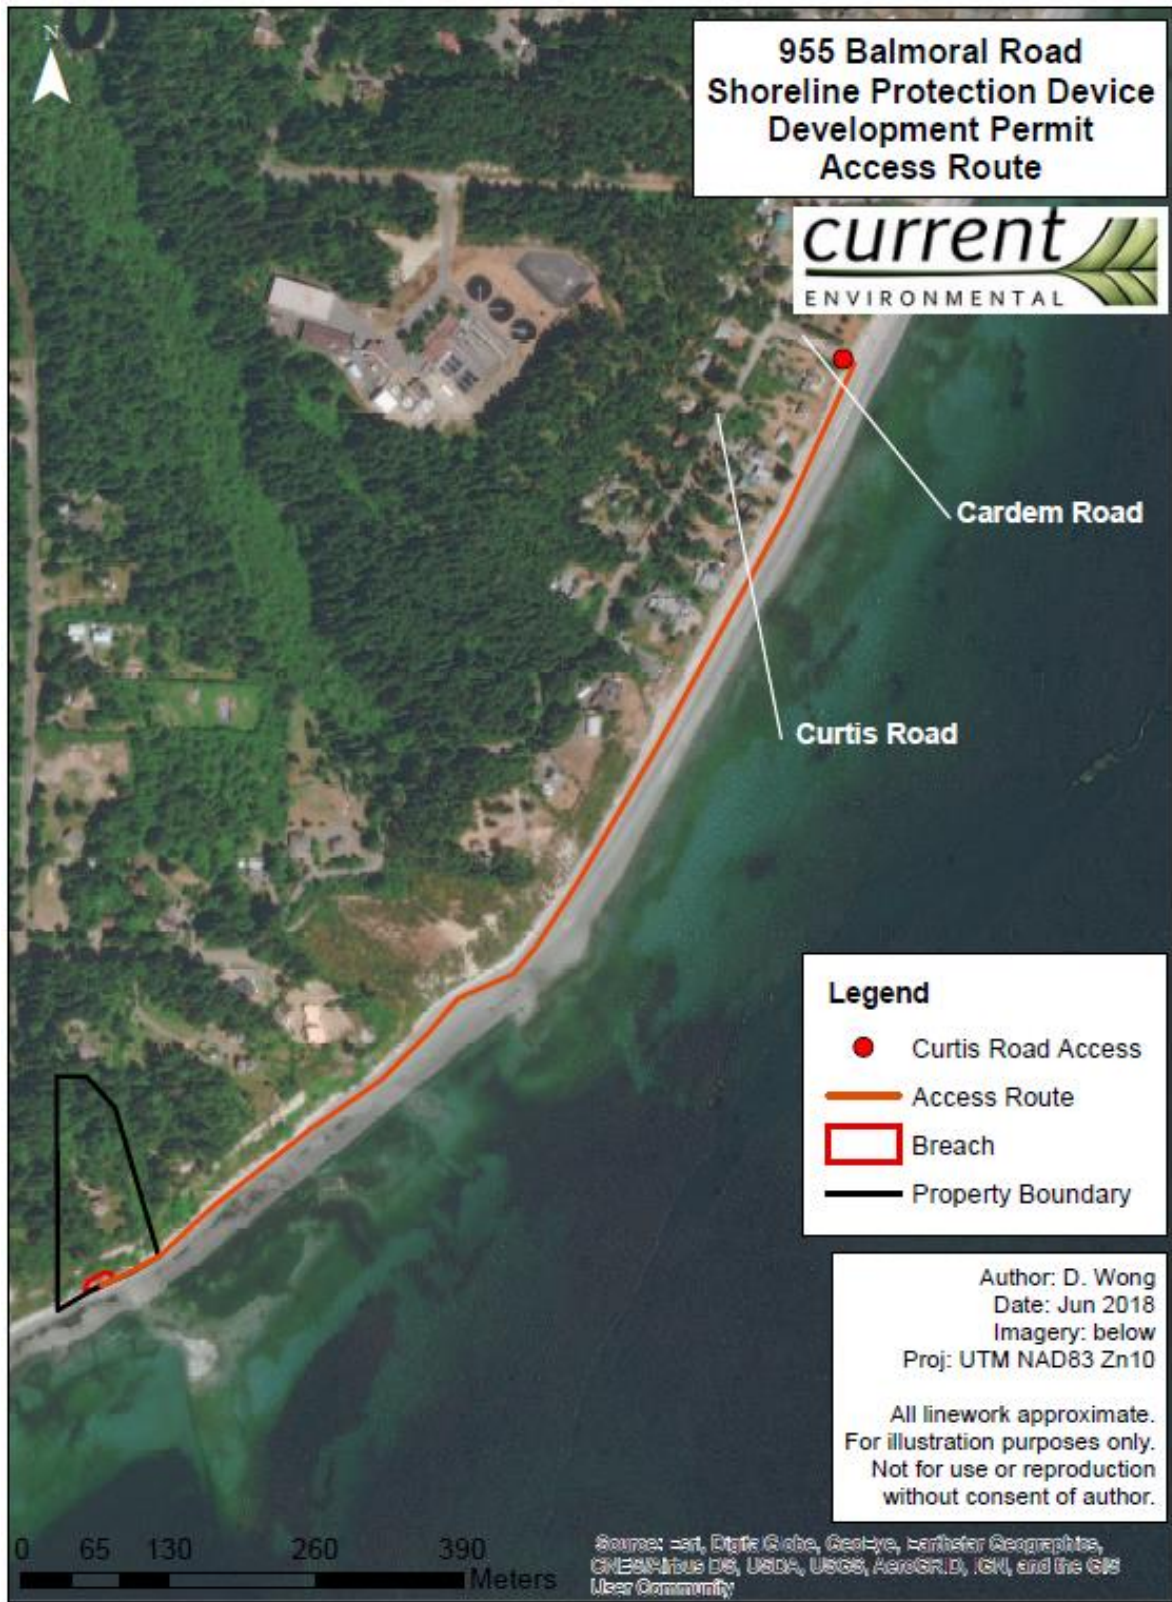
Figure 3. Map of the access route for machinery to work on the shoreline at 955 Balmoral Road.

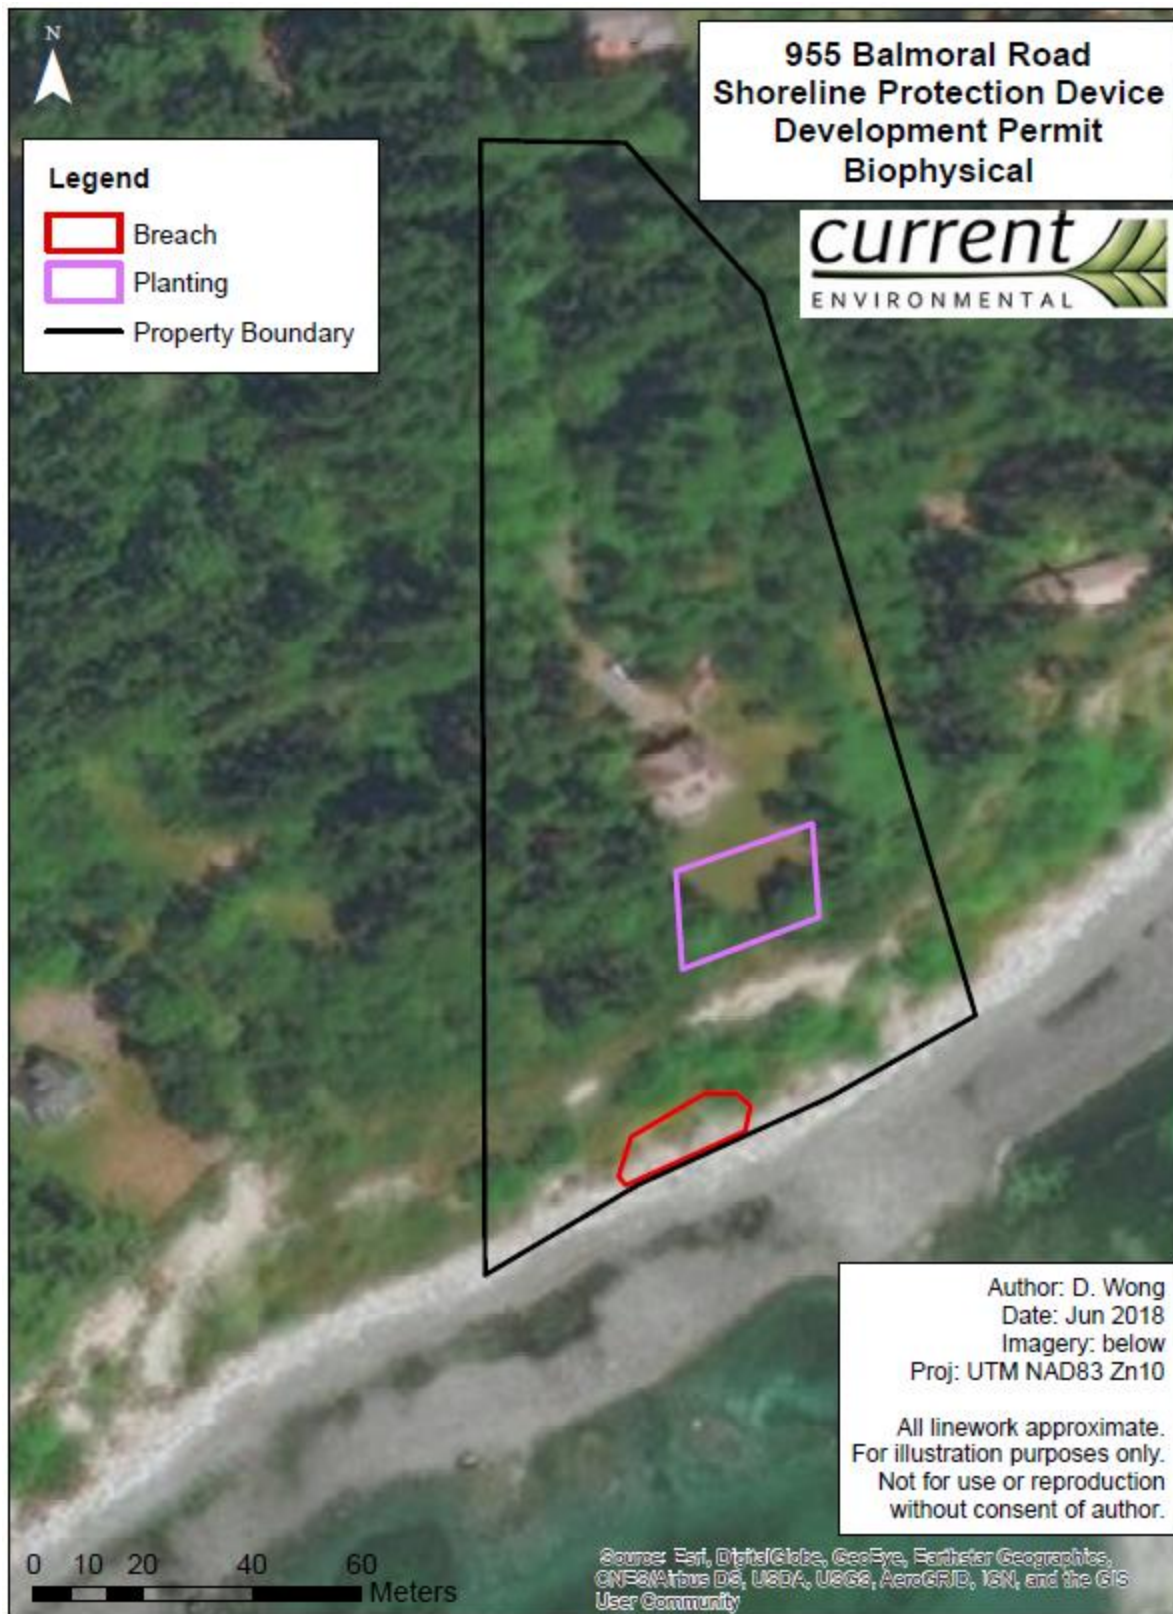
Figure 4. Map showing the approximate locations of the breach and area to be planted.

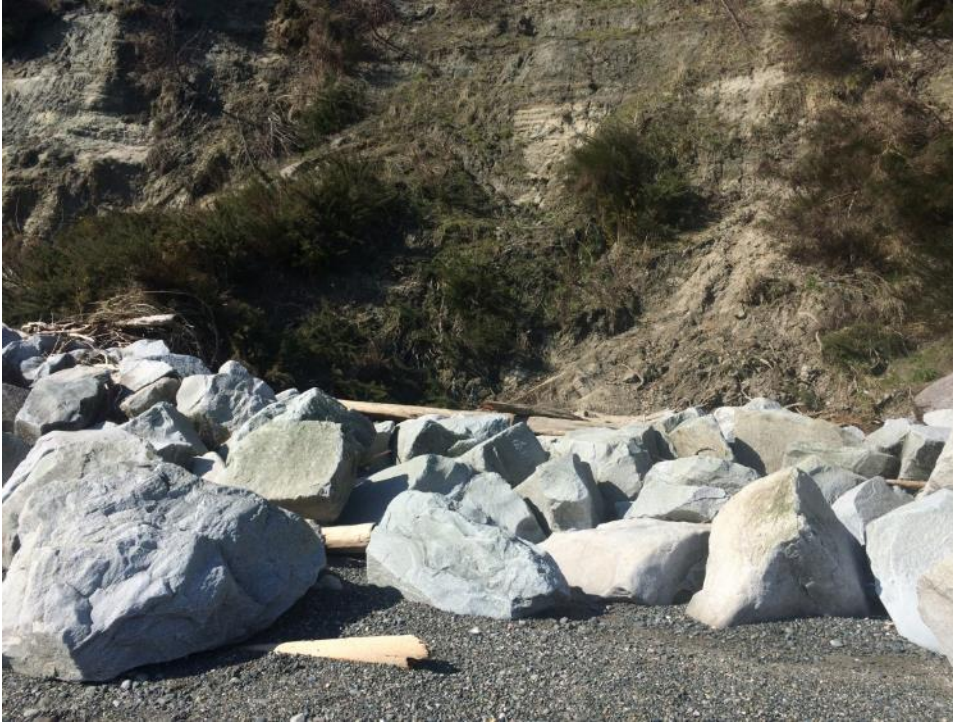
Photo 1. View of the breach in rip rap at the subject property.

The existing rip rap is located partially within and partially outside of the property boundaries for the subject property and was originally installed in 1993. There is a breach in the existing rip rap structure, and the proponent wishes to repair the damage. The breach is located on a portion of the rip rap which is partially outside of the property boundary on Crown land (Photo 1), but repairs are entirely within property boundary landward of the existing rip rap toe (Appendix A). The area of proposed work is outside of the area below high water mark that requires a DFO Request for Review (RFR). There is no requirement for an RFR for machine access to the site.

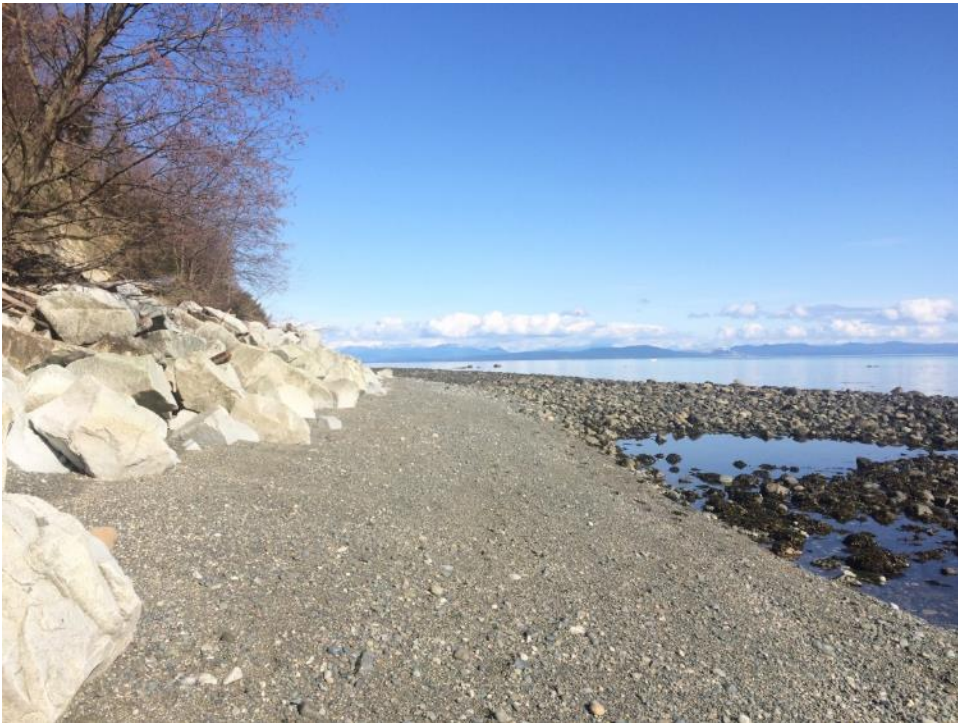
Photo 3. View of the shoreline adjacent to the subject property looking east.

Substrates were assessed from the high water mark (HWM) to the water's edge at the time of the assessment. The substrates were characterized by two distinct sizes measured from the toe of existing rip rap to the water's edge (Photo 3, Photo 4, and Photo 5). The first 6 m adjacent to the toe of the rip rap comprised of sandy pea gravel with

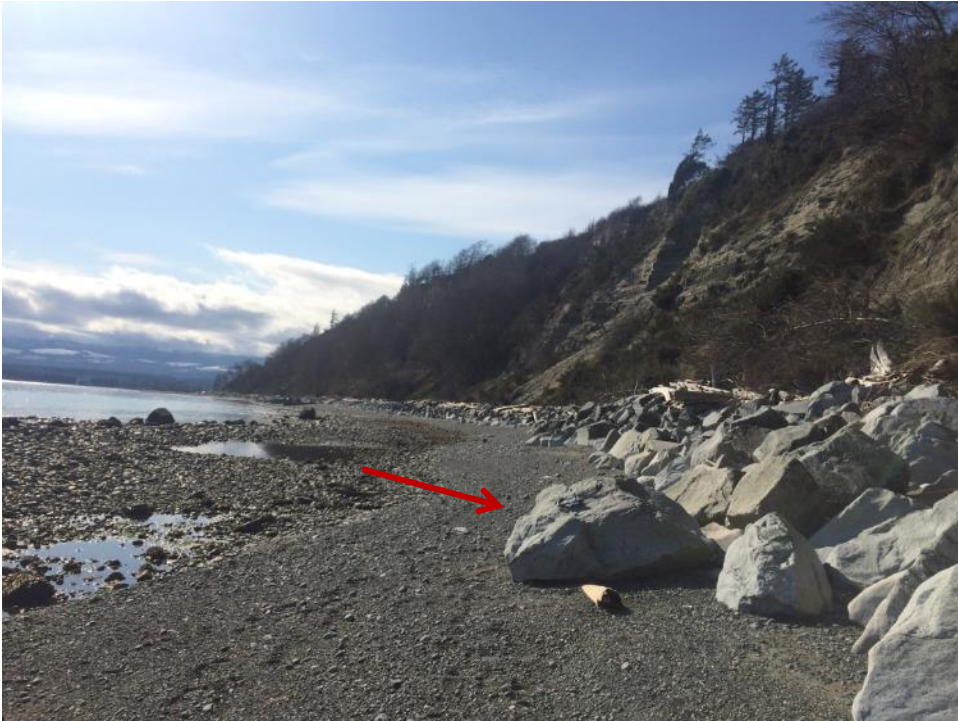
Photo 4. View of the shoreline adjacent to the subject property looking west. Note the rip rap out of place near foreground (red arrow).

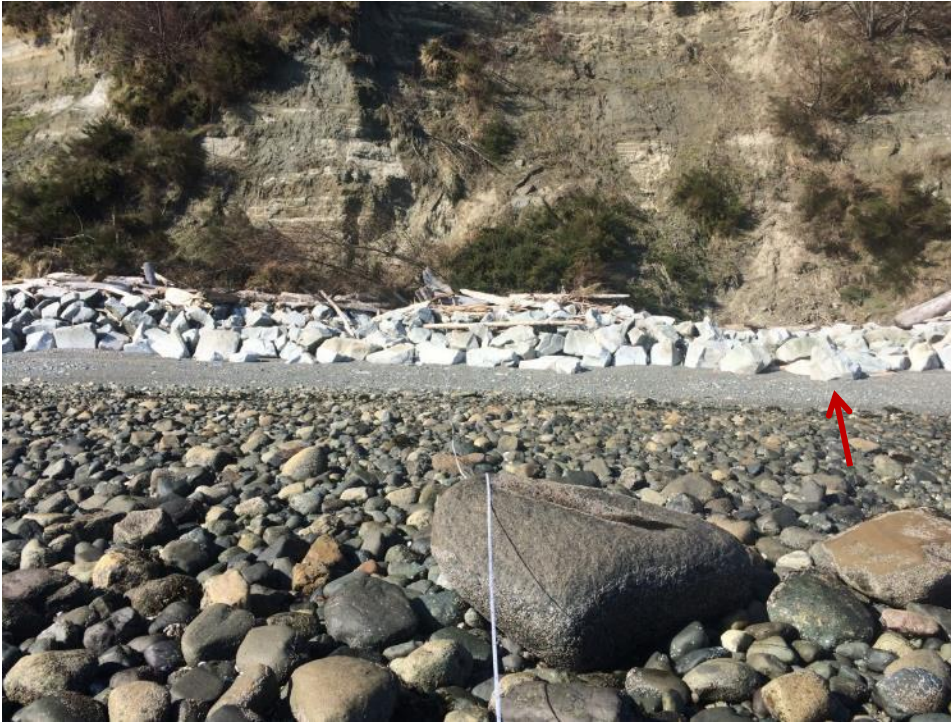
Photo 5. View of the shoreline adjacent to the subject property looking north. Note the breach in rip rap below a slope failure (red arrow).

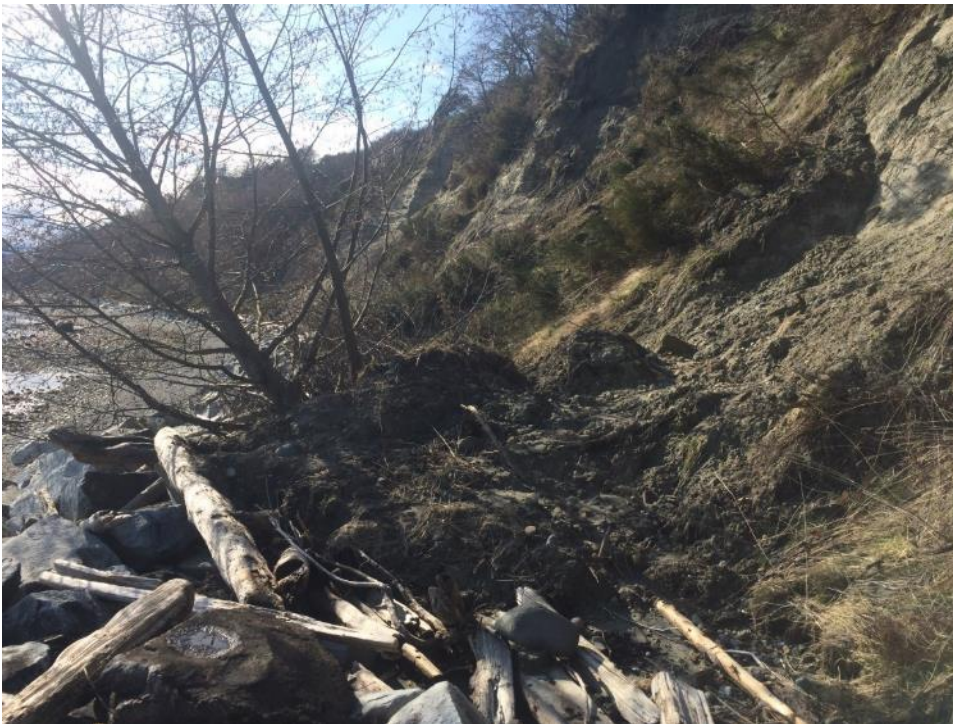
Photo 8. View of a recent slump and slanted alder.

The majority of the subject property is well vegetated; a small area has been almost entirely cleared of native vegetation in the space between the house and bluff (Photo 6), and has been maintained as a grass lawn. The rest of the property has suitable cover with native and invasive vegetation growing around the house at the property boundaries on the north, east, and west (Photo 7). Backshore vegetation near property boundaries includes Douglas-fir, young maple trees, Nootka rose, dull Oregon-grape, swordfern, and some Sitka spruce (potentially on the adjacent property). Invasive species on the property included Scotch broom, Himalayan blackberry, and holly. The face of the bluff was sparsely vegetated with alder trees, Scotch broom, and gorse. There has been some slumping on the face of the bluff. One alder near the base of the bluff has tipped downslope as a result of slope failure (Photo 8).

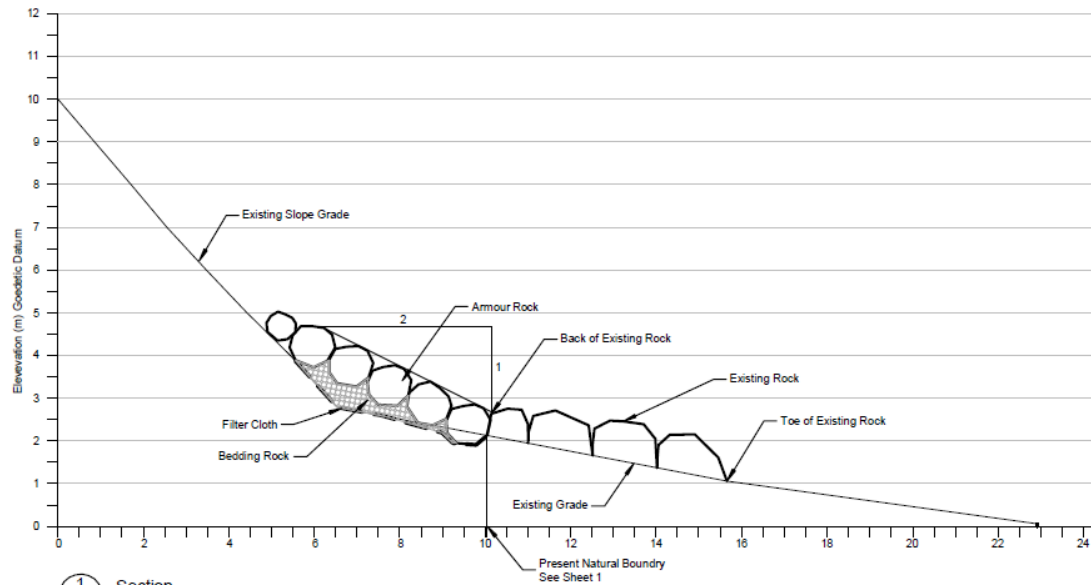
1 Section
3 Scale 1:100

- Remove Woody Debris
- Excavate Trench for Toe of Rock
- Place Filter Cloth Armtex 400 Non - Woven or Equal
- Place Bedding Rock 300mm Minus Angular Rock
- Place Armour Rock 1m ± 0.2m Measured by Average of 3 Perpendicular Directions, No Single Dimension Less Than 0.6m
- Rock Shall Be Hard Dense Granitic or Basaltic Rock

To repair the breach, a small trench will be excavated, lined with non-woven geotextile, and filled with bedding rock (300 mm minus) and rip rap (approx. 1 m). Rip rap will be installed at a 2:1 slope. See Sheet 3 of designs in Appendix A for specifications.

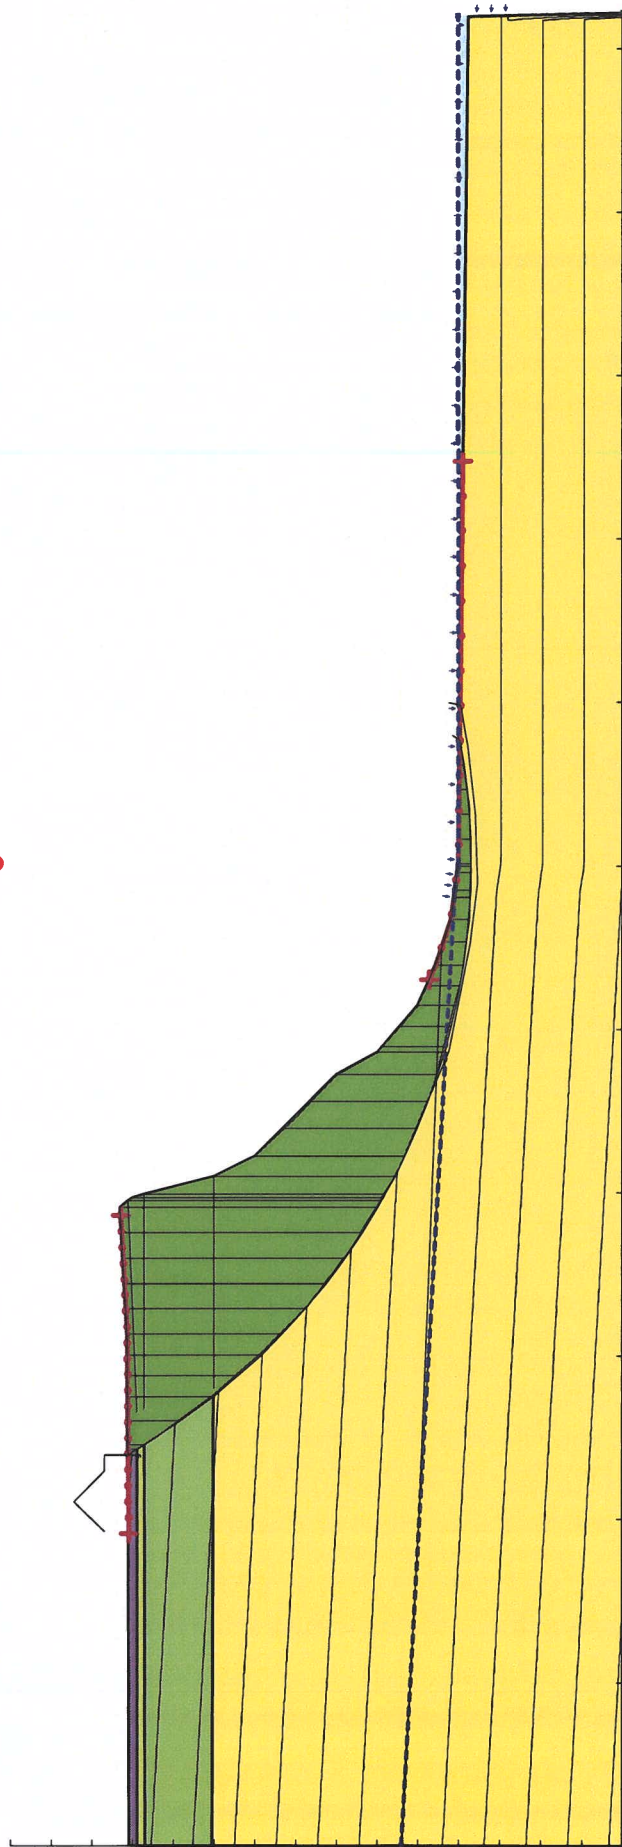
955 Balmoral Rd, CVRD, BC
 Seismic, K = 0.15, FoS = 1.144

Color	Name	Model	Unit Weight (kN/m ³)	Cohesion (kPa)	Phi (°)
Grey	Overburden	Mohr-Coulomb	17	0	30
Yellow	Quartz Sands	Mohr-Coulomb	21	0	40
Light Green	Sandy Gravels	Mohr-Coulomb	21	0	35
Dark Green	Vashon Till	Mohr-Coulomb	22	95	40
