**RE: Request to Place Notice on Title, 5862 Aldergrove Drive (Paguin / Korpan)
Lazo North (Electoral Area B)
Lot 3, Block 29, Comox District, Plan 19922, PID 003-643-654**

To recommend placement of a Notice on Title for failing to obtain the required permits for the construction of a deck and accessory structure (yurt).

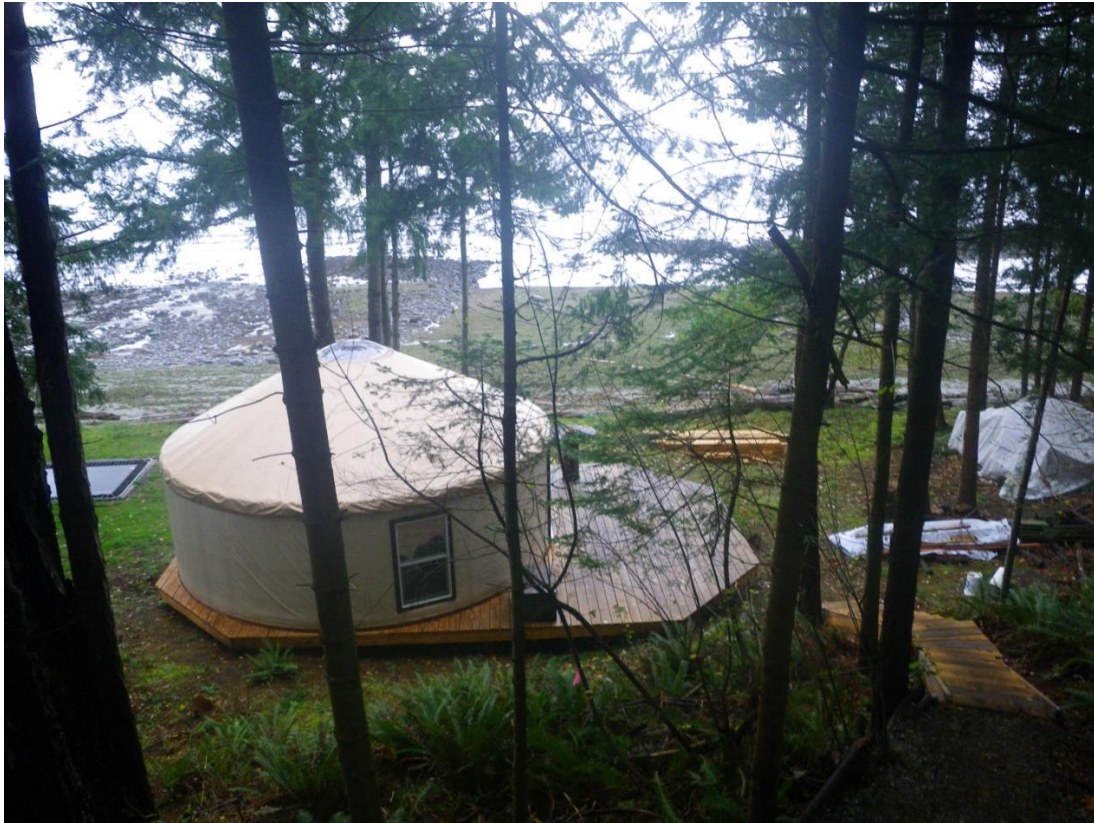
In August 2016 the Comox Valley Regional District (CVRD) received a written bylaw complaint that questioned construction activity on the property. Planning and Bylaw Enforcement staff attended and noted stairs being constructed down the slope of the property to replace an existing set. Staff also took note of an accessory structure that had been constructed on top of the deck. It was noted that the accessory structure had been constructed without a required building permit and in fact the deck in the end had been constructed above grade, to an extent that a building permit was required (Figures 1 and 2).

Figure 1: Deck and Accessory Structure

AND FURTHER THAT the board direct the owner of the property to remove the structure above the deck and adjust the grade to comply with Development Permit DP 4B 16, approved in 2016;

- Owner has been contacted numerous times but is unwilling to apply.
- Owner could remedy this by removal of the yurt and bringing in fill to ensure deck is at grade.

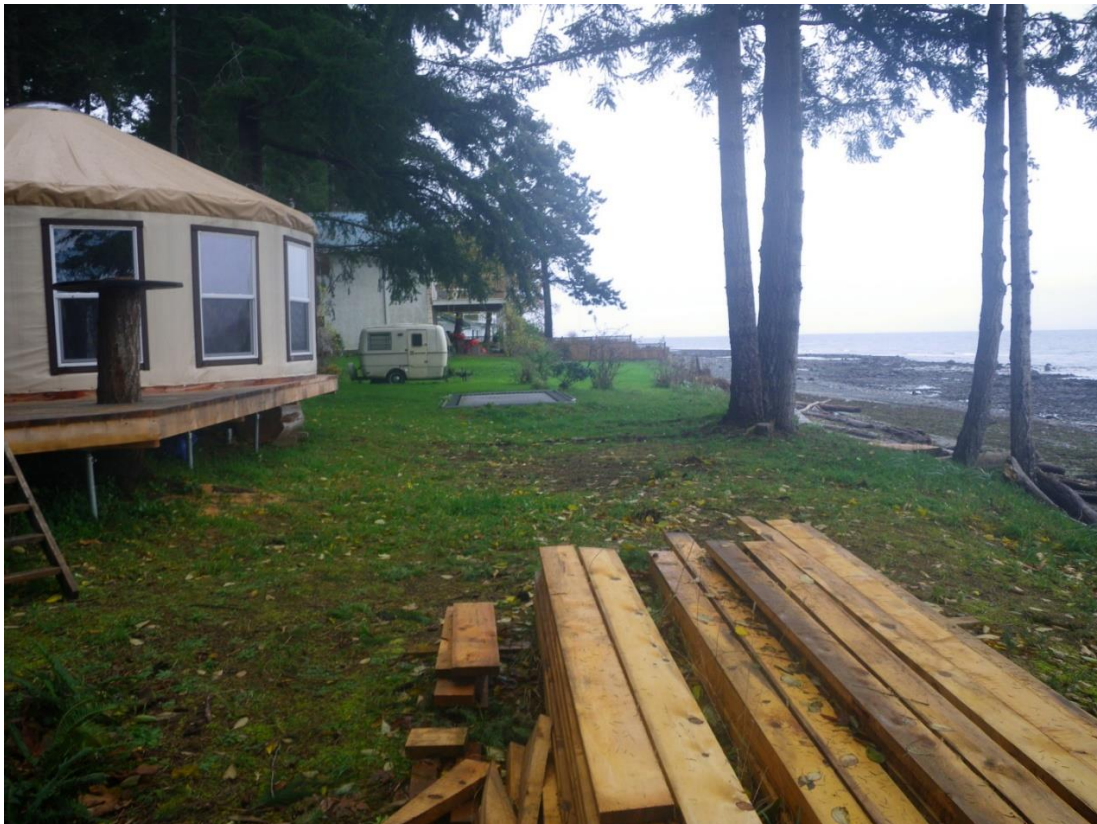
Figure 2: Deck Exceeding 600mm to the Adjacent Ground
